CONSOLIDATED SEWER MAINTENANCE DISTRICT CONDITION ASSESSMENT PROGRAM REPORT PROJECT Y0TV0708A

**CONDITION ASSESSMENT REPORT
COUNTY OF LOS ANGELES DEPARTMENT OF PUBLIC WORKS
CONSOLIDATED SEWER MAINTENANCE DISTRICT**

PROJECT NAME: Y0TV0708A	PROJECT MGR: Marzena Laskowska
PROJECT DATE: 08/22/07 - 10/12/07	CONTACT NO: (626) 300-3348
SUP. DISTRICT(S): 5	MAP PAGE(S): 1885,1938,1939,1940
Report By: Marzena Laskowska	Report Date: 10/08/08

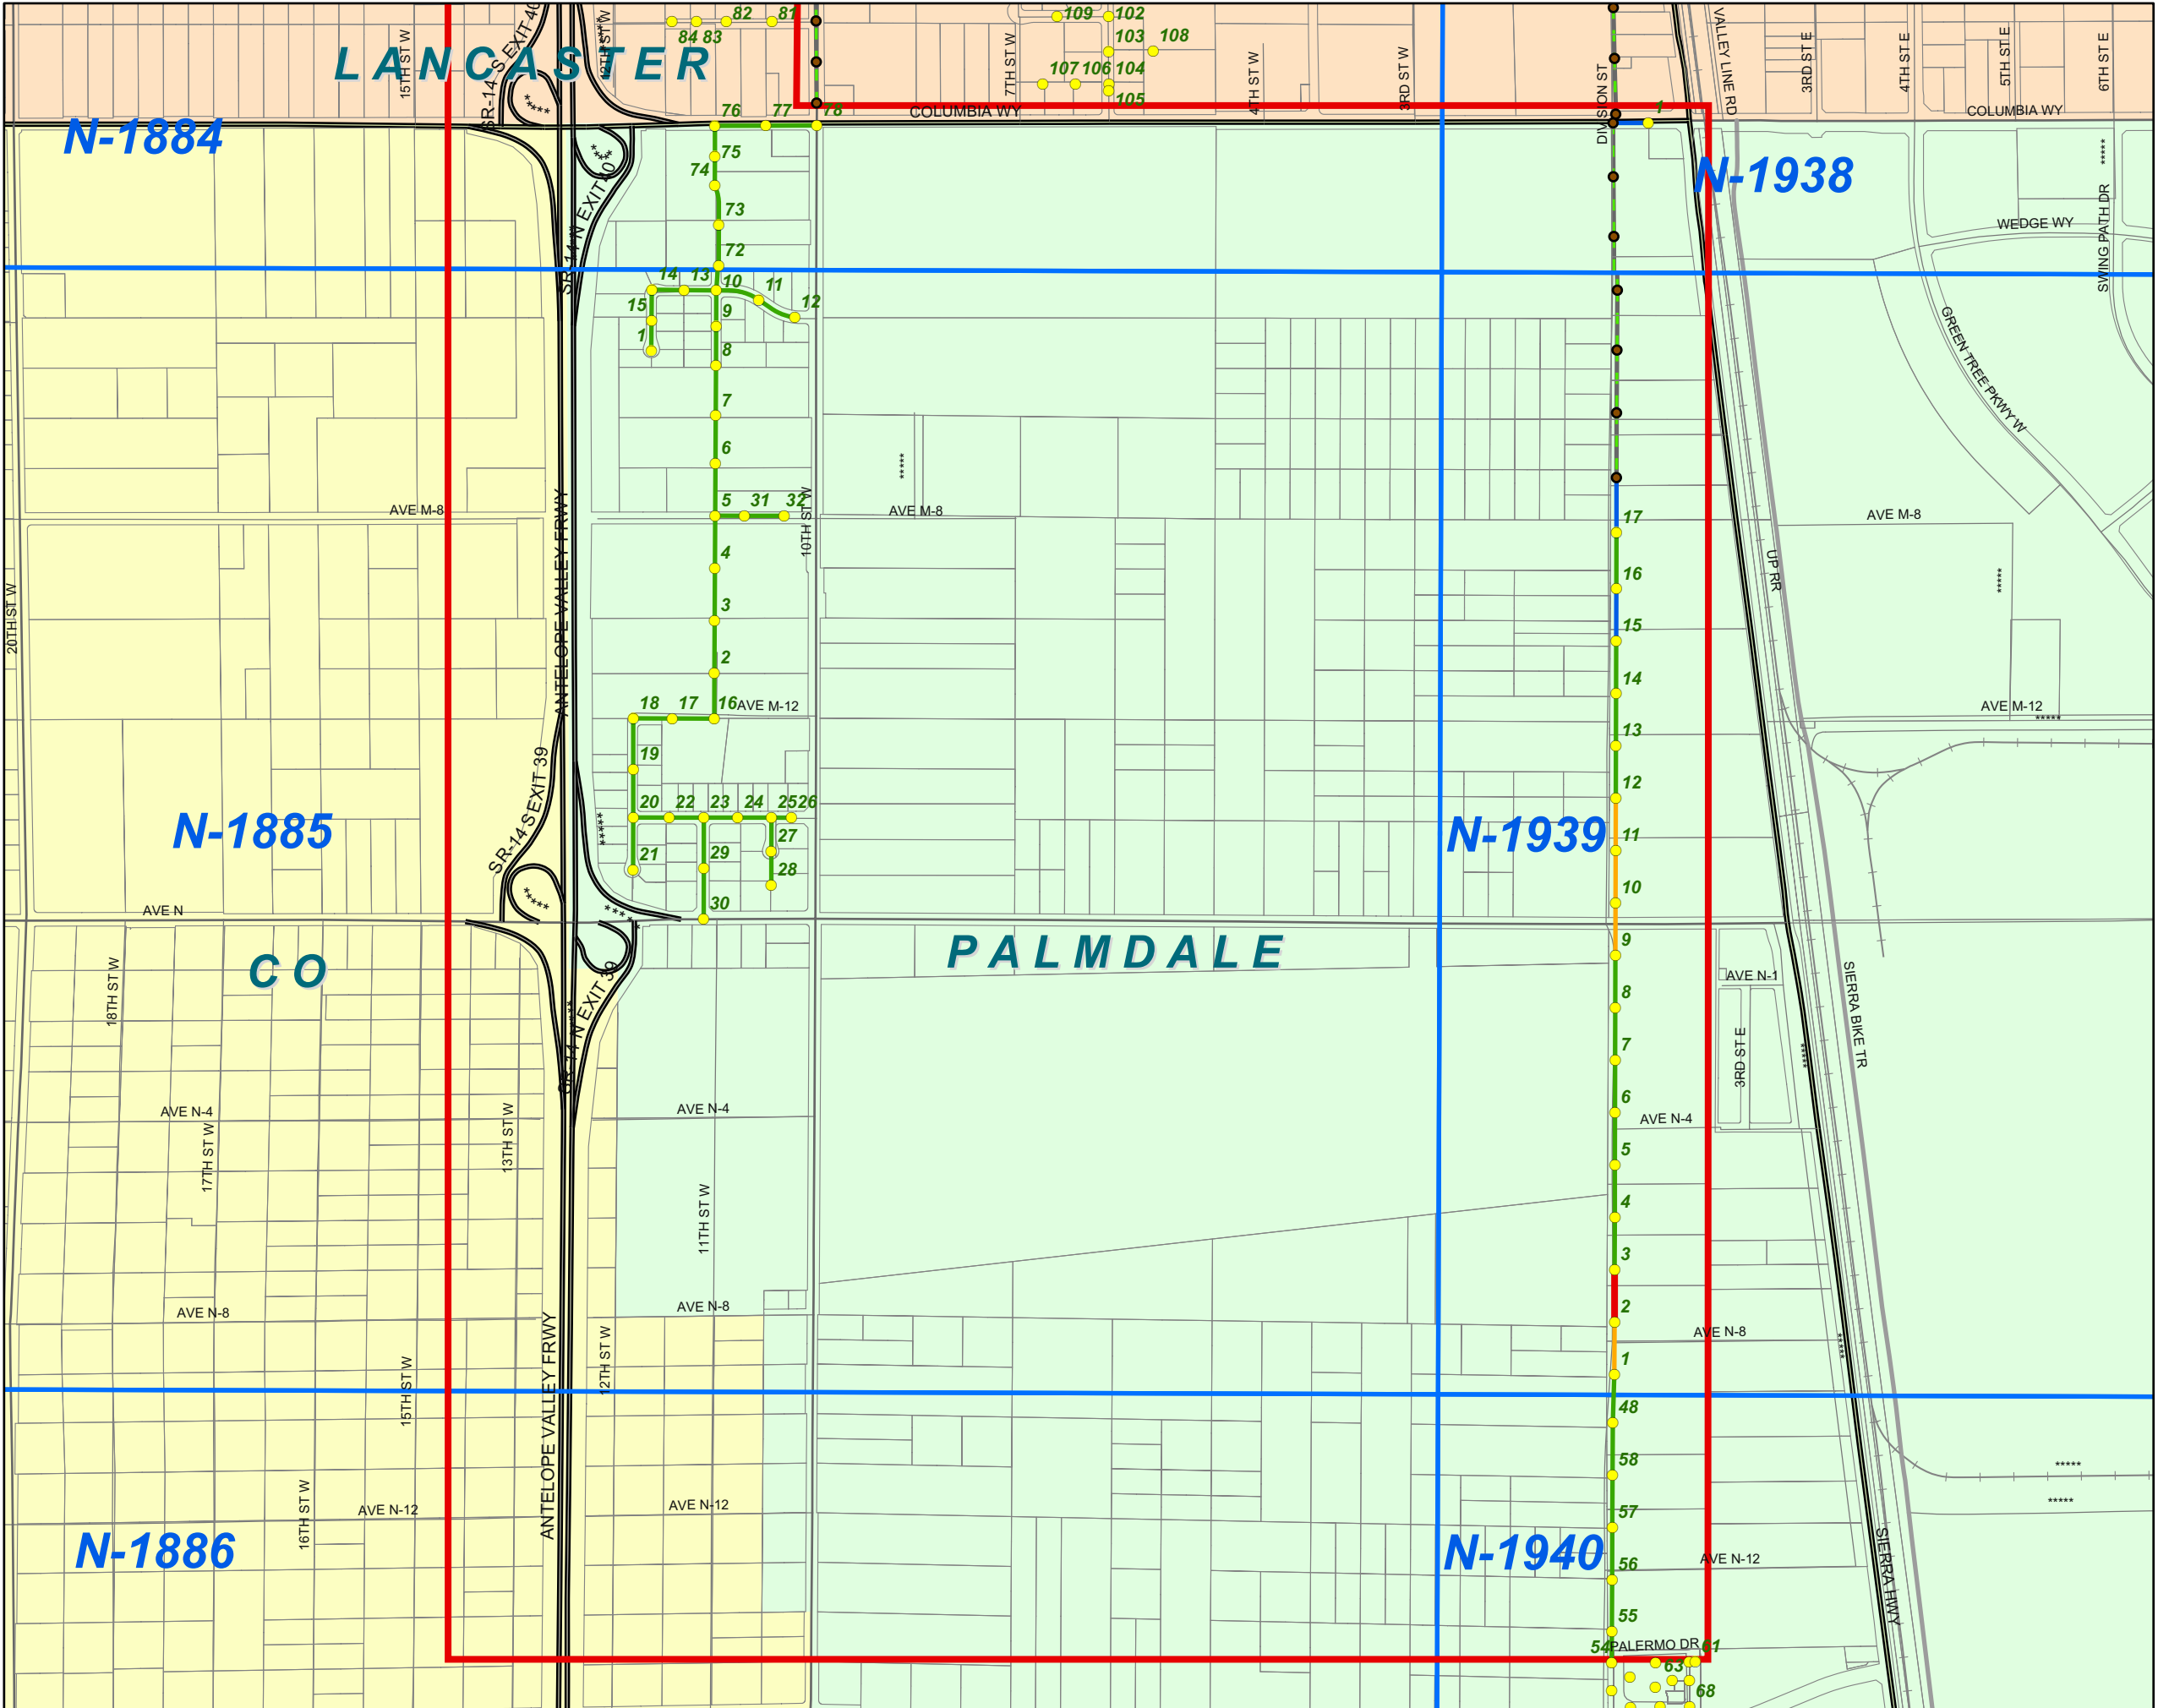
QUICK MAINTENANCE RATING (QMR)

Our inspection revealed that approximately 98 percent of the system televised was free of blockages or restrictions that would impede sewer flows. However, the remaining 2 percent of the inspected pipe segments within the City of Palmdale area had a PACP maintenance grade of 4 or 5 as indicated in the Quick Maintenance Rating Table shown below. This segment has been incorporated into our routine cleaning schedule with corrective action taken as noted on the Quick Maintenance Rating Report Priority List (Enclosure 2). Also included is a color-coded map showing the quick maintenance rating for each pipe segment.

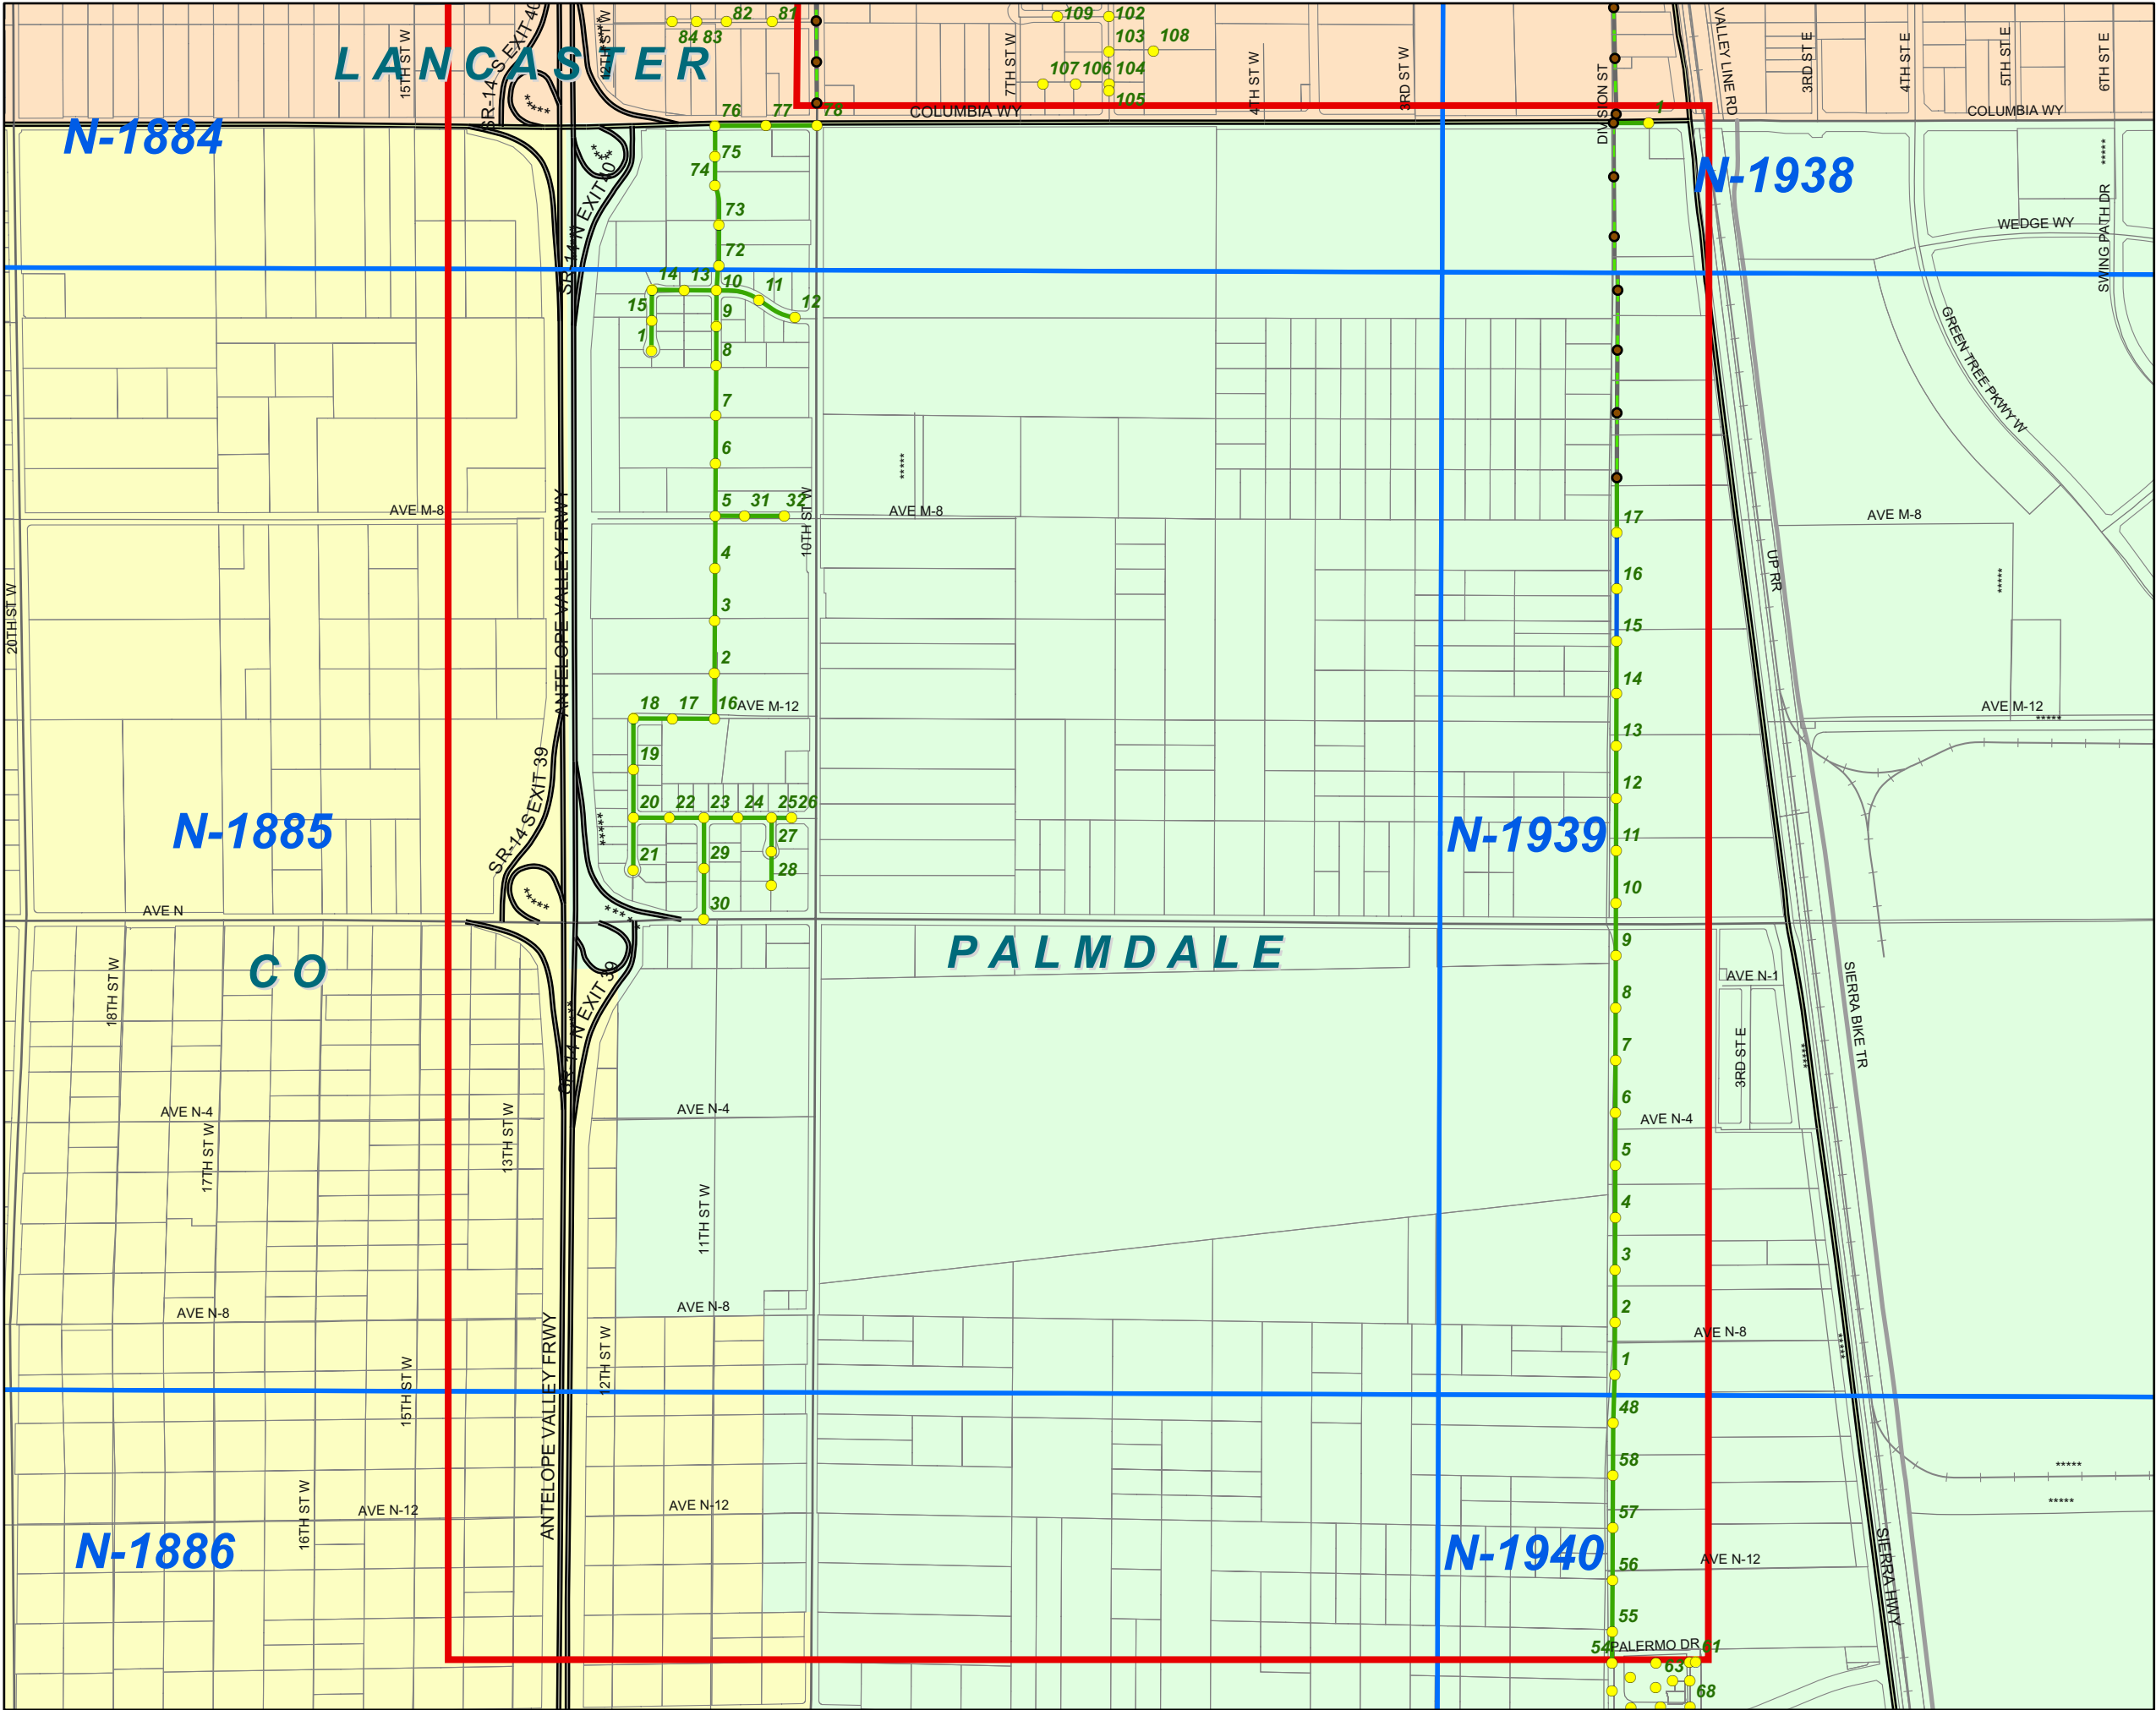
QUICK STRUCTURAL RATING (QSR)

Our inspection revealed that 100 percent of the inspected pipe segments within the City of Palmdale were free of severe structural defects as indicated in the Quick Structural Rating Table shown below. A color-coded map showing the Quick Structural Rating for each pipe segment is located in Enclosure 3.

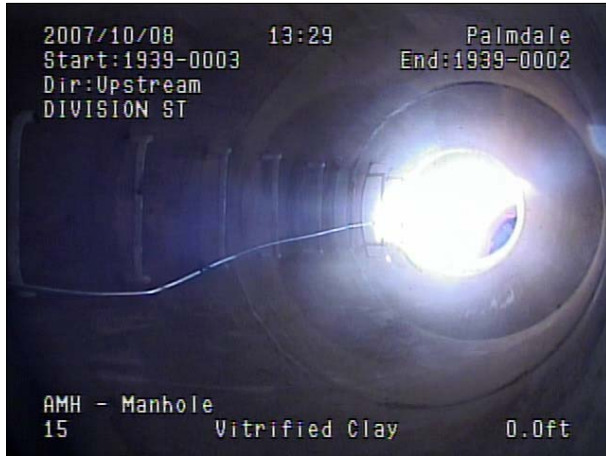
Photo: 2460, Tape/Media No.: A315-011, 00:00:35
 0FT, Manhole, within 8 inch: NO, Remarks: 1939-0002

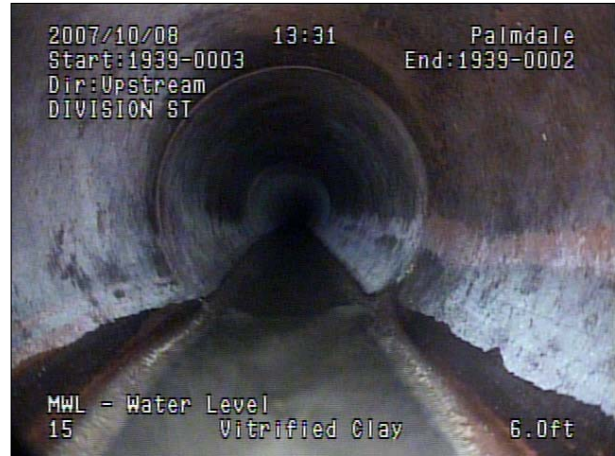
Photo: 2461, Tape/Media No.: A315-011, 00:02:40
 6FT, Water Level, 15 %, within 8 inch: NO

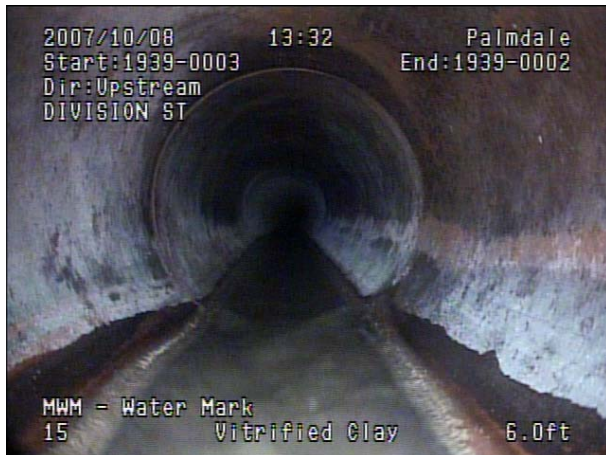
Photo: 2462, Tape/Media No.: A315-011, 00:03:04
 6FT, Water Mark, 20 %, within 8 inch: NO

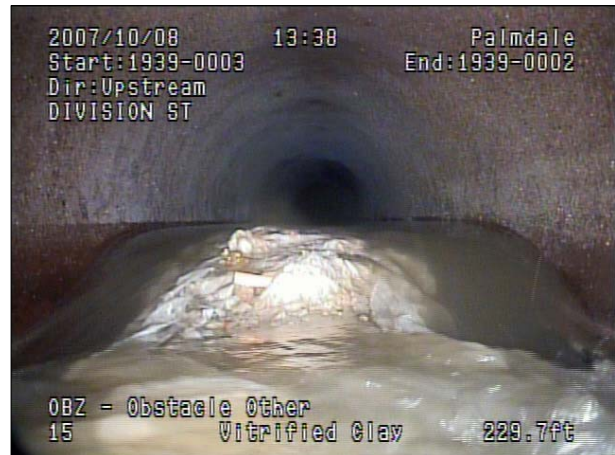
1:850	position	code	observation	MPEG	photo	grade
	0.00	AMH	Manhole, within 8 inch: NO, Remarks: 1939-0002	00:00:35	2460	
	6.00	MWL	Water Level, 15 %, within 8 inch: NO	00:02:40	2461	
	6.00	MWM	Water Mark, 20 %, within 8 inch: NO	00:03:04	2462	
	229.70	OBZ	Obstacle Other, from 3 to 9 o'clock, 40 %, within 8 inch: NO, Remarks: DEBRIS	00:09:35	2463	M 5
	347.40	AMH	Manhole, within 8 inch: NO, Remarks: 1939-0002	00:12:53	2464

Photo: 2463, Tape/Media No.: A315-011, 00:09:35
 229.7FT, Obstacle Other, from 3 to 9 o'clock, 40 %, within 8 inch: NO, Remarks: DEBRIS

Item No.	QMR	Start MH	End MH	Street	Observation	Corrective Action Taken
1	5100	1939-0003	1939-0002	DIVISION ST	Obstacle rocks	Hydrojet (Cleaned 8/27/08)

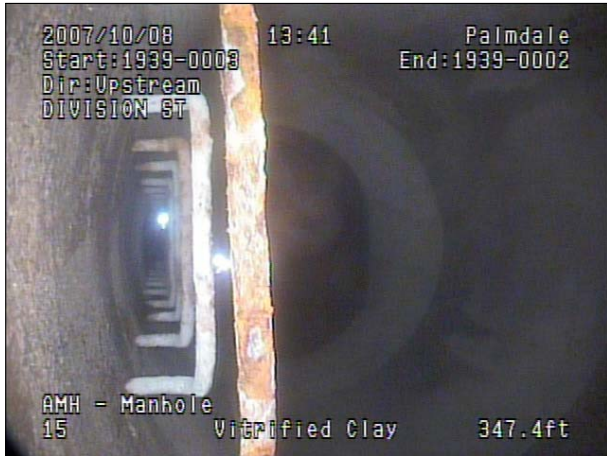
Photo: 2464, Tape/Media No.: A315-011, 00:12:53
347.4FT, Manhole, within 8 inch: NO, Remarks: 1939-0002
