**CONSOLIDATED SEWER MAINTENANCE DISTRICT
CONDITION ASSESSMENT PROGRAM REPORT
PROJECT Y0TV0910B**

**CONDITION ASSESSMENT REPORT
COUNTY OF LOS ANGELES DEPARTMENT OF PUBLIC WORKS
CONSOLIDATED SEWER MAINTENANCE DISTRICT**

PROJECT NAME:	Y0TV0910B	PROJECT MGR:	Kari Eskridge
PROJECT DATE:	07/21/2010	CONTACT NO:	(626) 300-3390
SUP. DISTRICT(S):	1	MAP PAGE(S):	2073 □ 2074
Report By:	Eric Liu	Report Date:	04/26/2011

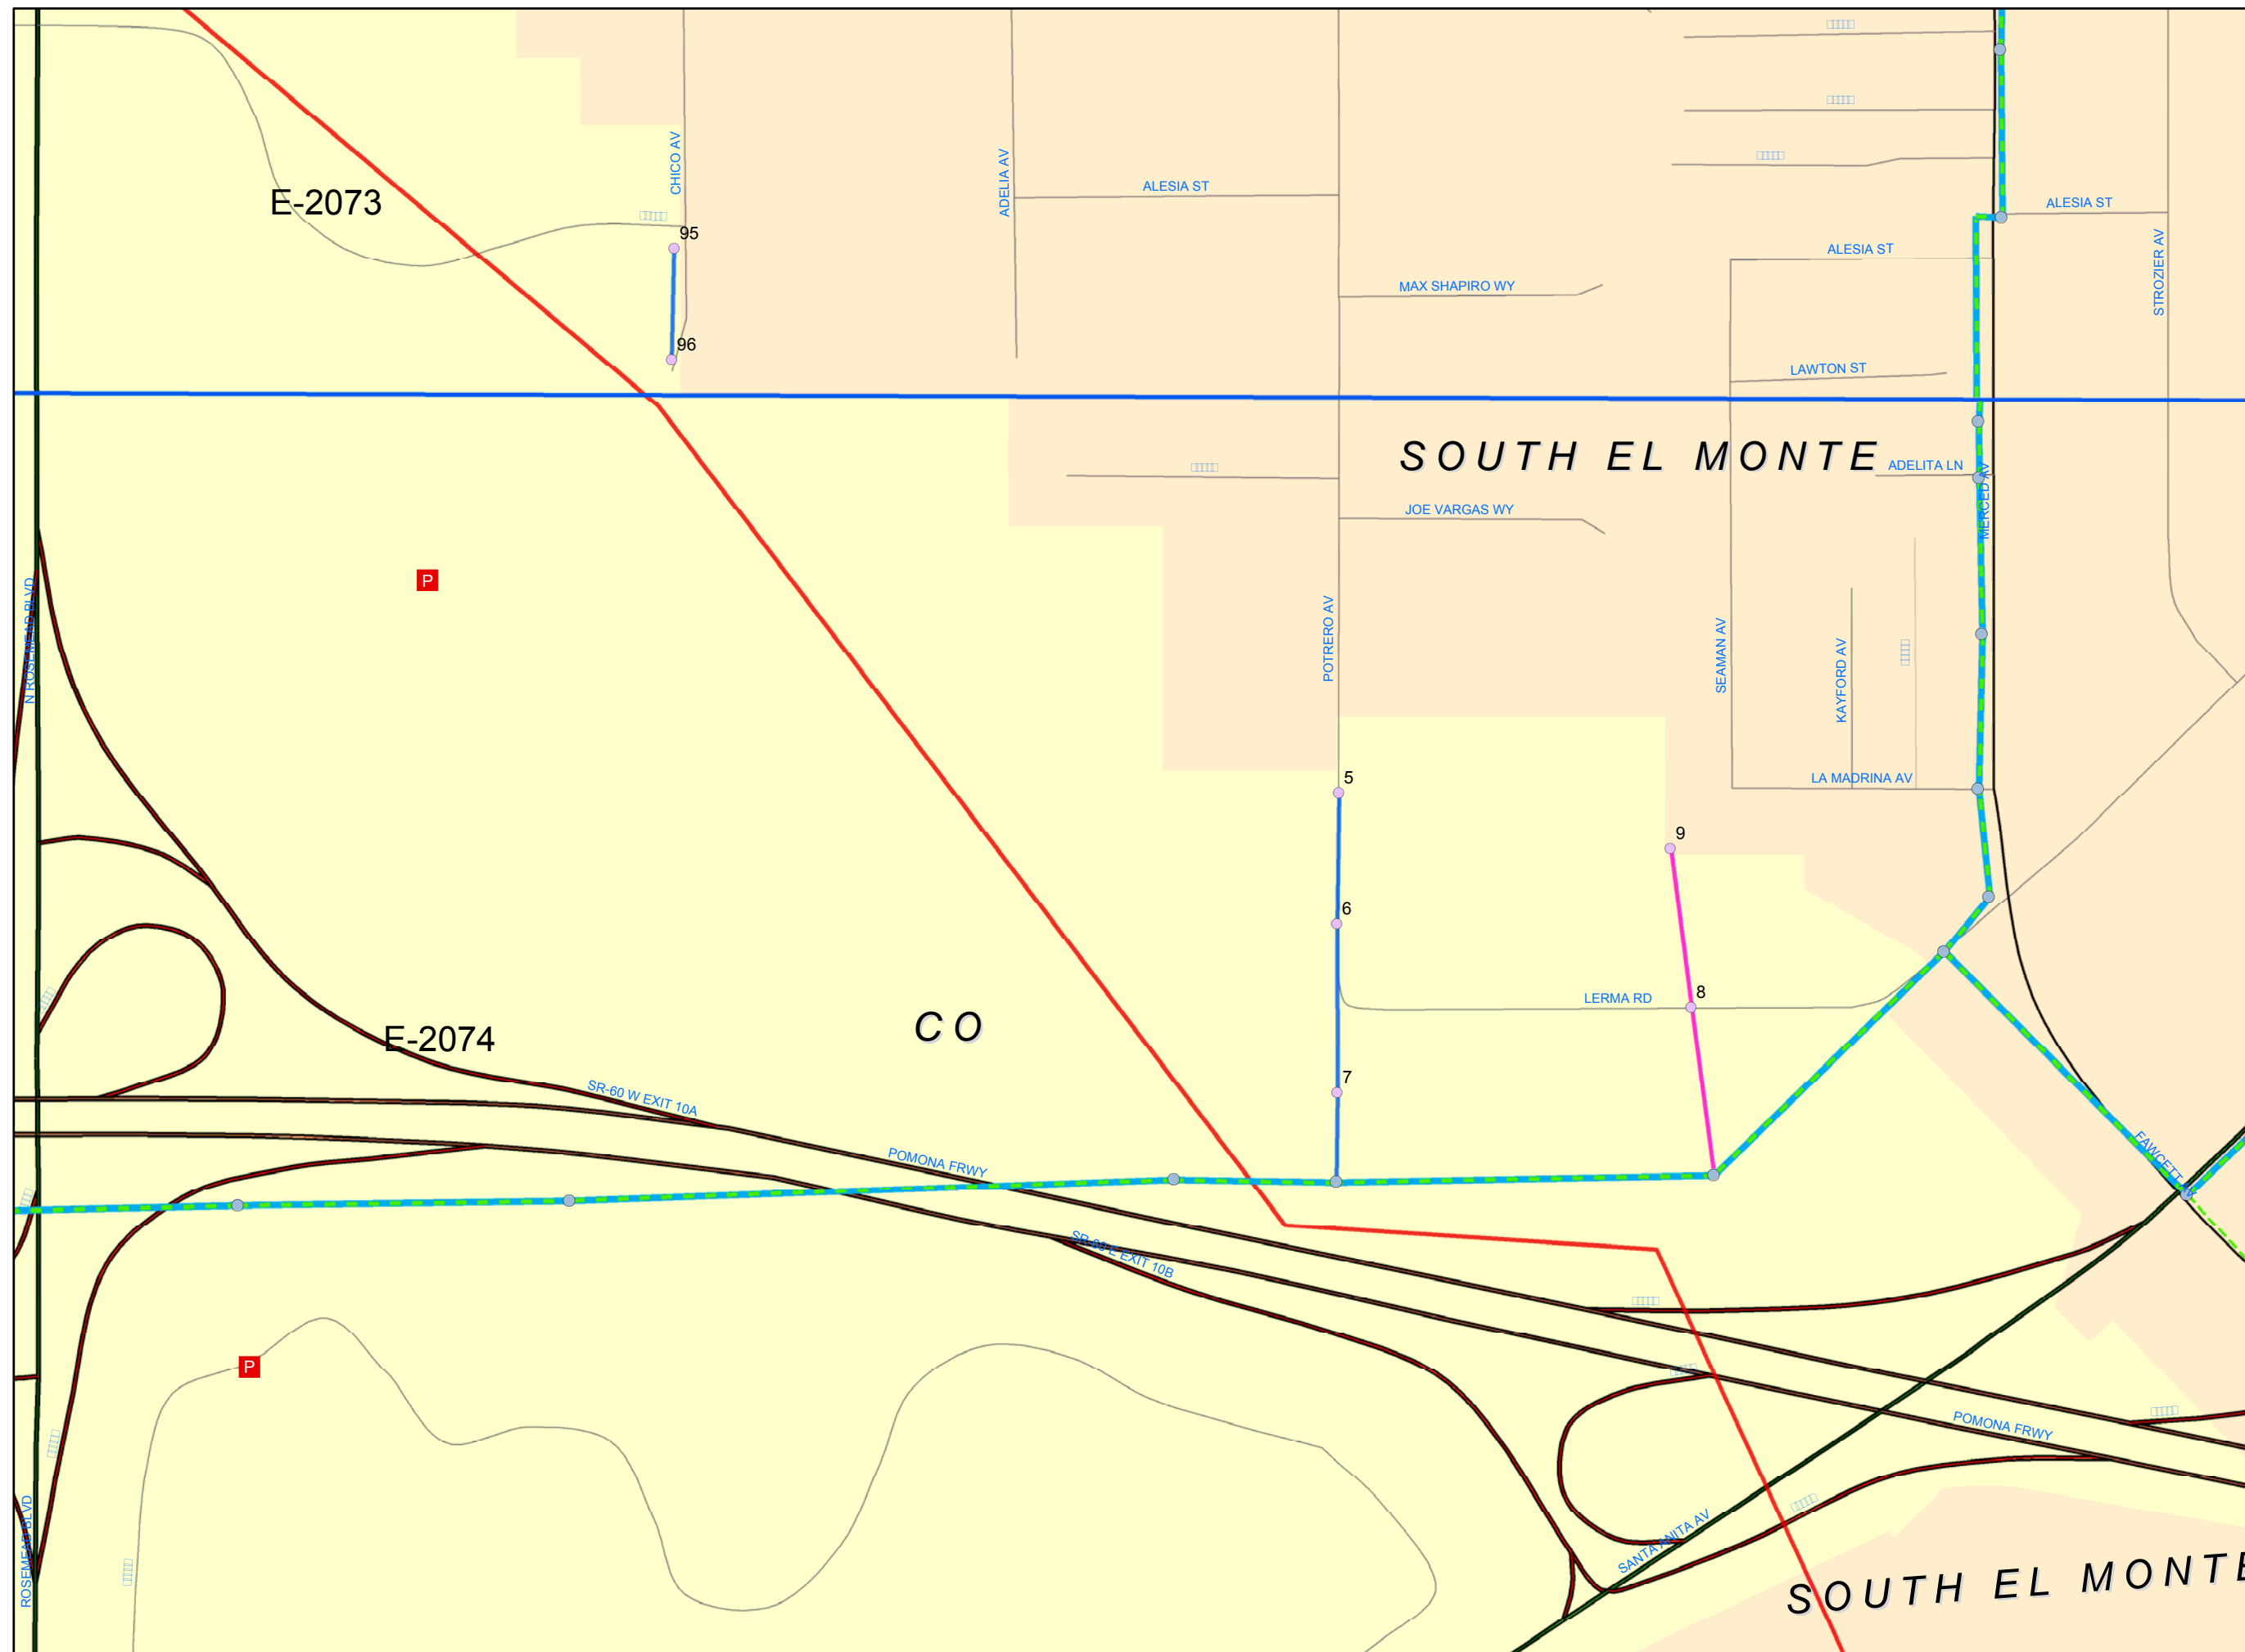
QUICK
 MAINTENANCE
 RATING
 (QMR)

ITEM NO.	QMR	START MH	END MH	STREET	OBSERVATION	CORRECTIVE ACTION TAKEN
1	4121	2074-0008	2074-0009	Easement on Lerma by Merced	Sag: 82' - 112'	No action needed.
2	4121	2074-0008	2074-TRNK	Easement on Lerma by Merced	Root ball: 154'	Contractor cleaned at inspection: 03/18/2010

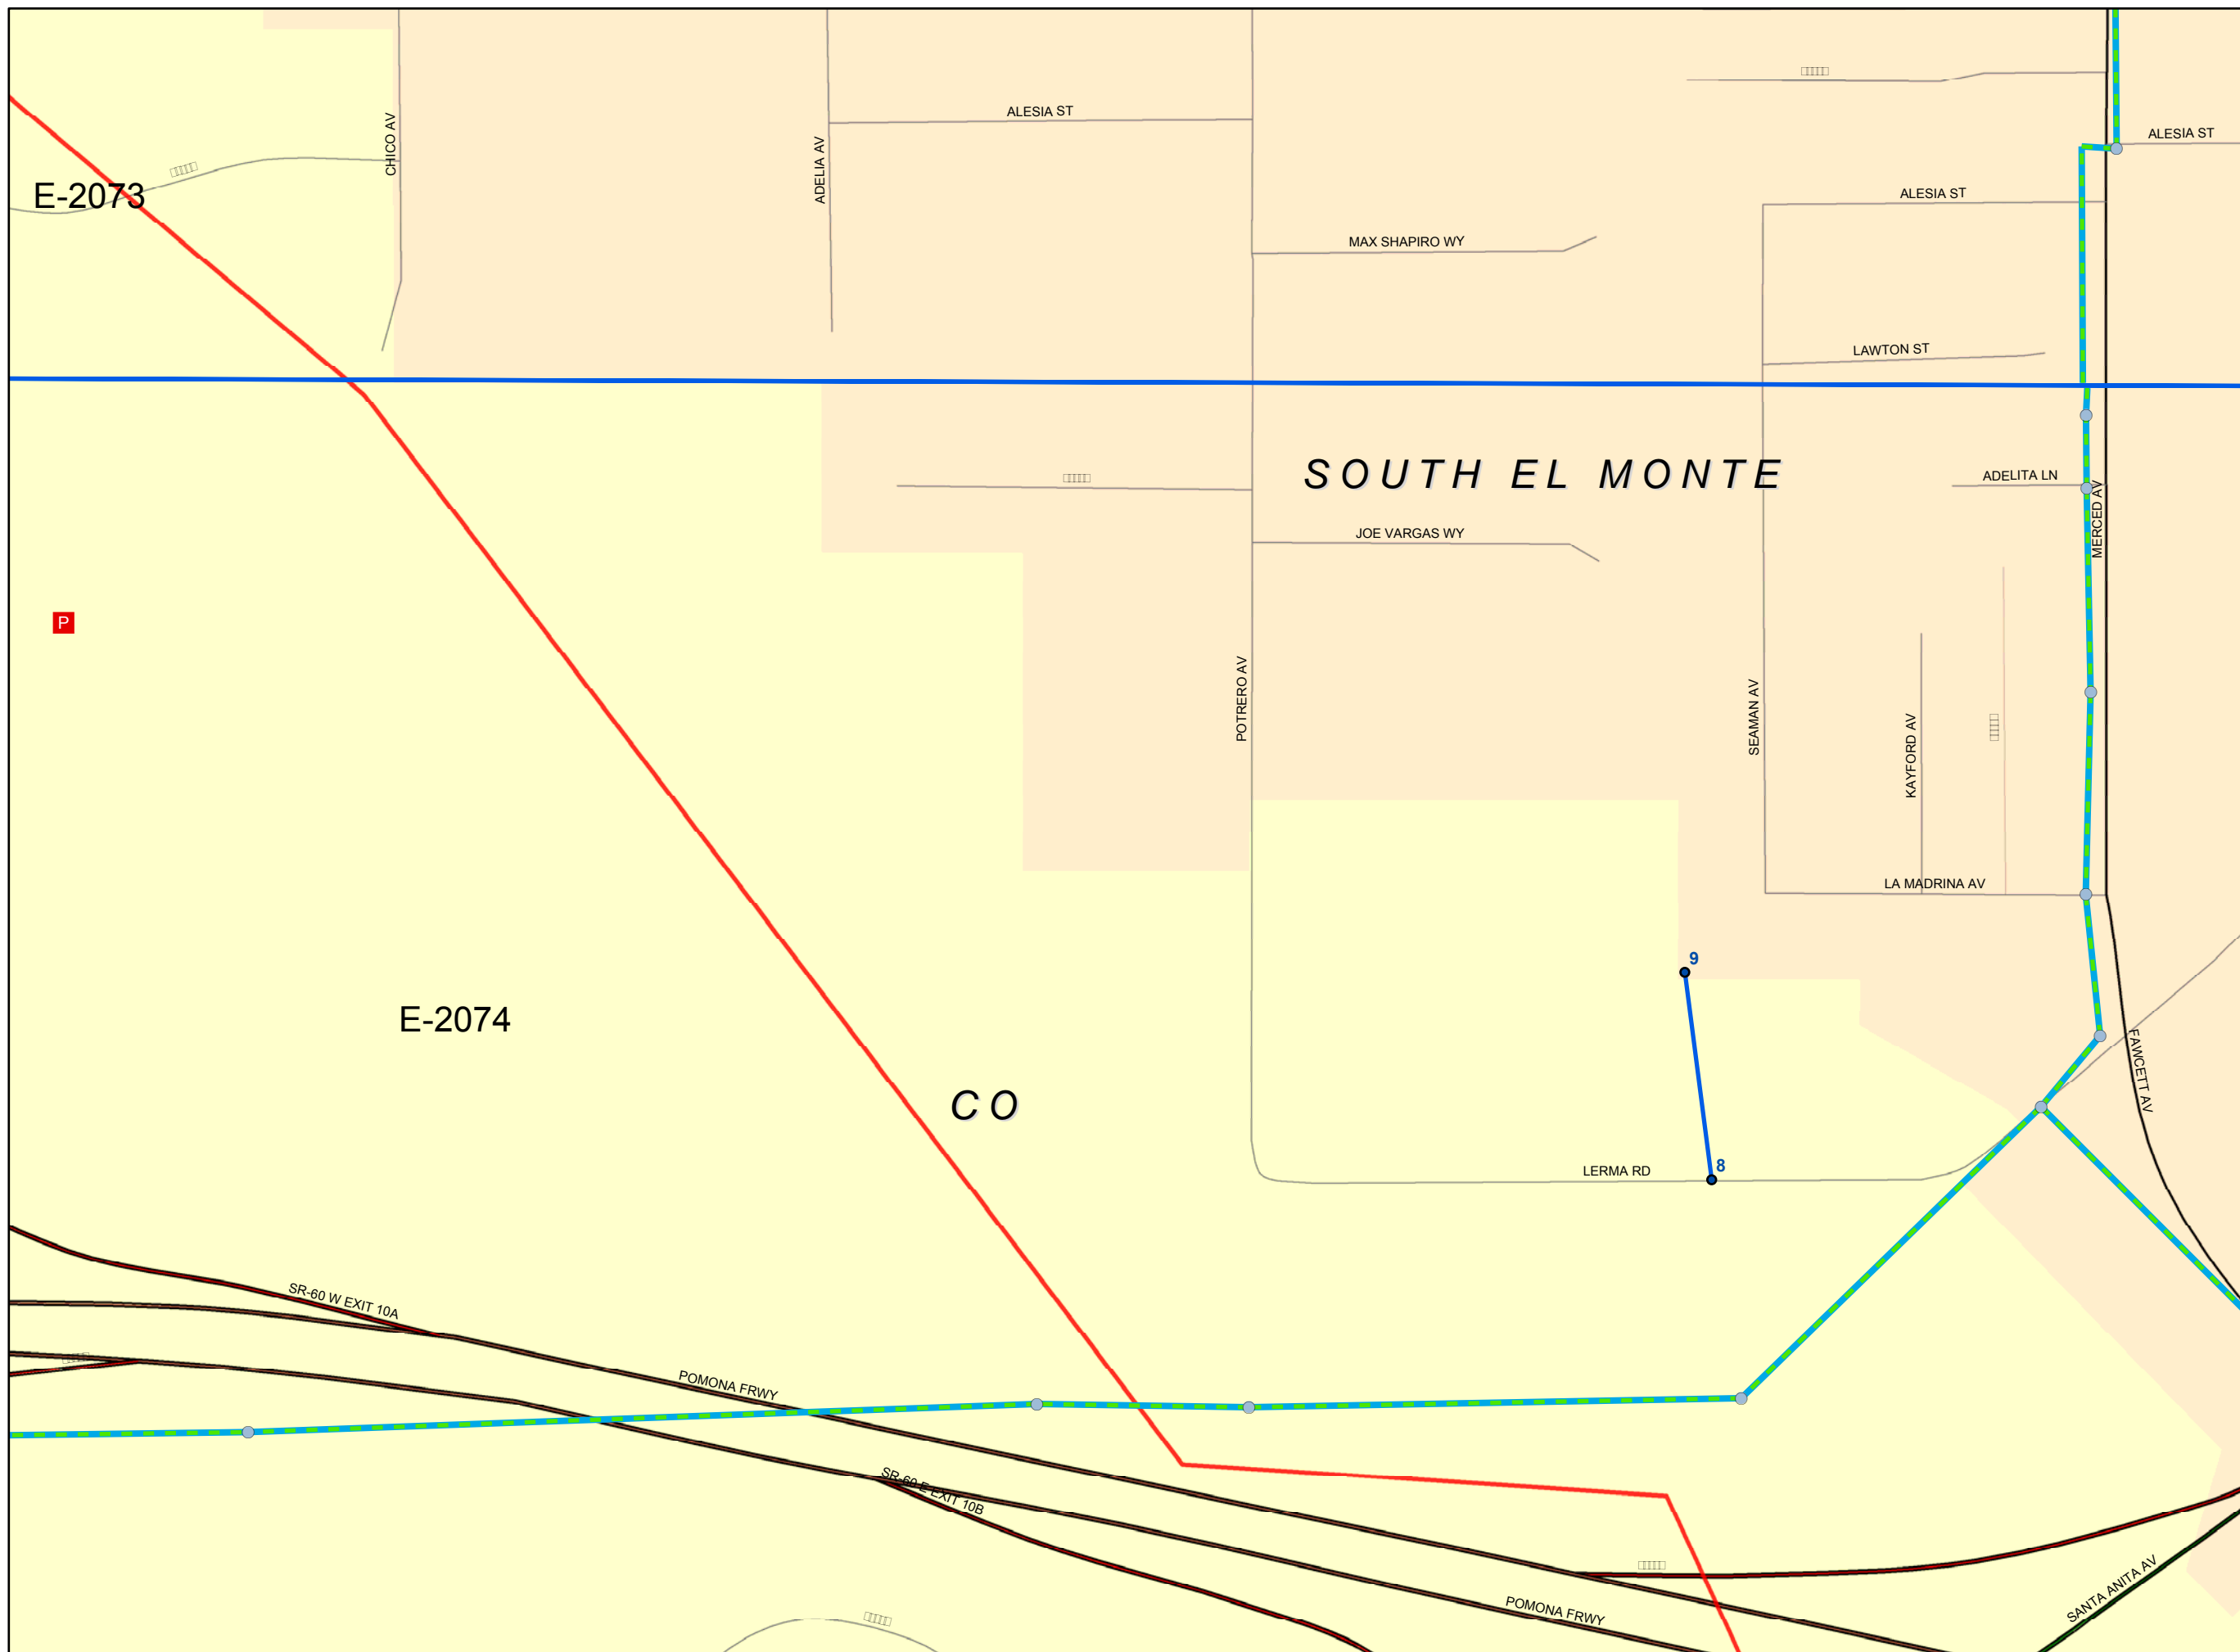
HIGH WATER LEVELS

Item No.	QMR	START MH	END MH	STREET	OBSERVATION	SAG (ft)
1	4121	2074-0008	2074-0009	Easement on Lerma by Merced	High water level; Sag (50%): 82' - 112'	30

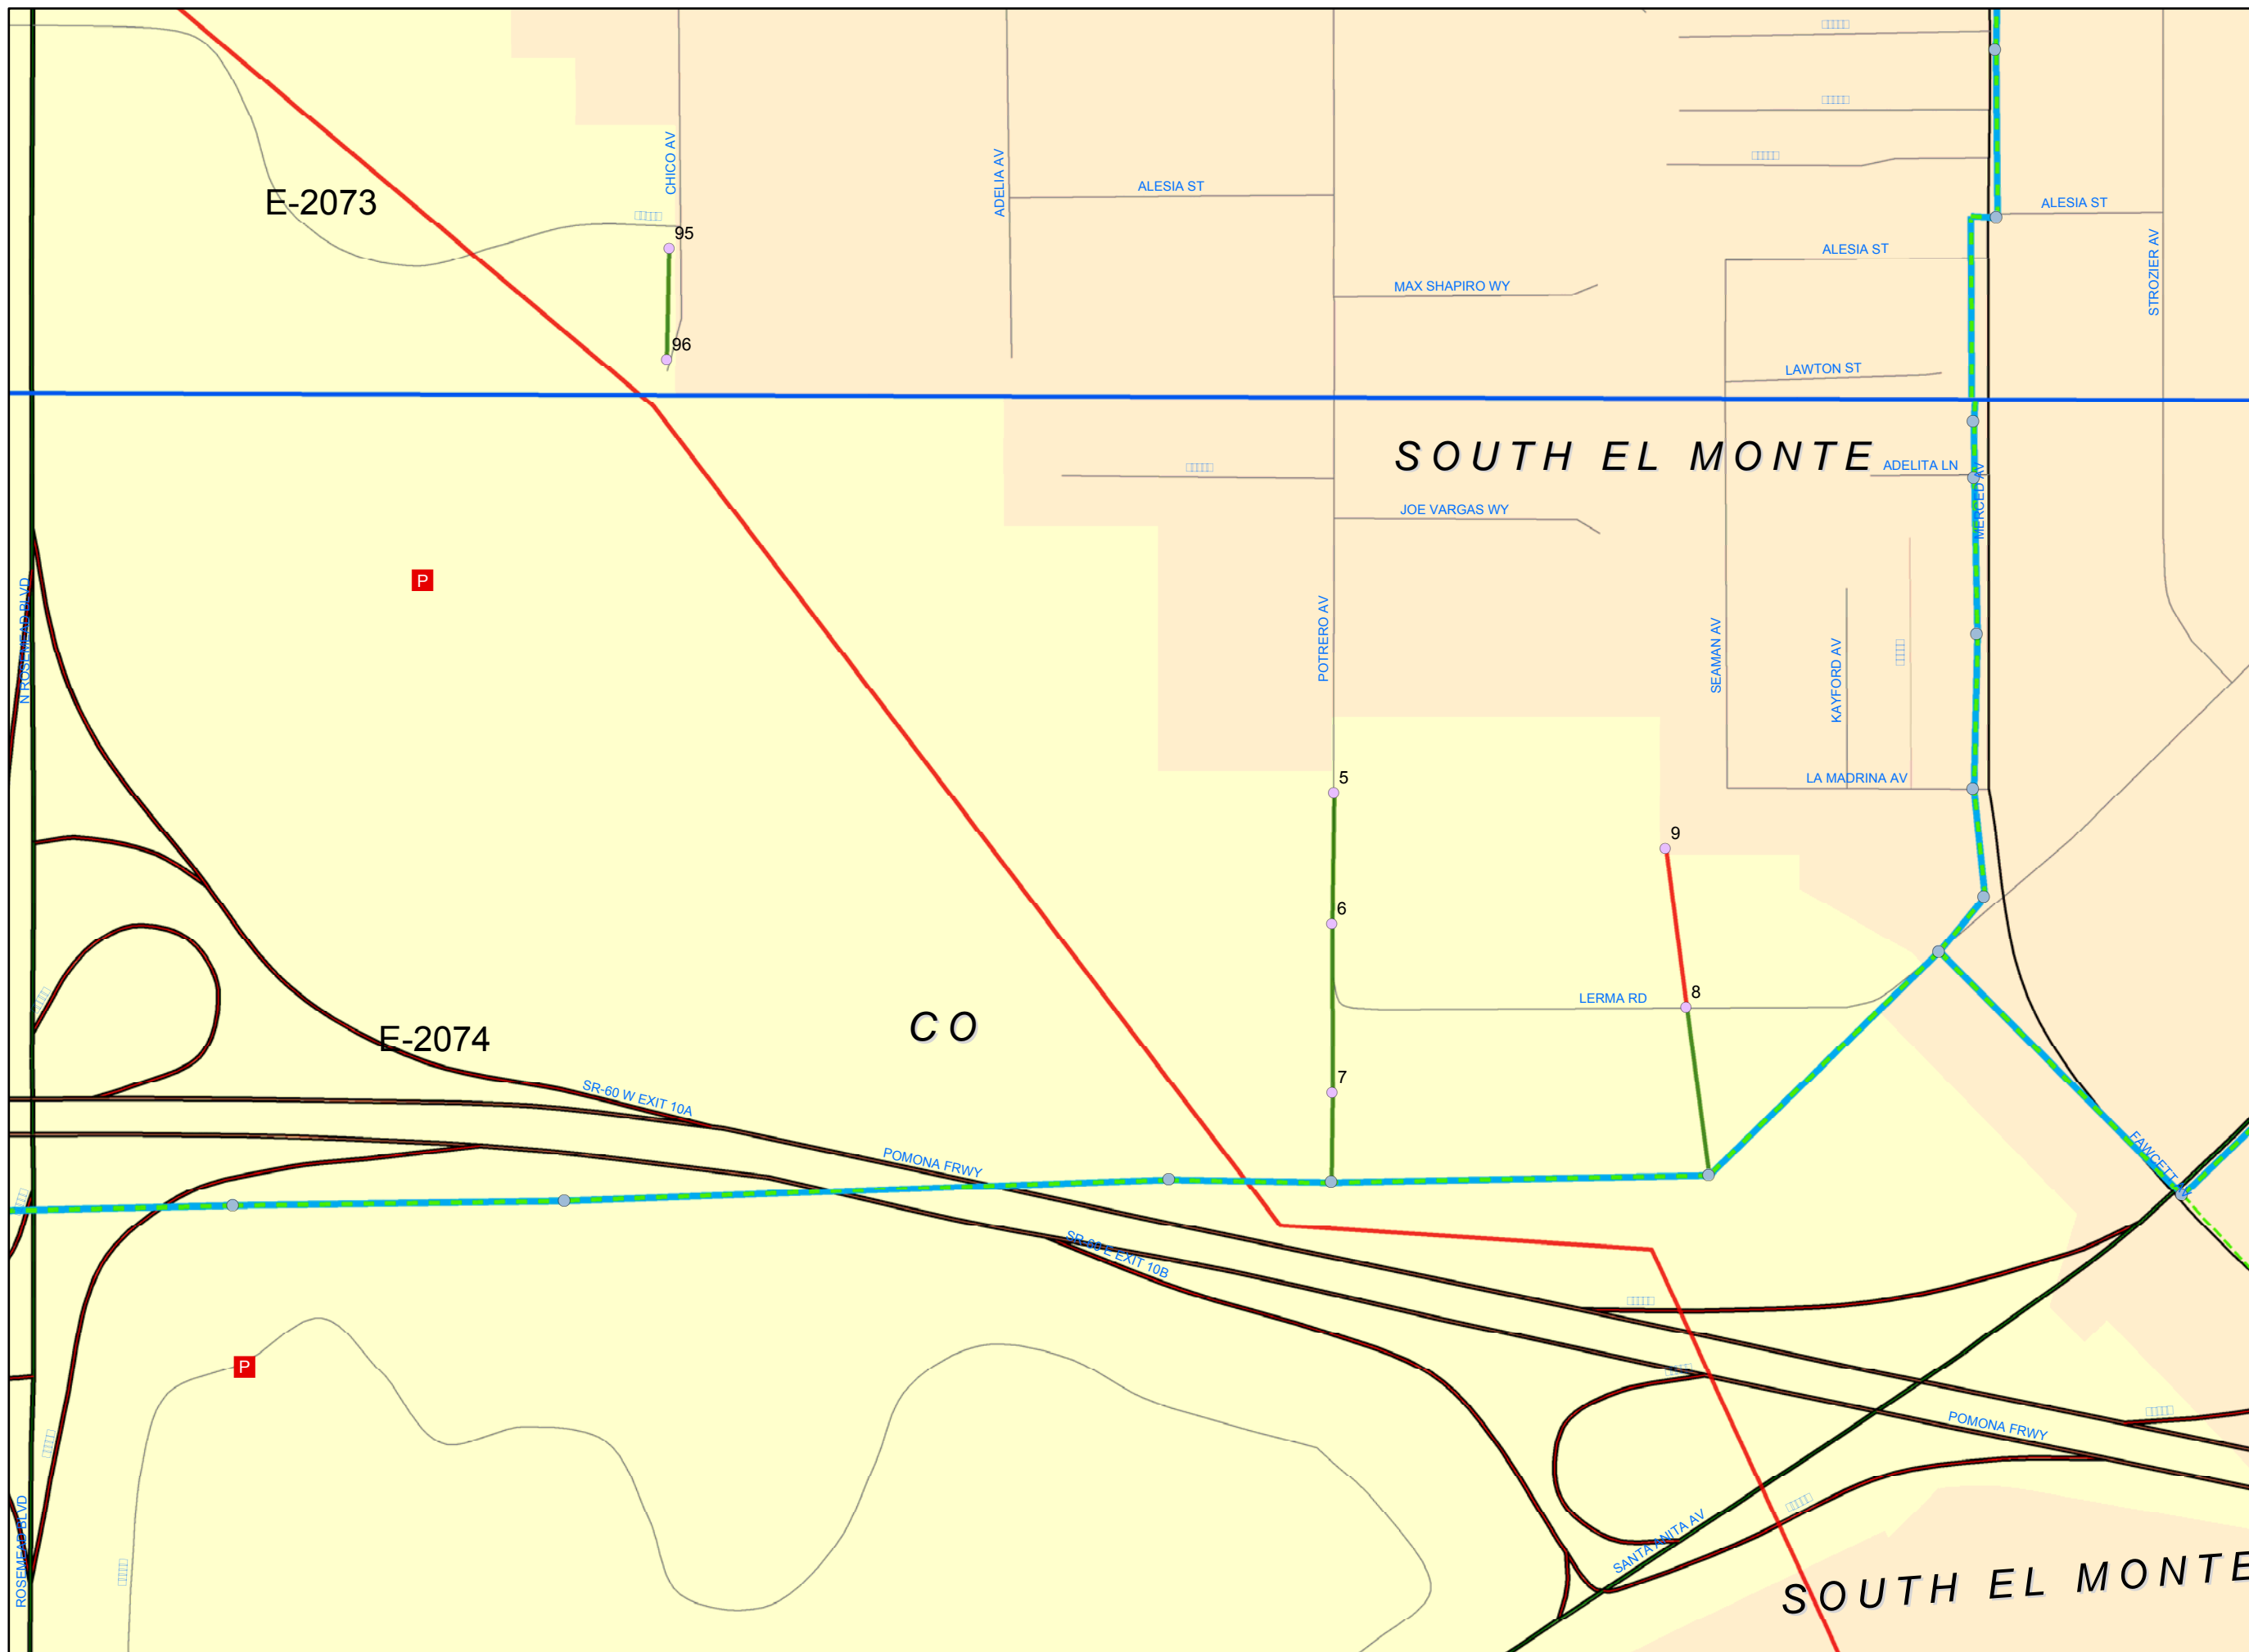
QUICK
 STRUCTURAL
 RATING
 (QSR)

ITEM NO.	QSR	START MH	END MH	STREET	OBSERVATION: LOCATION	PROPOSED CORRECTIVE ACTION	LENGTH OF REPAIR (FT)
1	5100	2074-0008	2074-0009	Easement on Lerma by Merced	Broken (tap break-in) with concrete patch visible: 200'	Point Repair
