September 21, 2022
2017-116.006

Re: *Devil's Gate Reservoir Restoration Project – Phase 2 Restoration Qualitative Monitoring Conducted on August 26, 2022*

1.0 INTRODUCTION

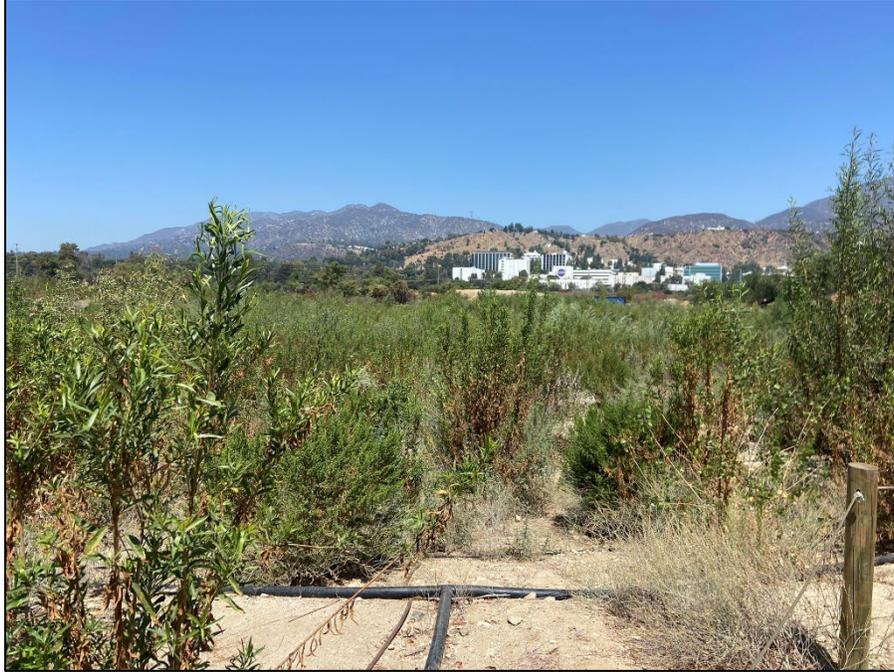
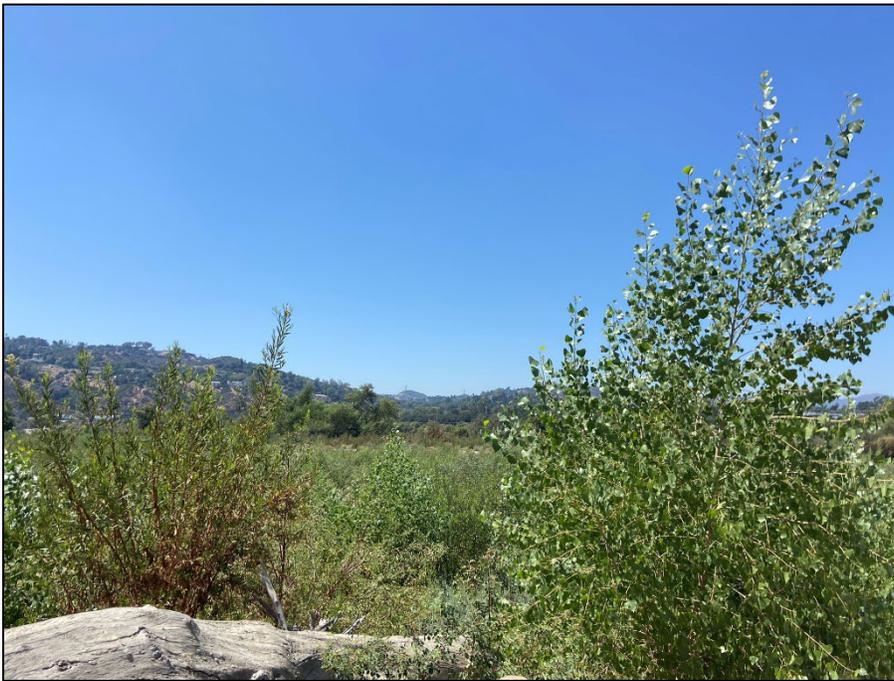
The overall health of the container plants in DG-W-1 was noted as being good. Approximately 10 to 15 percent of the container plants in DG-W-1 were noted as showing varied levels of stress and a negligible number were noted as being dead or missing. This is approximately five percent more than the percentage of plants that were showing stress during the last monitoring event. Stress appears to primarily be the result of drought stress from recent high temperatures but may also be occurring as a result of 1) herbivory by rabbits or other wildlife, 2) competition from nonnative and invasive weeds, 3) misplaced emitters, or 4) recreational traffic through the mitigation areas. In addition, some of the mulefat (*Baccharis salicifolia*) in this mitigation area were showing signs of minor dieback that appeared to be the result of *Baccharis* leaf blister and/or dodder (*Cuscuta* sp.). A handful of Fremont's cottonwoods (*Populus fremontii*) were also showing minor dieback which appeared to be the result of natural recruitment of mulefat within their basins. Evidence of dieback from *Phytophthora cactorum*, including wilting, stunted growth, leaf spotting, and/or browning along leaf margins and tips, was not observed on any of the container plants. The willows (*Salix* sp.) and Fremont's cottonwoods (*Populus fremontii*) in this mitigation area were no longer showing signs of seasonal dieback. Formal mortality counts were taken for DG-W-1 during the 2021 and 2022 quantitative monitoring events. Some of the container plants were noted as lacking well defined basins and should have their basins properly constructed and/or repaired. The irrigation line appeared to be functioning properly for most areas of the mitigation area during the monitoring visit; however, some basins appeared to be dry and should be inspected for functionality. The installation of plants in the DG-W-1 mitigation area appears to have been completed successfully. The current issues identified during the monitoring visit are not expected to have an effect on the continued growth of the plants in the mitigation area. Photos 1 and 2 in Attachment B document the mitigation area during the monitoring visit.

Photo 1: Overview Mitigation Area DG-W-1 (Johnson Field)

Photo 2: Overview Mitigation Area Overview Mitigation Area DG-W-1 (Johnson Field)

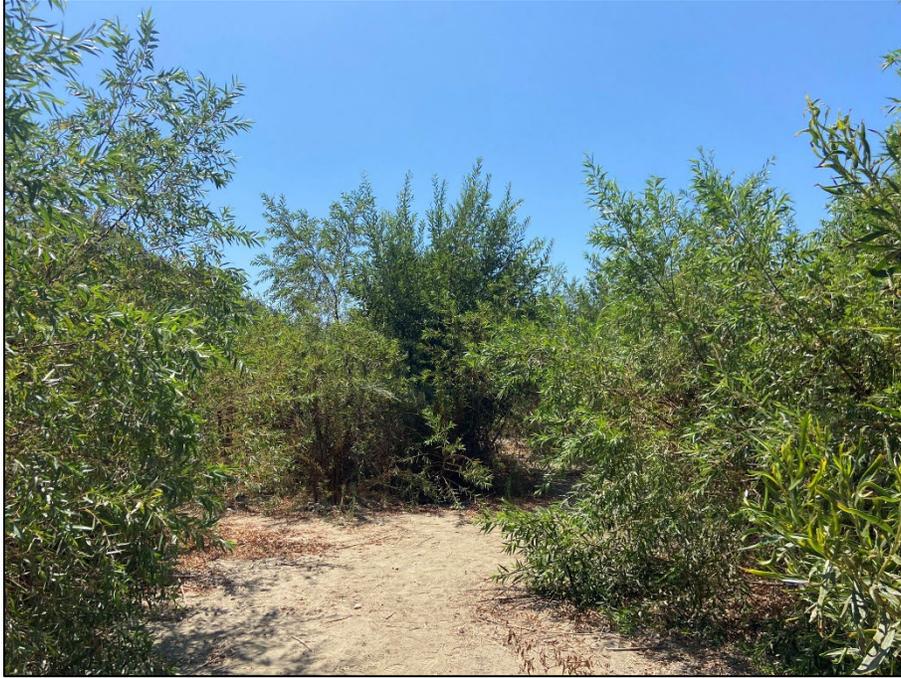
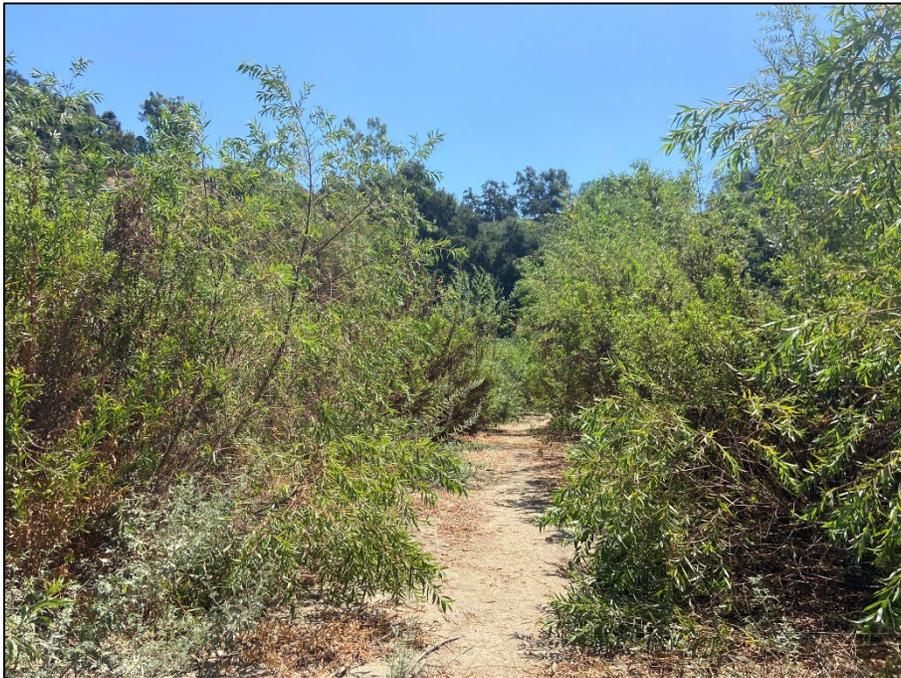
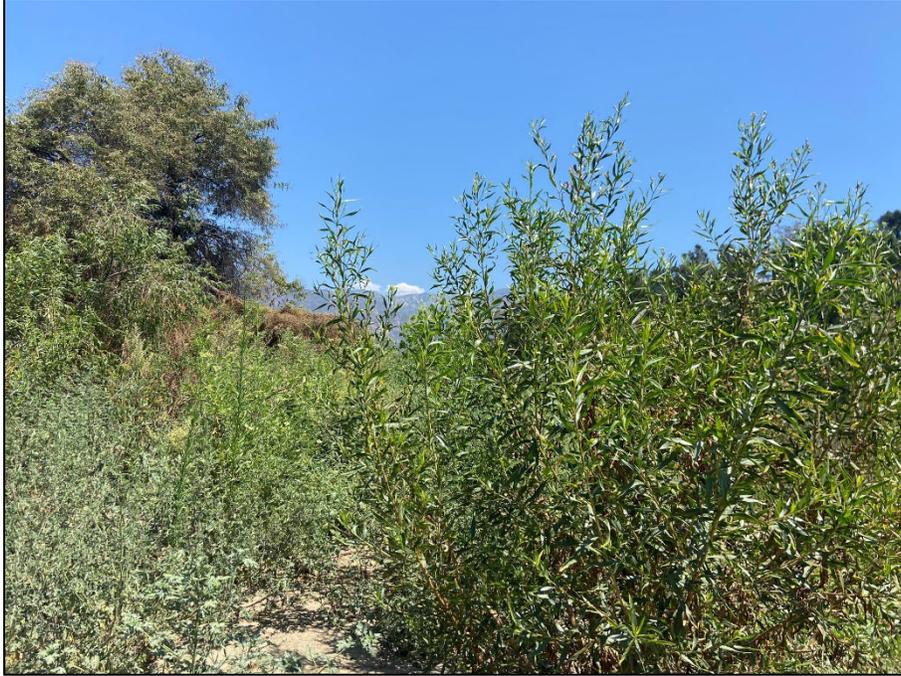
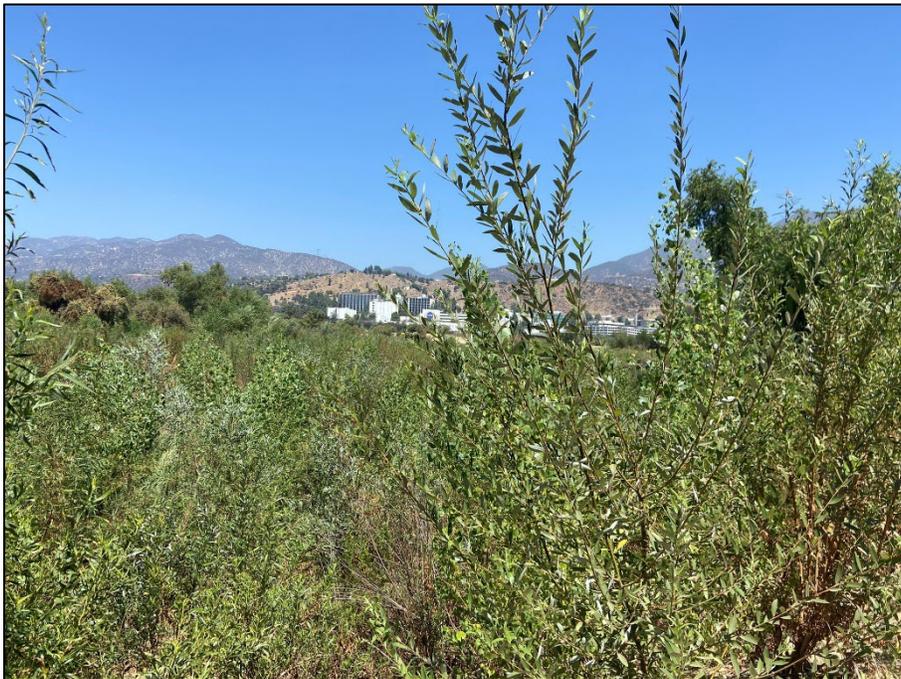
The overall health of the container plants in DG-2, DG-2 New Channels, and DG-2 WOUS was noted as being good. Approximately less than five percent of the container plants were noted as showing varied levels of stress and a negligible number were noted as being dead or missing. This is approximately the same percentage of plants that were showing stress during the last monitoring event. Stress may be occurring due to similar reasons described for DG-W-1. Evidence of dieback from *Phytophthora cactorum*, including wilting, stunted growth, leaf spotting, and/or browning along leaf margins and tips, was not observed on any of the container plants. Similar to DG-W-1, the willows and Fremont's cottonwoods in this mitigation area were no longer showing seasonal dieback. Formal mortality counts were taken for DG-2, DG-2 New Channels, and DG-2 WOUS during the 2021 and 2022 quantitative monitoring events. Some of the container plants were noted as lacking well defined basins and should have their basins properly constructed and/or repaired. The irrigation line appeared to be functioning properly during the monitoring visit. During the monitoring visit, the grade control structure that was installed at the northern end of DG-2 New Channels where the channels connect to DG-W-1 was inspected for erosion. Minor erosion was observed, mostly towards the western end of the structure; however, no major erosion issues were observed, and the structure appears to be functioning properly. The installation of plants in the DG-2, DG-2 New Channels, and DG-2 WOUS mitigation areas appears to have been completed successfully. The current issues identified during the monitoring visit are not expected to have an effect on the continued growth of the plants in the mitigation area. Photos 3 through 6 in Attachment B document the mitigation areas during the monitoring visit. Photos 15 and 16 in Attachment B document the condition of the grade control structure during the monitoring visit.

Photo 3: Overview Mitigation Area Overview Mitigation Area DG-2 & DG-2 WOUS

Photo 4: Overview Mitigation Area DG-2 & DG-2 New Channels

Photo 5: Overview Mitigation Area DG-2 & DG-2 WOUS

Photo 6: Overview Mitigation Area DG-2, DG-2 New Channels, DG-2 WOUS

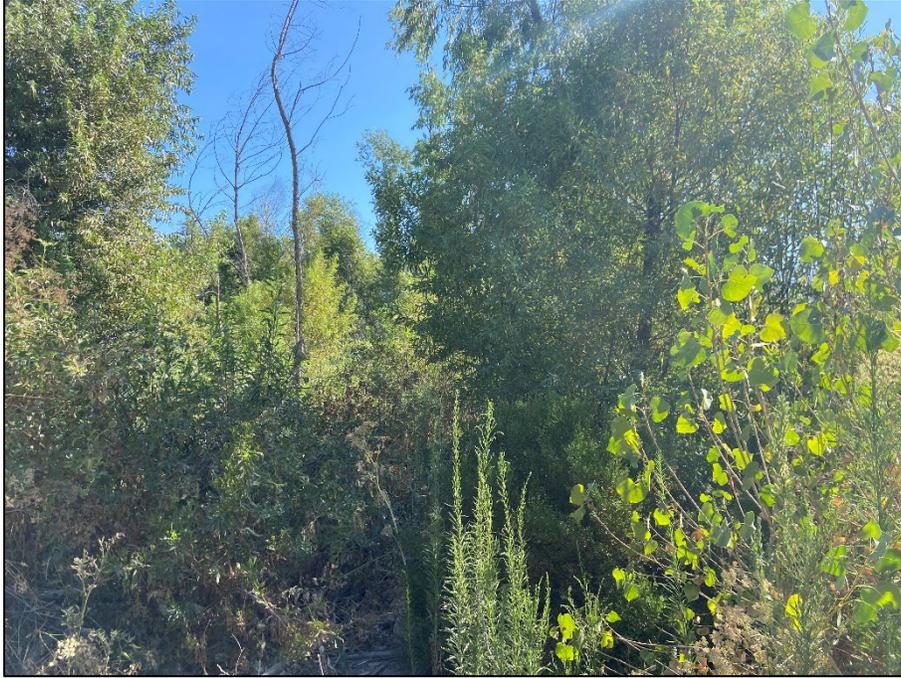
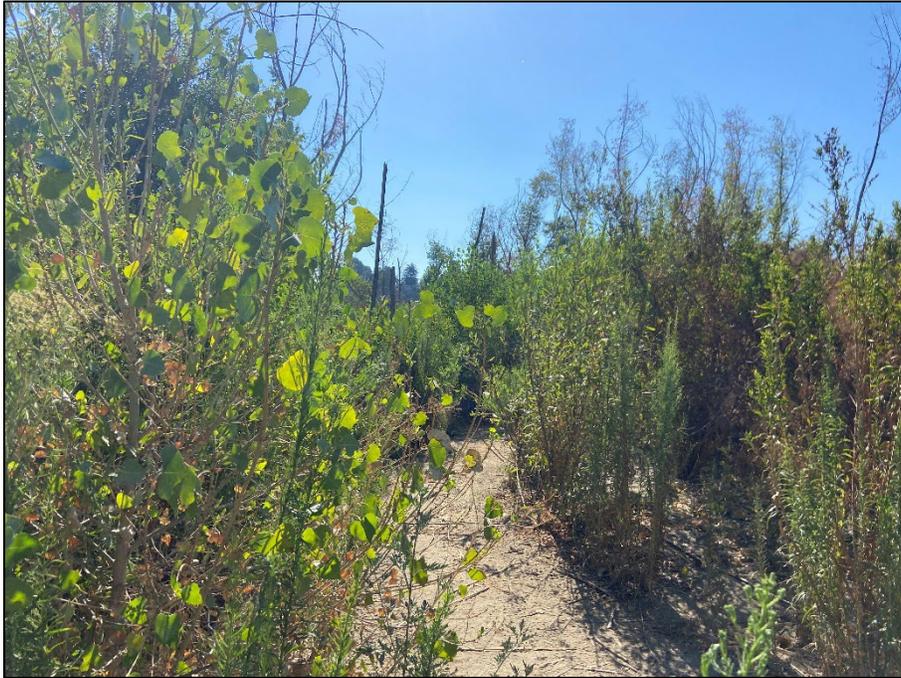
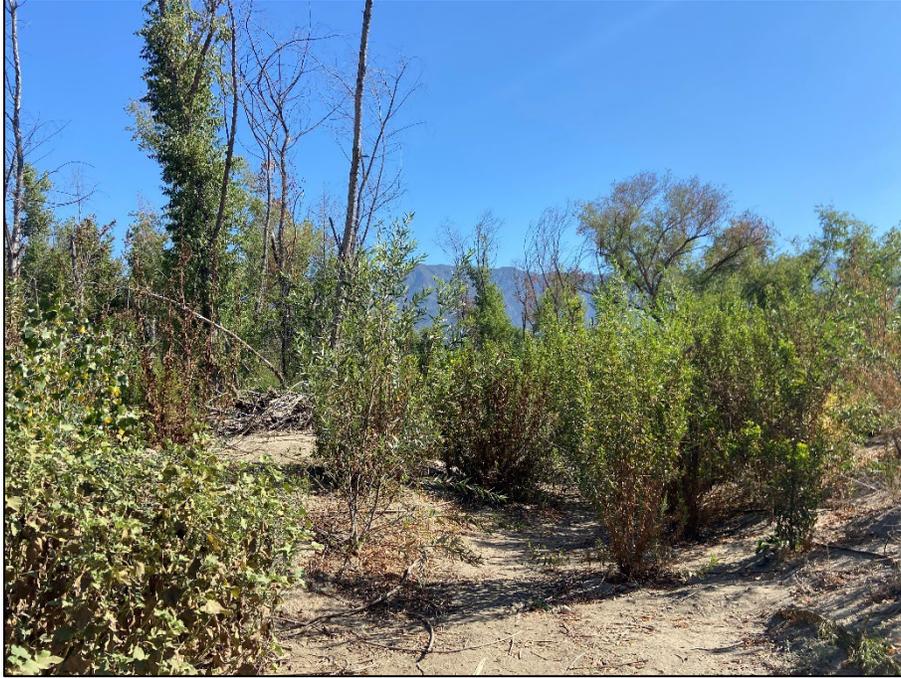
The overall health of the container plants in mitigation area DG-W-2 was noted as being good. Approximately 20 to 25 percent of the container plants were noted as showing varied levels of stress and a negligible number were noted as being dead or missing. This is approximately 15 to 20 percent higher than the percentage of plants that were showing stress during the last monitoring event. Stress may be occurring due to similar reasons described for DG-W-1. Evidence of dieback from *Phytophthora cactorum*, including wilting, stunted growth, leaf spotting, and/or browning along leaf margins and tips, was not observed on any of the container plants. Formal mortality counts were taken for DG-W-2 during the 2021 and 2022 quantitative monitoring events. Some of the container plants were noted as lacking well defined basins and should have their basins properly constructed and/or repaired. The irrigation line appeared to be functioning properly for most areas of the mitigation area during the monitoring visit; however, some basins appeared to be dry and should be inspected for functionality. The installation of plants in the DG-W-2 mitigation area appears to have been completed successfully and the issues noted during the monitoring are not expected to have an impact on the continued growth of the plants. Photos 7 through 9 in Attachment B document the mitigation area during the monitoring visit.

During the monitoring visit, it was noted that many of the existing mature black willow (*Salix gooddingii*) in this mitigation area were continuing to show additional dieback and additional branch failure. Signs of infestation from the polyphagous shot-hole borer (PSHB) noted during previous monitoring visits included entry/exit holes, frass, galleries, fungal residue, and branch failure. Further investigation into this issue is being conducted with the help from the Los Angeles County Department of Agricultural Commissioner/Weights & Measures (ACWM) and preliminary surveys mostly showed only low to moderate infestation in these areas. It should be noted that evidence of infestation was only noted on existing mature willows and not on any of the recently installed container plants. It should also be noted that many of the existing willows showing dieback were showing significant new growth.

Photo 7: Overview Mitigation Area DG-W-2 (Mining Pit)

Photo 8: Overview Mitigation Area DG-W-2 (Mining Pit)

Photo 9: Overview Mitigation Area DG-W-2 (Mining Pit)

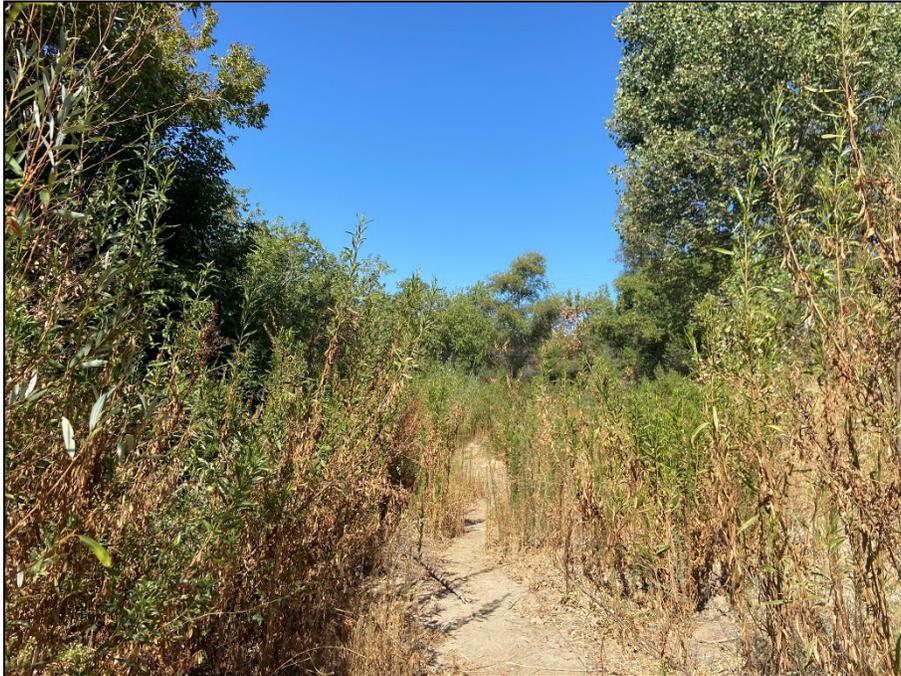
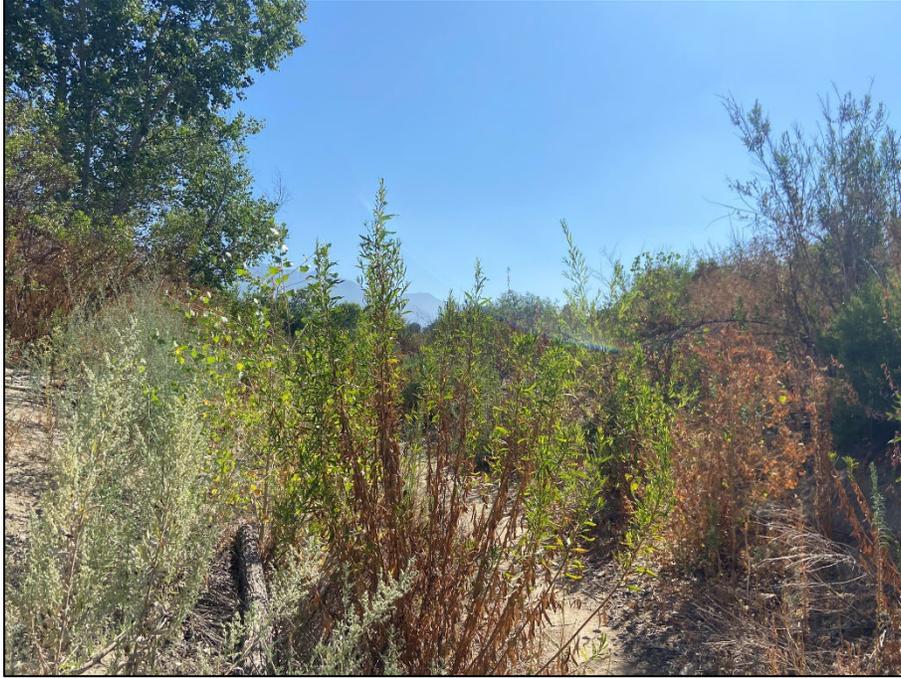
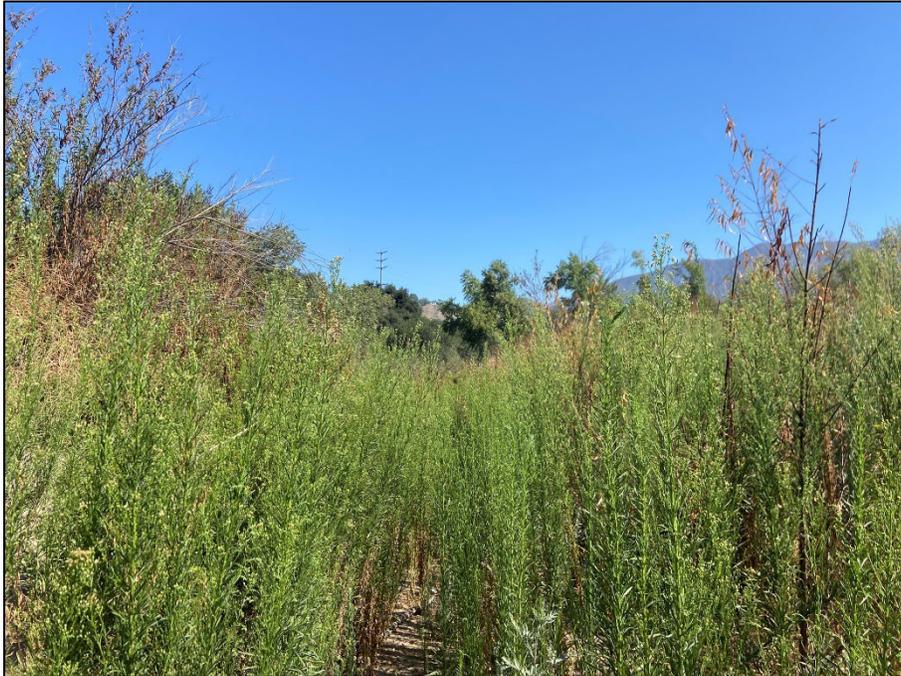
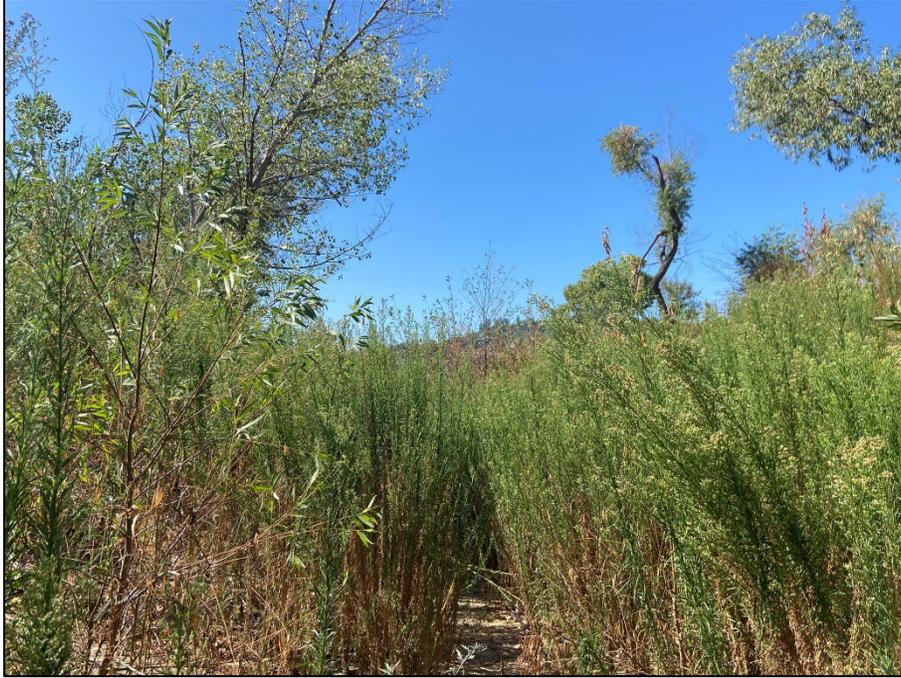
The overall health of the container plants in mitigation area DG-W-2 was noted as being good. Approximately 25 to 30 five percent of the container plants were noted as showing varied levels of stress and a negligible number were noted as being dead or missing. This is approximately 20 to 25 percent higher than the percentage of plants that were showing stress during the last monitoring event. Stress may be occurring due to similar reasons described for DG-W-1. Evidence of dieback from *Phytophthora cactorum*, including wilting, stunted growth, leaf spotting, and/or browning along leaf margins and tips, was not observed on any of the container plants. Formal mortality counts were taken for DG-W-2 Outlet during the 2021 and 2022 quantitative monitoring events. Some of the container plants were noted as lacking well defined basins and should have their basins properly constructed and/or repaired. In addition, mature willows in this area were noted as having branch failure, likely due to recent high winds. The irrigation line appeared to be functioning properly for most areas of the mitigation area during the monitoring visit; however, some basins appeared to be dry and should be inspected for functionality. The installation of plants in the DG-W-2 Outlet mitigation area appears to have been completed successfully and the issues noted during the monitoring are not expected to have an impact on the continued growth of the plants. Photos 10 through 13 in Attachment B document the mitigation area during the monitoring visit.

Photo 10: Overview Mitigation Area DG-W-2 (Mining Pit Outlet)

Photo 11: Overview Mitigation Area DG-W-2 (Mining Pit Outlet)

Photo 12: Overview Mitigation Area DG-W-2 (Mining Pit Outlet)

Photo 13: Overview Mitigation Area DG-W-2 (Mining Pit Outlet)

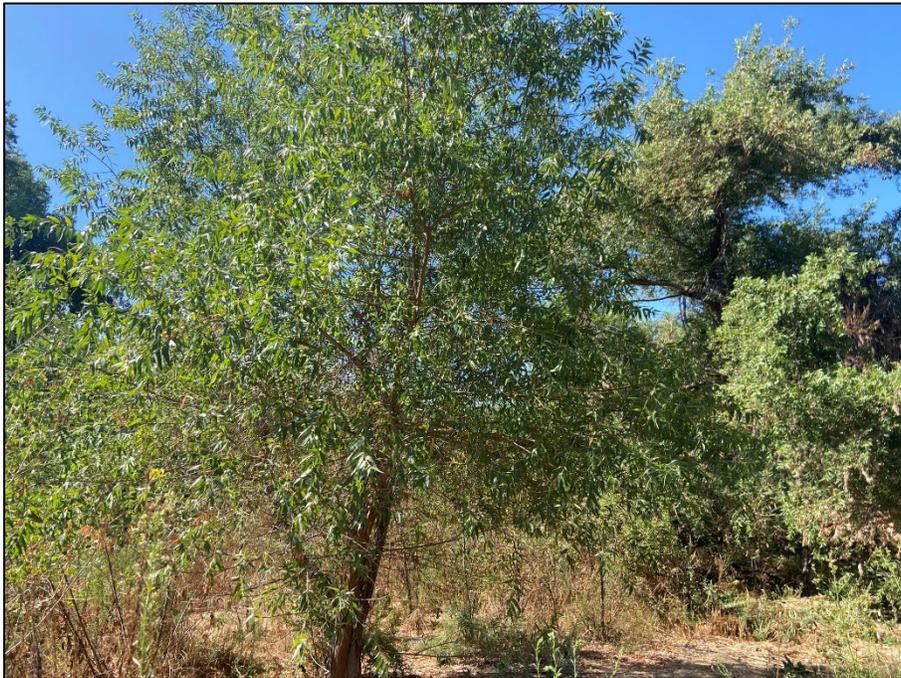
The overall health of the container plants in mitigation areas DG-4 Sheet Flow (northern) and DG-SF-1 was noted as being good. Approximately five percent of container plants were showing varied levels of stress which is approximately the same percentage of container plants that were showing stress during the previous monitoring event. Stress may be occurring due to similar reasons described for DG-W-1. Evidence of dieback from *Phytophthora cactorum*, including wilting, stunted growth, leaf spotting, and/or browning along leaf margins and tips, was not observed on any of the container plants. Formal mortality counts were taken during the 2021 and 2022 quantitative monitoring events. Some of the container plants were noted as lacking well defined basins and should have their basins properly constructed and/or

repaired. In addition, minor herbivory of young plants was observed within the DG-4 Sheet Flow and DG-SF-1 areas and should continue to be monitored. The irrigation line appeared to be functioning properly during the monitoring visit. The installation of plants in the DG-4 Sheet Flow and DG-SF-1 mitigation areas appears to have been completed successfully and the issues noted during the monitoring are not expected to have an impact on the continued growth of the plants. Photo 14 in Attachment B document the mitigation area during the monitoring visit.

Photo 14: Overview Mitigation Area DG-4 Sheet Flow/Sheet Flow-1
