Re: *Devil's Gate Reservoir Restoration Project – Phase 1 Restoration Qualitative Monitoring Conducted on August 26, 2021*

1.0 INTRODUCTION

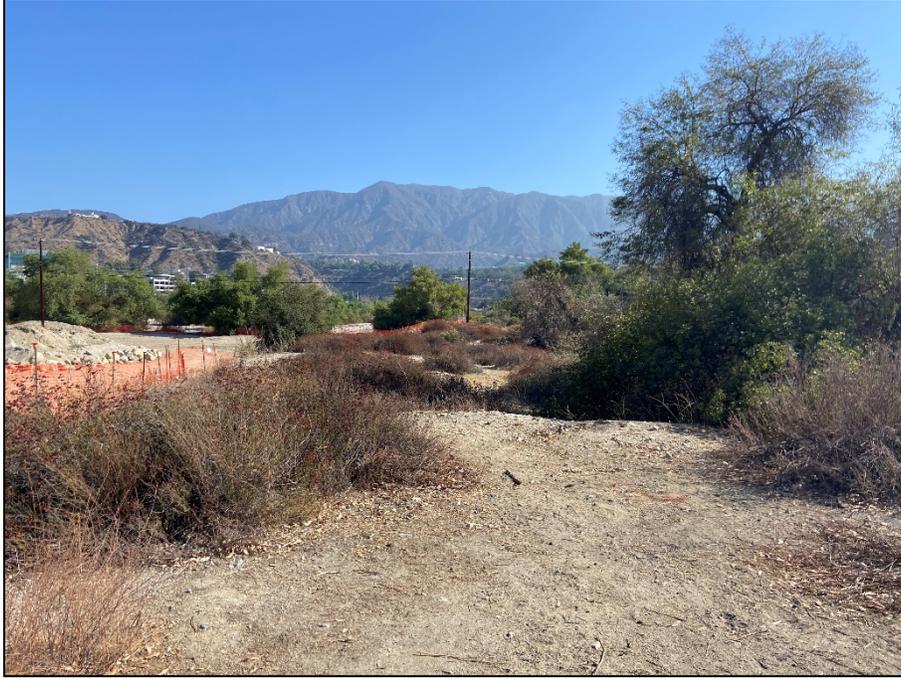
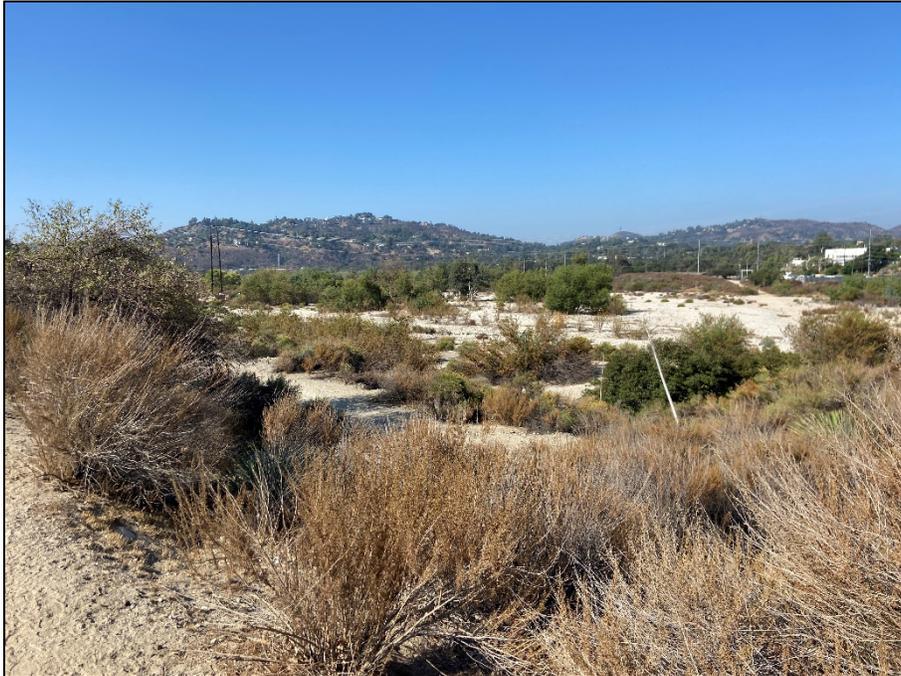
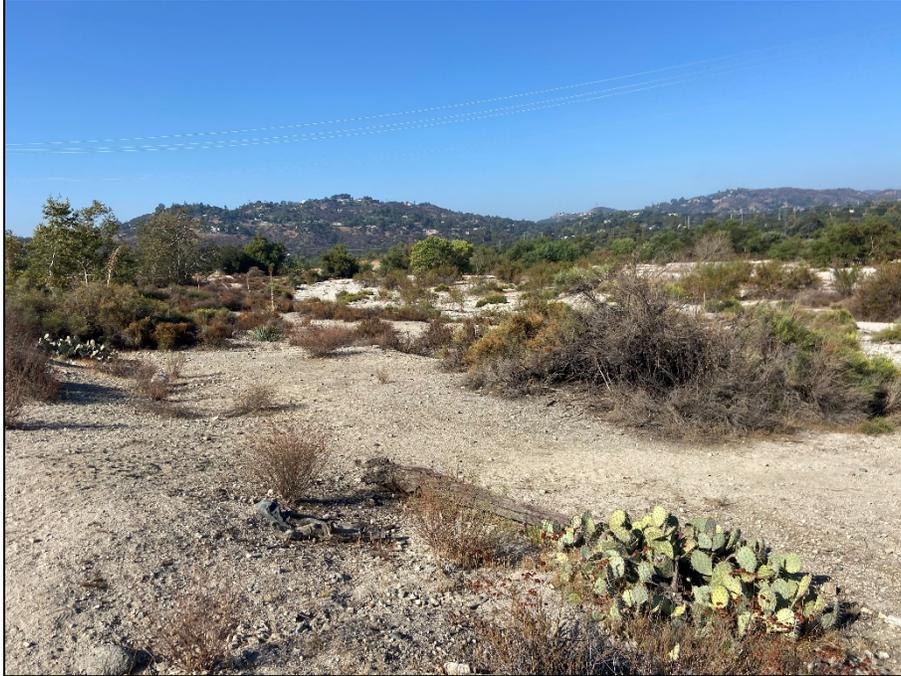
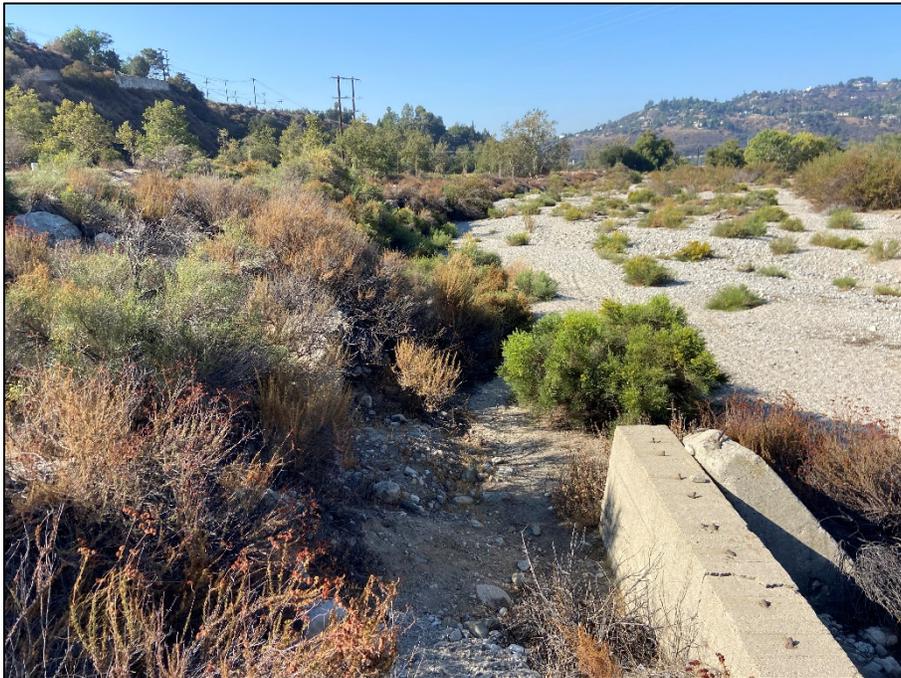
Container plants were not installed in the DG-1 or DG-1 WOUS mitigation areas, but these areas were seeded with native plant species. Native plant growth was noted throughout the DG-1 and DG-1 WOUS mitigation areas, likely both from natural recruitment and from seeding; however, germination was observed to be very minimal in the majority of these mitigation areas. Portions of DG-1 WOUS were noted as being scoured during the 2020 wet season and had minimal plant growth. Native plants such as deerweed (*Acmispon glaber*), California buckwheat (*Eriogonum fasciculatum*), and scale broom (*Lepidospartum squamatum*) were observed sprouting in the DG-1 and DG-1 WOUS mitigation areas. In addition, dodder (*Cuscuta sp.*) was observed growing on some of the shrubs in this mitigation area, which could lead to future decline of these shrubs. Native cover for the DG-1 and DG-1 WOUS mitigation areas was estimated to be 55 to 60 percent with some areas having relatively dense cover and other areas being scoured and/or having minimal cover. Photos 1 through 4 in Attachment B document the mitigation area during the monitoring visit.

Nonnative weed cover in DG-1 and DG-1 WOUS was estimated at approximately less than one percent, if the dead annual weeds are excluded, which is approximately 5 to 10 percent lower than the level of weed cover that was observed during the previous qualitative monitoring event. Nonnative species observed in DG-1 and DG-1 WOUS included black mustard (*Brassica nigra*), red brome (*Bromus madritensis ssp. rubens*), Mediterranean grass (*Schismus barbatus*), and tree tobacco (*Nicotiana glauca*); however, all of the annual species were observed to be dead for the season.

Photo 1: Overview Mitigation Area DG-1

Photo 2: Overview Mitigation Area DG-1

Photo 3: Overview Mitigation Area DG-1

Photo 4: Overview Mitigation Area DG-1 WOUS

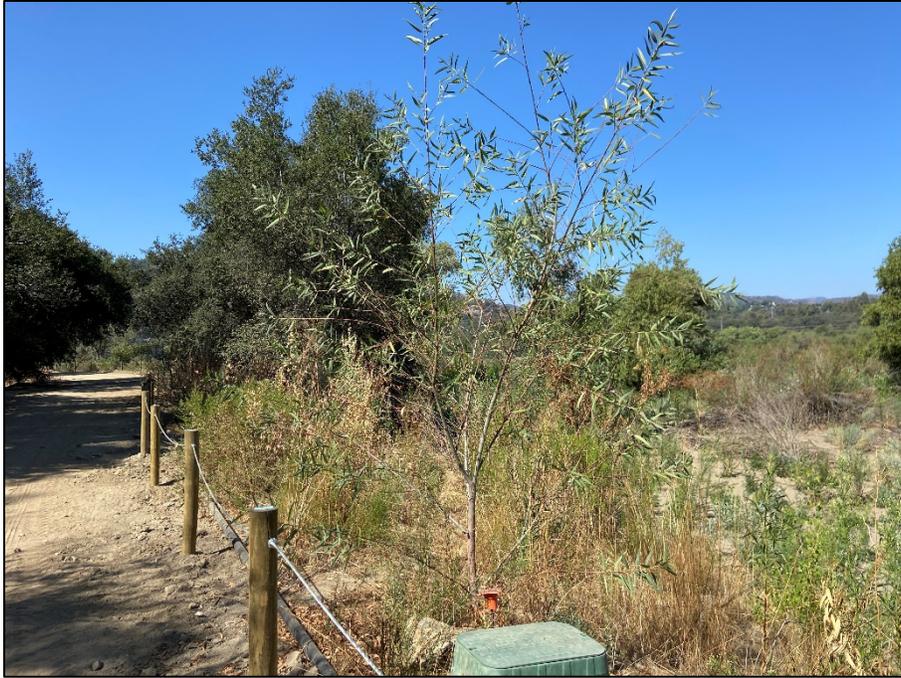
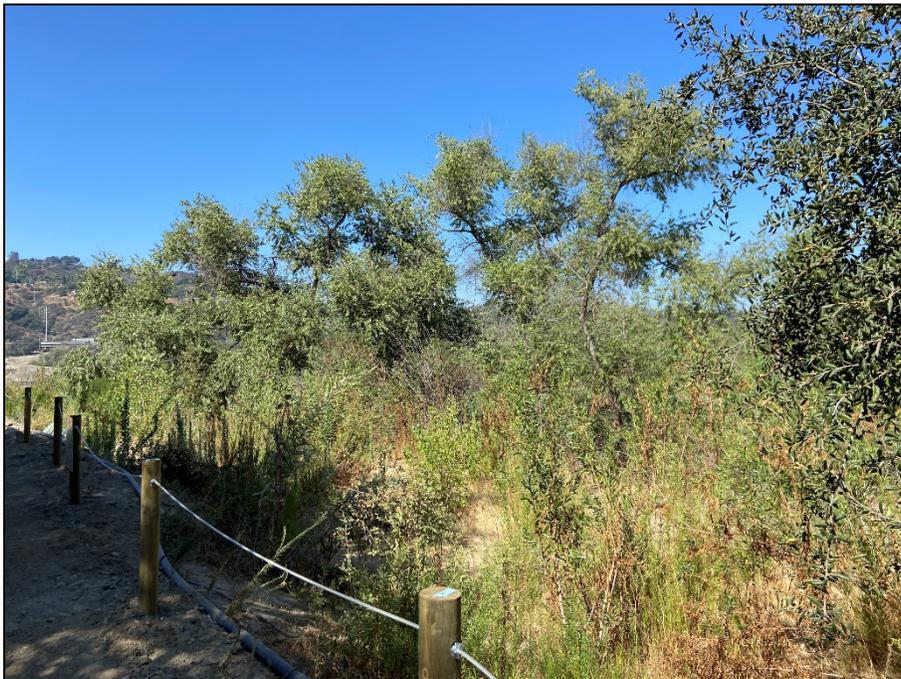
The overall health of the container plants in DG-2A was noted as being good. Approximately 15 percent of the container plants in DG-2A were noted as showing varied levels of stress, which is approximately 10 percent higher than the percentage of container plants that were showing stress during the previous

qualitative monitoring event. Stress may be occurring as a result of 1) herbivory by rabbits or other wildlife, 2) competition from nonnative and invasive weeds, 3) misplaced emitters, or 4) recreational traffic through the mitigation areas. There were no additional container plants noted as being missing or dead. Formal mortality counts were taken for DG-2A during the 2020 quantitative monitoring and were included in the 2020 annual reporting. Some of the planting basins were observed to have minor erosion and should be repaired. The installation of plants in the DG-2A mitigation area appears to have been completed successfully. The current issues identified during the monitoring visit are not expected to have an effect on the continued growth of the plants in the mitigation area. Photos 5 through 6 in Attachment B document the mitigation area during the monitoring visit.

Nonnative weed cover in DG-2A was estimated at approximately less than one percent, which is approximately 45 percent lower than the level of weed cover that was observed during the previous qualitative monitoring event. Nonnative species observed in DG-2A included black mustard, red brome, and Mediterranean grass; however, all of these annual nonnative species were observed to be mostly dead for the season.

Photo 5: Overview Mitigation Area DG-2A

Photo 6: Overview Mitigation Area DG-2A

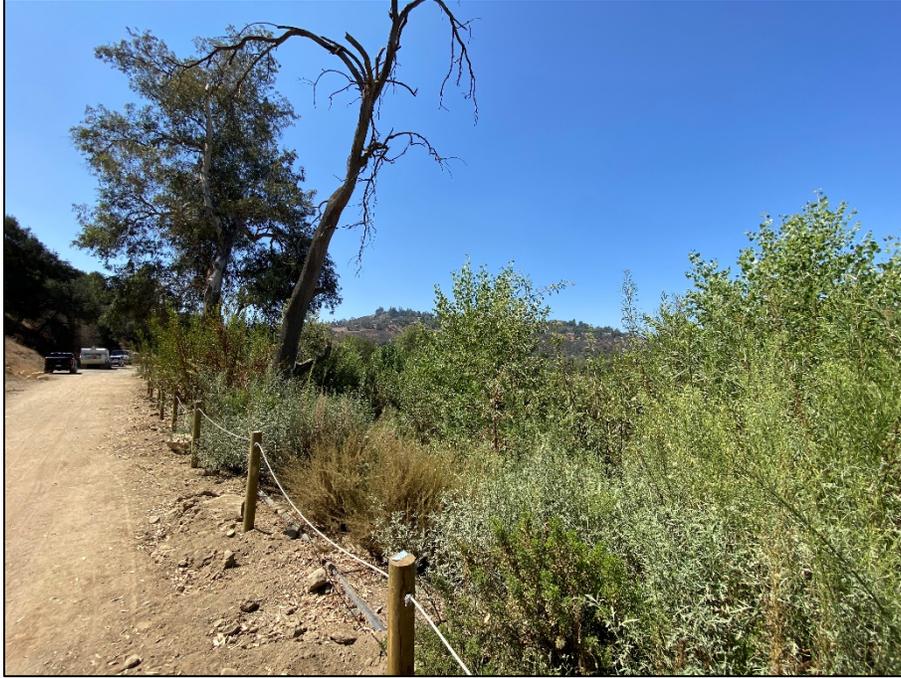
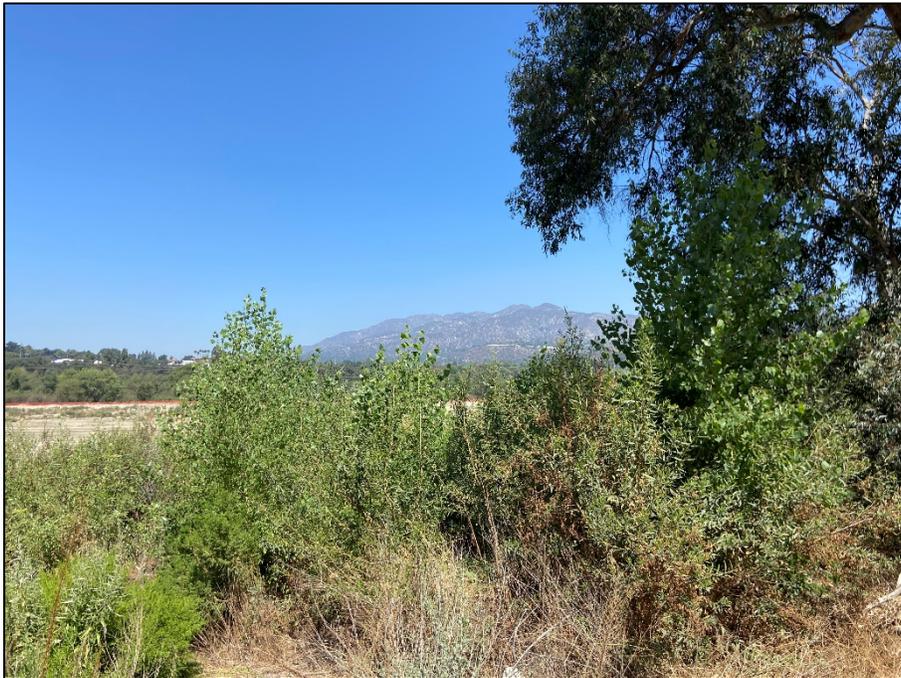
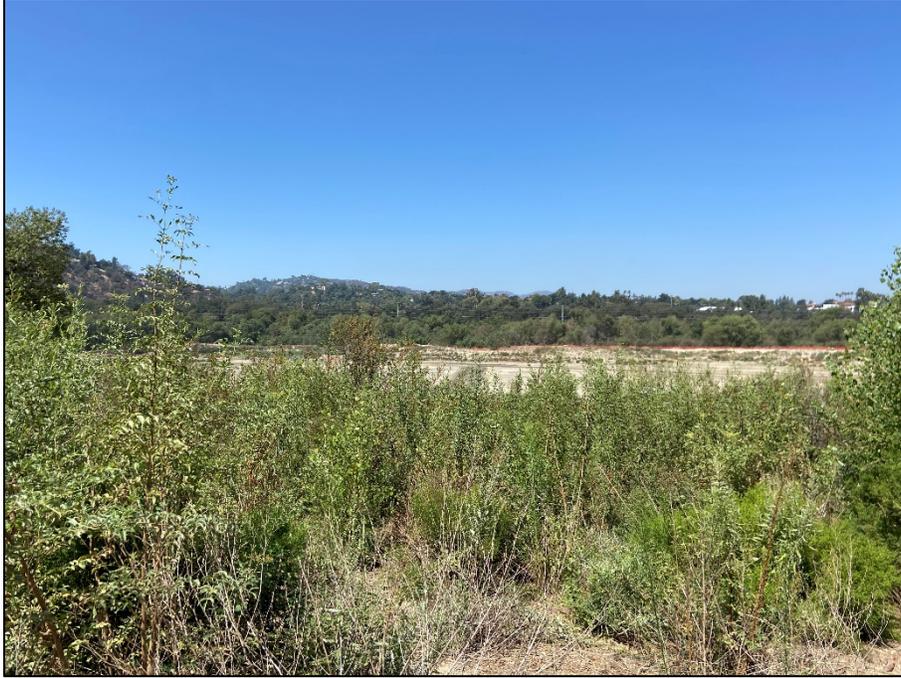
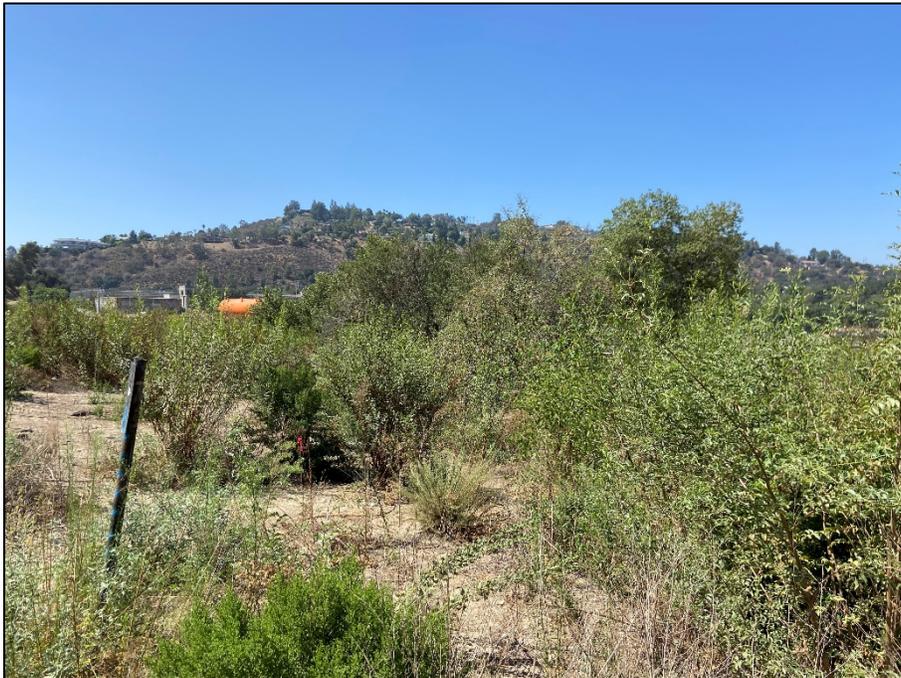
The overall health of the container plants in DG-2B was noted as being good. Approximately less than five percent of the container plants in DG-2B were noted as showing varied levels of stress, which is approximately the same percentage of container plants that were showing stress during the previous qualitative monitoring event. Stress was likely due to the same reasons as those described for DG-2A. In addition, insect galls were observed on several of the willow species. Formal mortality counts were taken for DG-2B during the 2020 quantitative monitoring and were included in the 2020 annual reporting. Some of the planting basins were observed to have minor erosion and should be repaired. The installation of the plants in the DG-2B mitigation area appears to have been successfully completed. The current issues identified during the monitoring visit are not expected to have an effect on the continued growth of plants in the mitigation area. Photos 7 through 10 in Attachment B document the mitigation area during the monitoring visit.

Nonnative weed cover in DG-2B was estimated at approximately less than five percent, which is approximately 25 percent less than what was observed during the previous qualitative monitoring event. Nonnative species observed in DG-2B included black mustard, poison hemlock (*Conium maculatum*), perennial pepperweed (*Lepidium latifolium*), and black nightshade (*Solanum nigrum*).

Photo 7: Overview Mitigation Area DG-2B

Photo 8: Overview Mitigation Area DG-2B

Photo 9: Overview Mitigation Area DG-2B

Photo 10: Overview Mitigation Area DG-2B

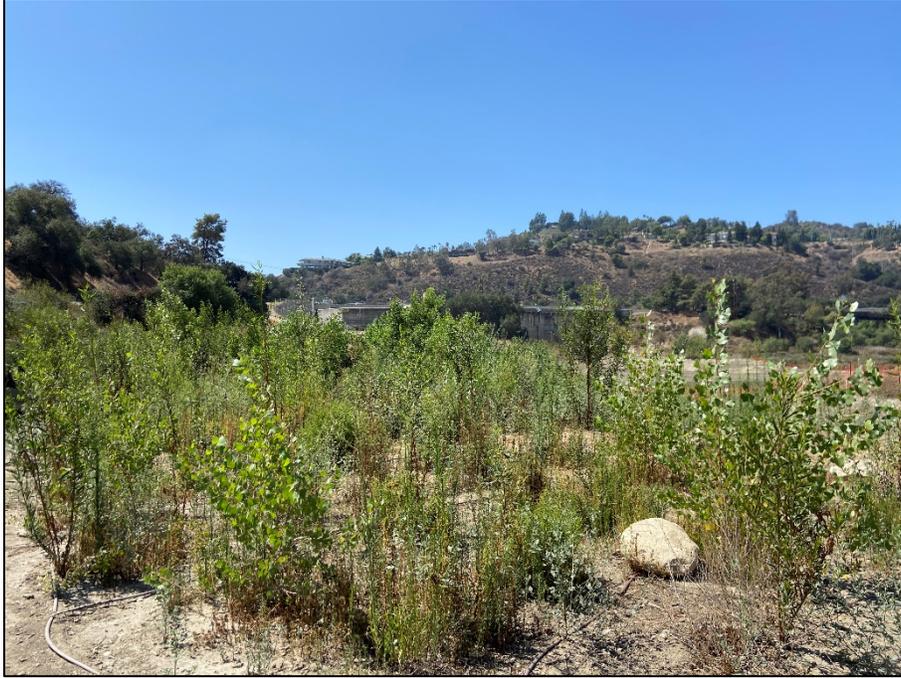
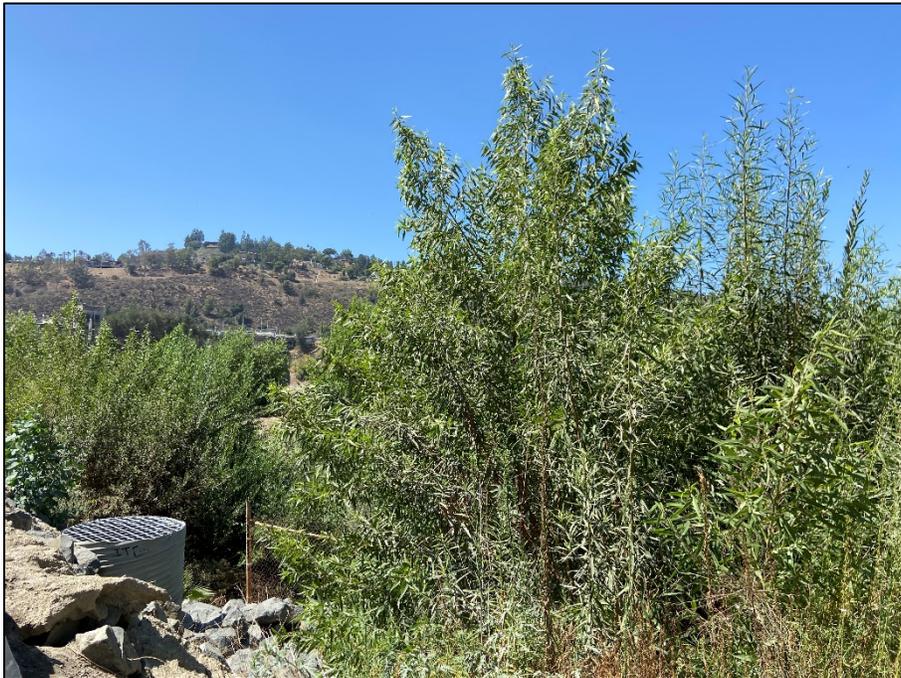
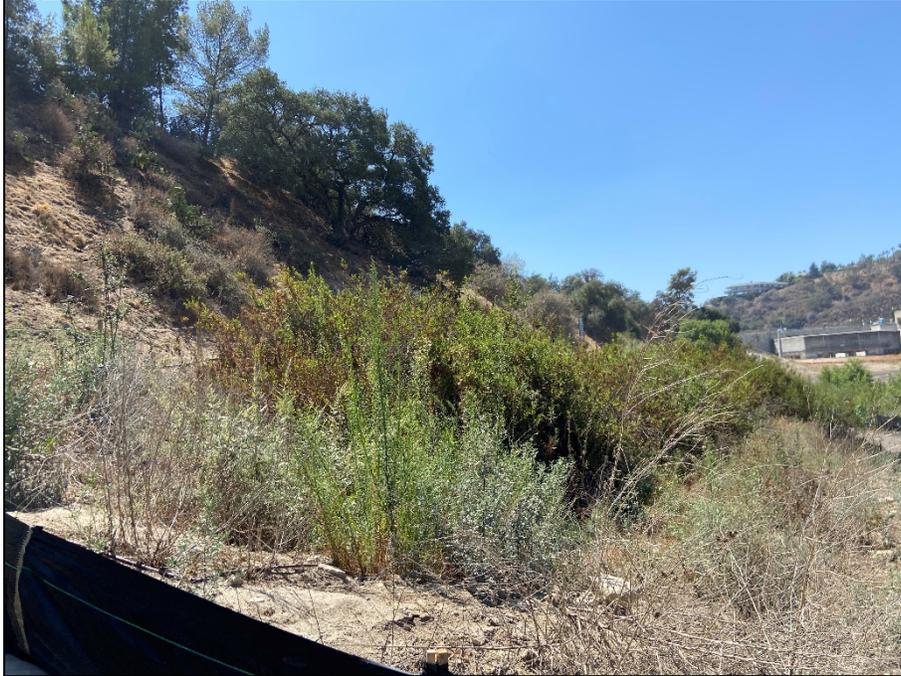
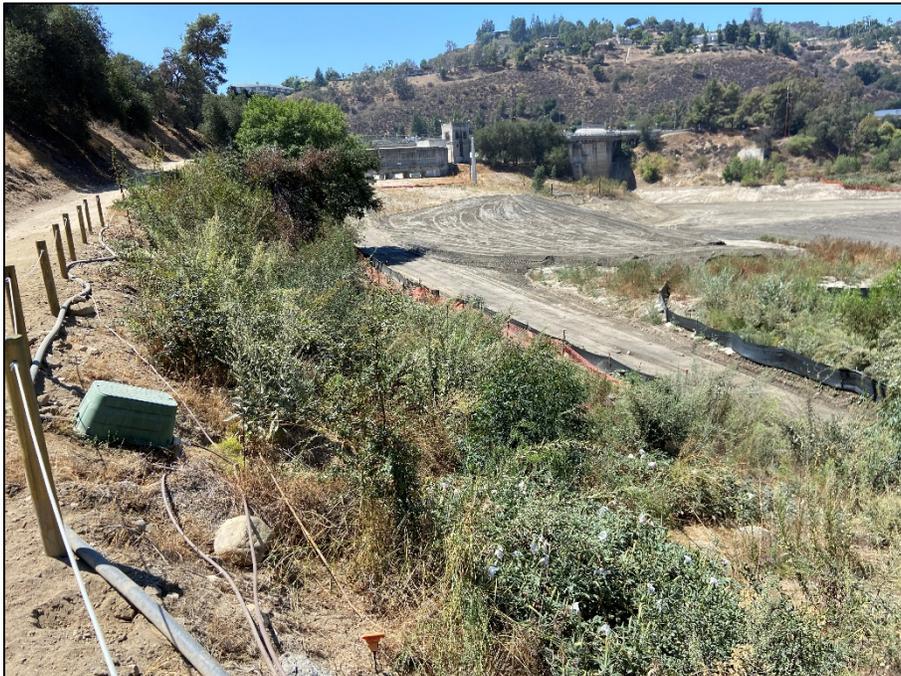
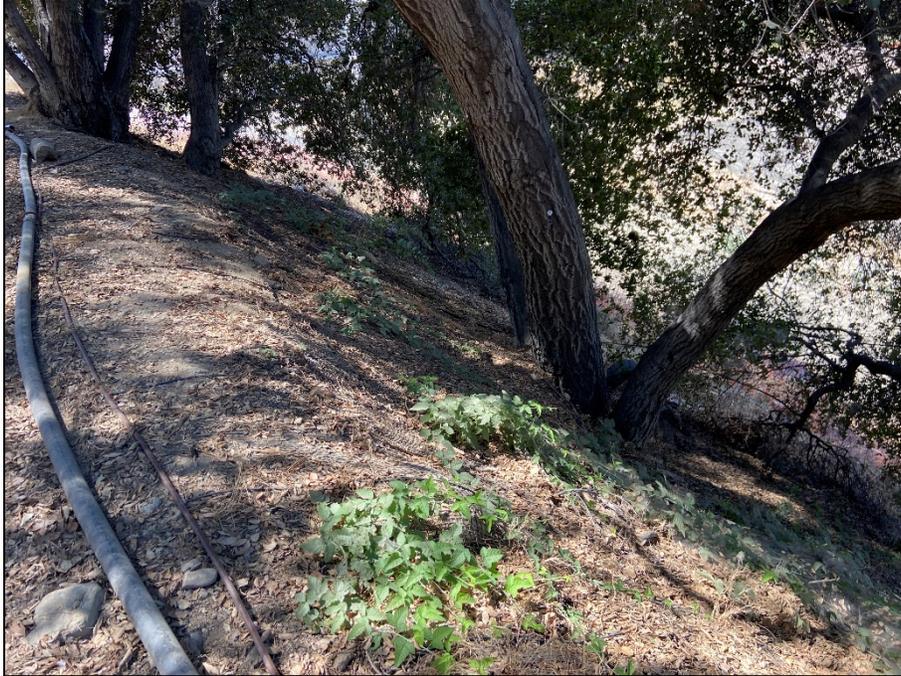
The overall health of the container plants in DG-3A was noted as being good. Approximately 10 percent of the container plants in the Coast Live Oak Woodland portions of DG-3A were noted as showing varied levels of stress, which is the same percentage of container plants that were showing stress during the previous qualitative monitoring event. In addition, several oaks were showing significant signs of decline and may not survive. The decline appears to be the result of erosion and misplaced emitters.

Approximately 5 percent of the container plants in the Mulefat Thickets portions of DG-3A were noted as showing varied levels of stress, which is approximately 10 percent less than the percentage of container plants that were showing stress during the previous qualitative monitoring event. Formal mortality counts were taken for DG-3A during the 2020 quantitative monitoring and were included in the 2020 annual reporting. The types of stress the plants were exhibiting are the same as those described for the plants in DG-2A. However, erosion is also a problem in some areas of DG-3A. Some of the planting basins were observed to have varied levels of erosion and should be repaired. The willow and mulefat stakes were observed to be thriving in this mitigation area. During the monitoring visit, the planted coast live oak (*Quercus agrifolia*) acorns were inspected for survivorship and health. Approximately 20 germinated coast live oak acorns appear to still be present in DG-3A. The majority of the germinated acorns appear to be in good health. During the monitoring, it was noted that an existing coast live oak tree (Tree Tag #39) was experiencing severe branch failure for multiple branches. The cause of the branch failure was unclear and further investigation should be conducted. The installation of the plants in the DG-3A mitigation area appears to have been completed successfully. The current issues noted during the monitoring are not expected to have a negative effect on the continued growth of the plants in the mitigation area. Photos 11 through 15 in Attachment B document the mitigation area during the monitoring visit.

Minor erosion to planting basins was observed throughout the Phase 1 mitigation areas, likely from recent storm events. In addition, severe erosion in DG-3A near Altadena Drain was observed. Recent rainfall has created a channel that flows to the south of Altadena Drain before connecting to the reservoir where severe berm erosion has occurred. Erosion to the upper slope in DG-3A was also observed. Due to the steepness of the slope in the Coast Live Oak Woodland portion of the DG-3A mitigation area, erosion will likely continue to be somewhat of an issue in this area; however, jute nettings are currently in place on the slope and will help to lessen the severity of erosion issues. As native cover increases in this area, erosion issues should lessen. The severity of the erosion should continue to be monitored in all planted areas and if warranted, erosion Best Management Practices (BMPs) should be installed in appropriate areas. This may only require the installation of straw wattles at select sites to prevent existing rills from becoming larger. However, until more native perennial plants become established in these areas, there is the potential that intense rainfall may create additional erosion problems.

Photo 11: Overview Mitigation Area DG-3A Altadena Drain

Photo 12: Overview Mitigation Area DG-3A Altadena Drain

Photo 13: Overview Mitigation Area DG-3A Oak Woodland

Photo 14: Overview Mitigation Area DG-3A Oak Woodland

Photo 15: Overview Mitigation Area DG-3A Oak Woodland

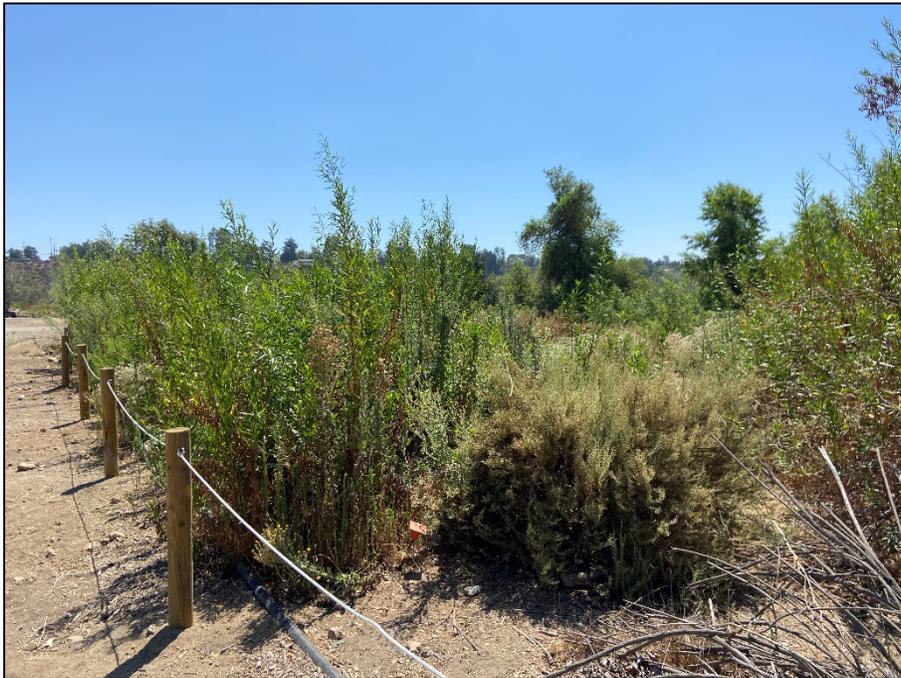
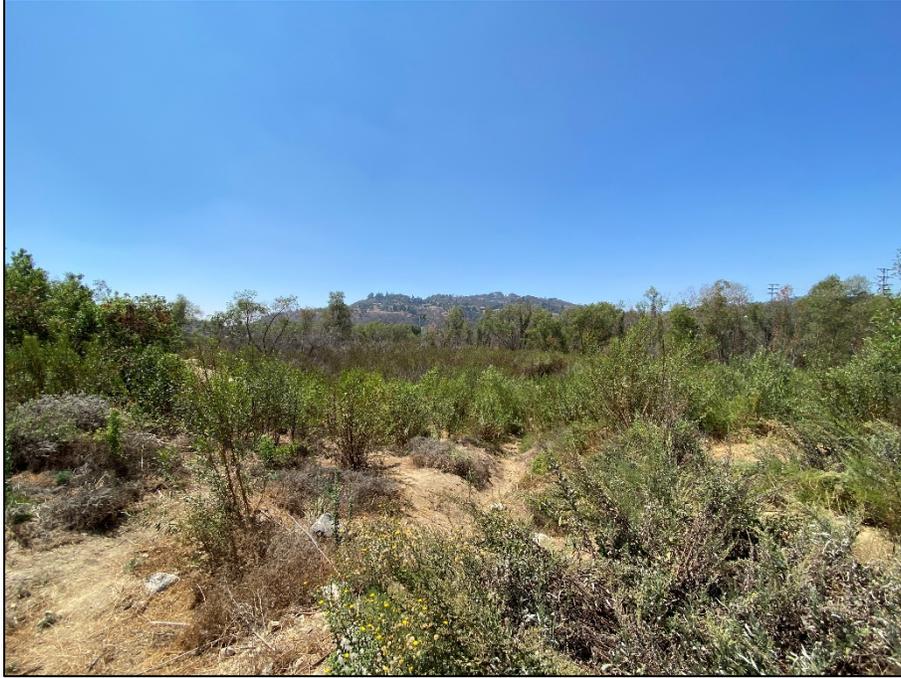
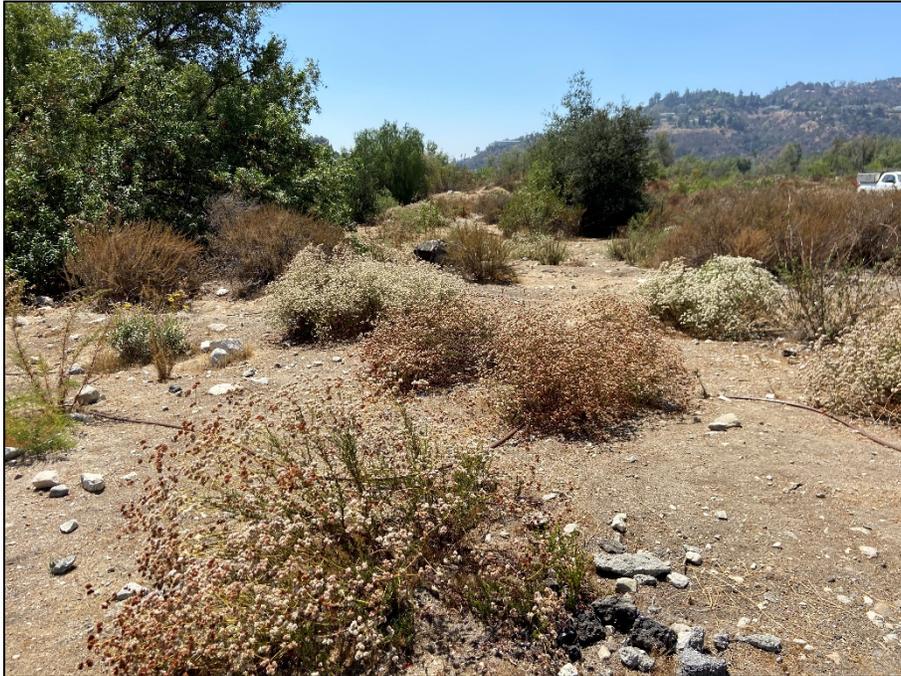
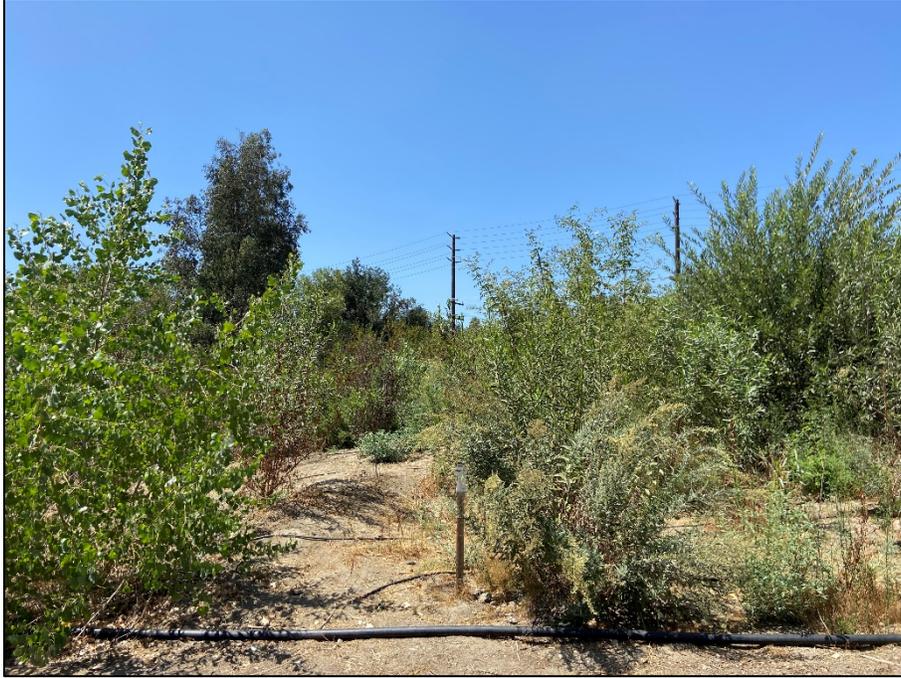
The overall health of the container plants in mitigation area DG-4 was noted as being good. Approximately five percent of container plants in the coastal sage scrub portions of DG-4 were showing varied levels of stress which is approximately five percent less than the percentage of plants showing stress during the previous qualitative monitoring event. Approximately 10 percent of container plants in the riparian portions of DG-4 were showing varied levels of stress, which is approximately the same as the percentage of plants showing stress during the previous qualitative monitoring event. The stress appears to be mostly due to the same reasons described in DG-2A. For most portions of DG-4, only a negligible number of container plants were noted as being missing or dead. Formal mortality counts were taken for DG-4 during the 2020 quantitative monitoring and were included in the 2020 annual reporting. The willow and mulefat stakes were observed to be thriving in this mitigation area. Some of the planting basins were observed to have minor erosion and should be repaired. The installation of plants in the DG-4 mitigation area appears to have been completed successfully and the issues noted during the monitoring are not expected to have an impact on the continued growth of the plants. Photos 16 through 19 in Attachment B document the mitigation area during the monitoring visit.

Nonnative weed cover in DG-4 was estimated at approximately 5 to 10 percent for most areas, which is approximately 35 to 40 percent less than what was observed during the previous qualitative monitoring event. In addition, weed abatement was observed to be actively occurring in the northern portion of DG-4 during the monitoring visit. Nonnative species observed in DG-4 included black mustard, red brome, poison hemlock, perennial pepperweed, and white horehound (*Marrubium vulgare*). Nonnative weed cover, especially perennial pepperweed, is a significant problem in portions of the DG-4 mitigation area. Because perennial pepperweed can produce dense colonies through seed germination and underground rhizomes (rhizomatous roots), removal of this species without the use of systemic herbicide is very difficult. In addition, many of the nonnative weeds observed in this mitigation area are starting to flower and will soon go to seed. Weed abatement should be conducted for this mitigation area as soon as possible.

Photo 16: Overview Mitigation Area DG-4

Photo 17: Overview Mitigation Area DG-4

Photo 18: Overview Mitigation Area DG-4

Photo 19: Overview Mitigation Area DG-4

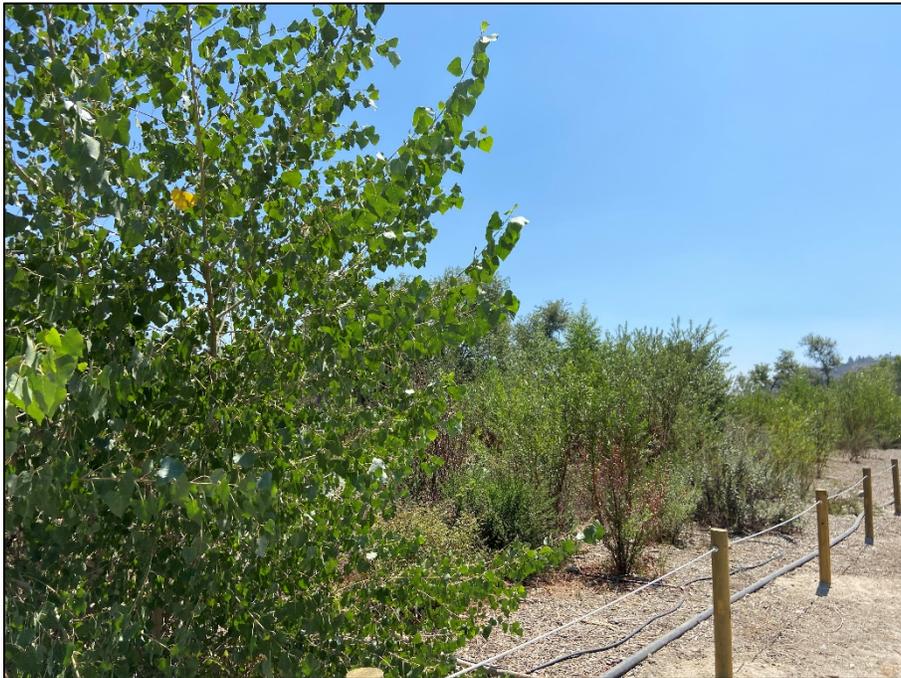
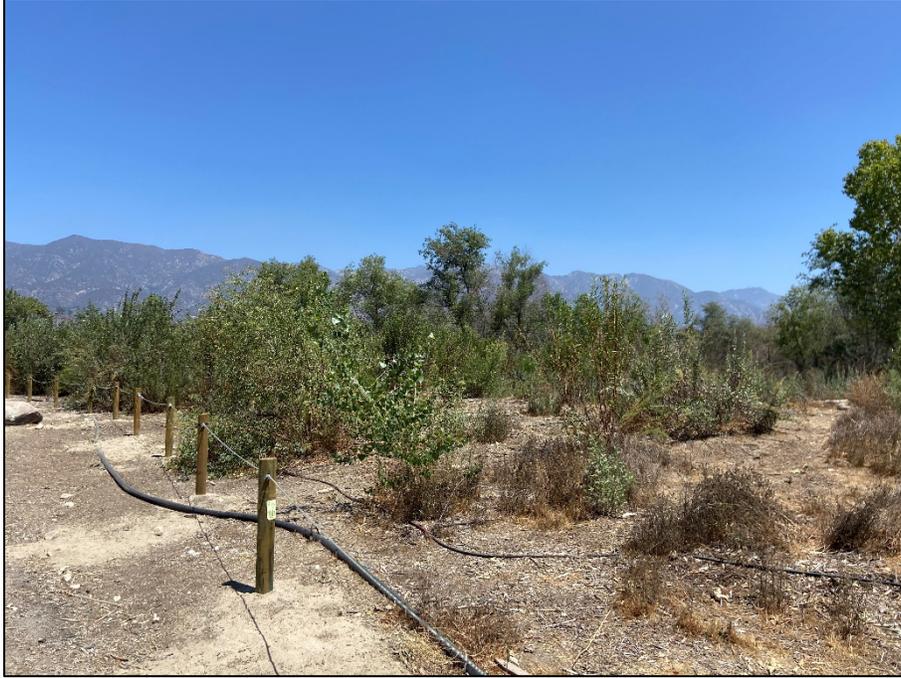
The overall health of the container plants in mitigation area DG-4B was noted as being good and this mitigation area is becoming well established. Approximately less than five percent of container plants were showing stress which is approximately the same percent of plants that were stressed during the previous qualitative monitoring event. The types of stress the plants were exhibiting are the same as those described for the plants in DG-2A. A negligible number of container plants were noted as being missing

or dead. Formal mortality counts were taken for DG-4B during the 2020 quantitative monitoring and were included in the 2020 annual reporting. Some of the planting basins were observed to have minor erosion and should be repaired. The installation of plants in the DG-4B mitigation area appears to have been completed successfully and the issues noted during the monitoring are not expected to have an impact on the continued growth of the plants. Photos 20 and 21 in Attachment B document the mitigation area during the monitoring visit.

Photo 20: Overview Mitigation Area DG-4B

Photo 21: Overview Mitigation Area DG-4B

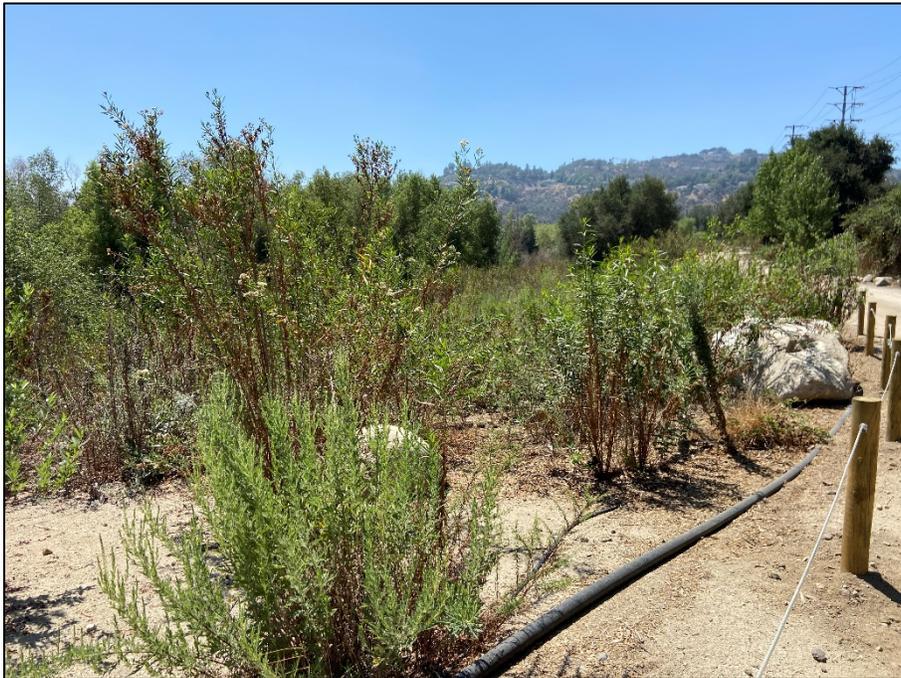
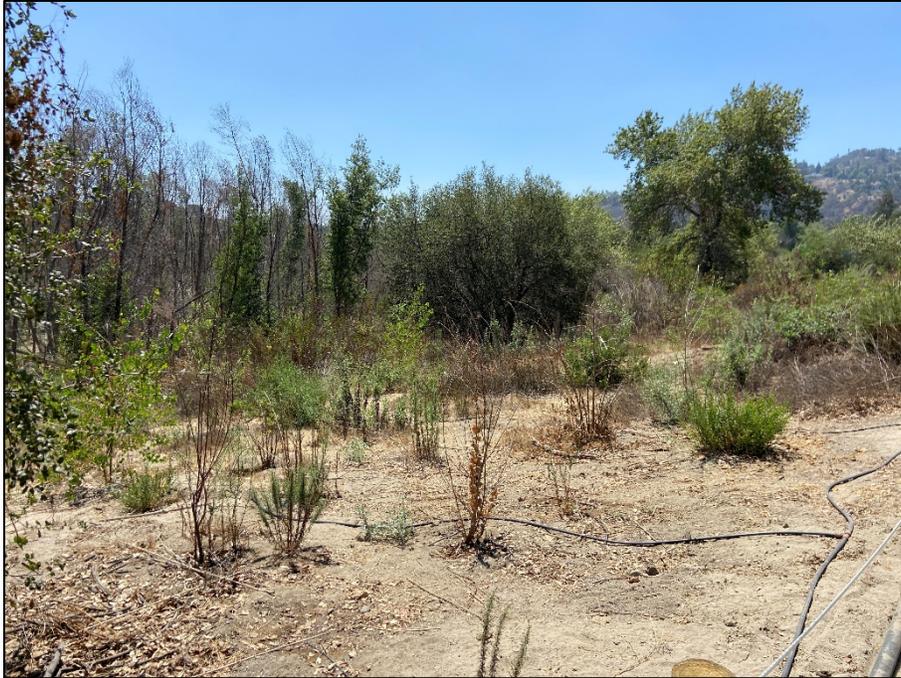
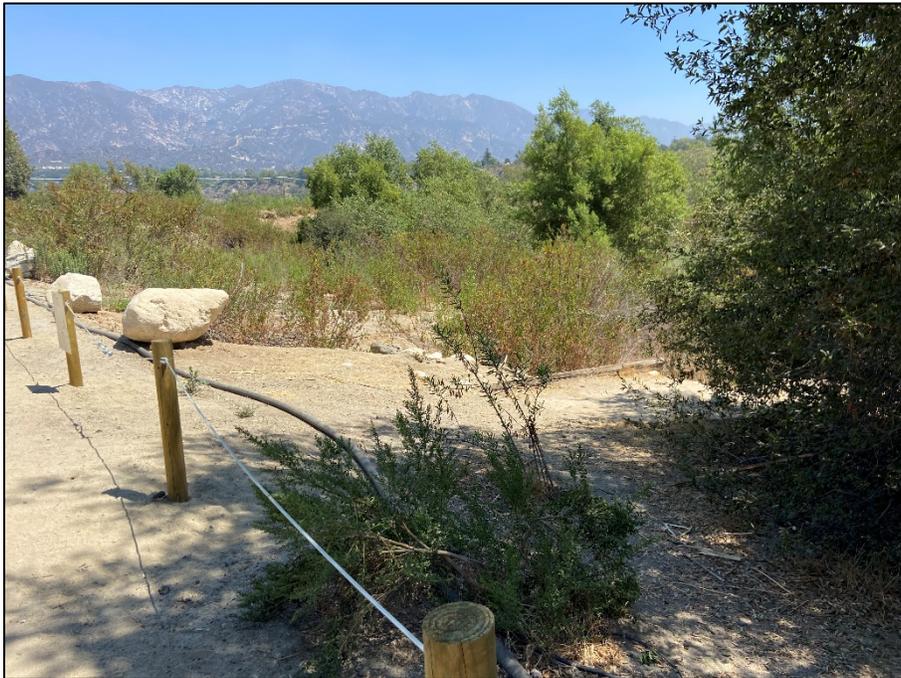
The overall health of the container plants in mitigation area DG-4C was noted as being good. Approximately 10 percent of all container plants were noted as showing minor levels of stress, which is approximately the same percentage of plants that were showing stress during the previous qualitative monitoring event. The types of stress the plants were exhibiting are the same as those described for the plants in DG-2A. A negligible number of container plants were noted as being missing or dead. Formal mortality counts were taken for DG-4C during the 2020 quantitative monitoring and were included in the 2020 annual reporting. Some of the planting basins were observed to have minor erosion and should be repaired. The installation of plants in the DG-4C mitigation area appears to have been completed successfully and the issues noted during the monitoring are not expected to have an impact on the continued growth of the plants. Photos 22 to 24 in Attachment B document the mitigation area during the monitoring visit.

Photo 22: Overview Mitigation Area DG-4C

Photo 23: Overview Mitigation Area DG-4C

Photo 24: Overview Mitigation Area DG-4C

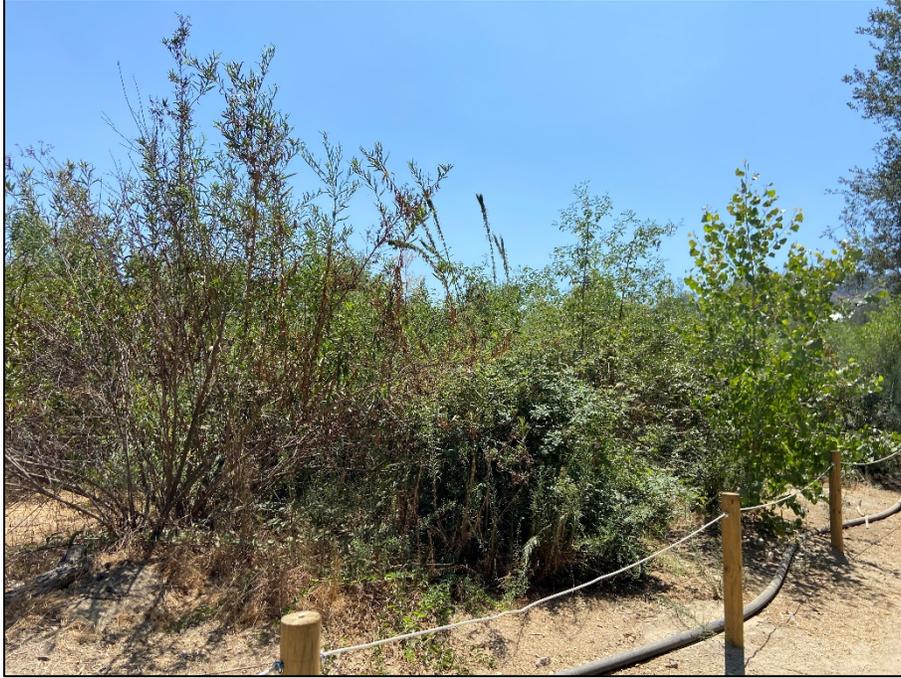
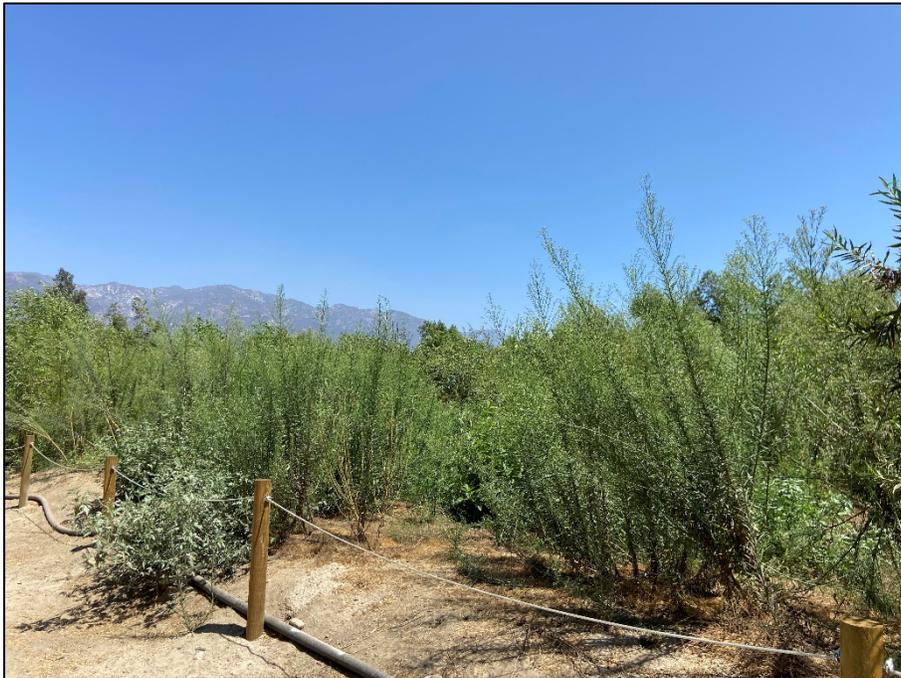
The overall health of the container plants in the DG-5 mitigation area was noted as being good. Approximately less than five percent of all container plants were noted as showing varied levels of stress,

which is approximately five percent less than the percentage of plants that were showing stress during the previous qualitative monitoring event. Formal mortality counts were taken for DG-5 during the 2020 quantitative monitoring and were included in the 2020 annual reporting. Some of the planting basins were observed to have minor erosion and should be repaired. The installation of plants in the DG-5 mitigation area appears to have been completed successfully and the issues noted during the monitoring are not expected to have a negative impact on the continued growth of the plants. Photos 25 and 26 in Attachment B document the mitigation area during the monitoring visit.

Photo 25: Overview Mitigation Area DG-5

Photo 26: Overview Mitigation Area DG-5
