November 17, 2021
2018-047.031

**Re: Devil's Gate Reservoir Restoration Project – Phase 2 Restoration Qualitative Monitoring
Conducted on October 20, 2021**

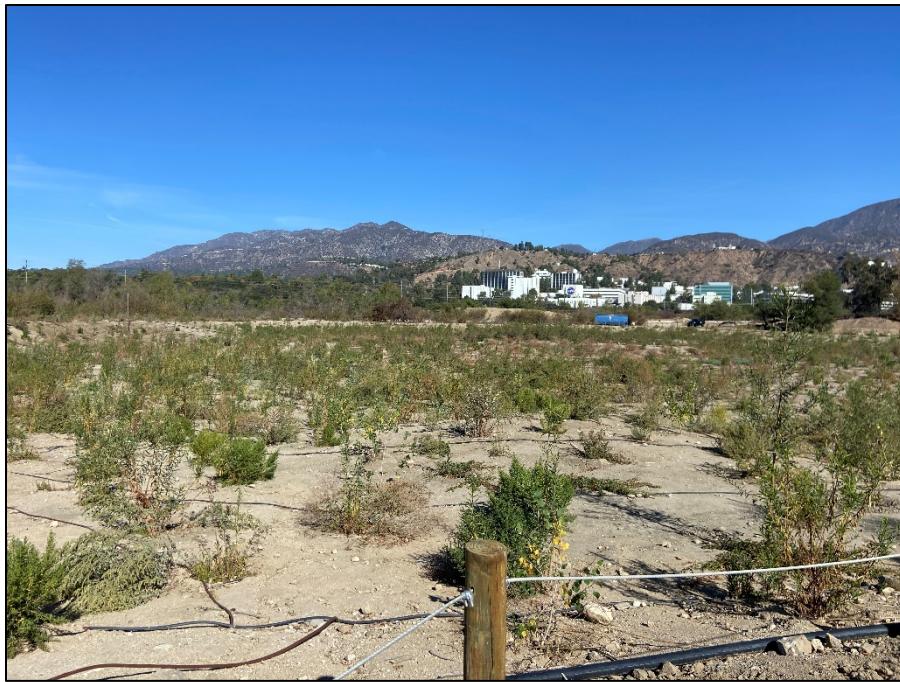
Photo 1: Overview Mitigation Area DG-W-1 (Johnson Field)

The overall health of the container plants in DG-W-1 was noted as being good. Approximately 10 to 15 percent of the container plants in DG-W-1 were noted as showing varied levels of stress and a negligible number were noted as being dead or missing. This is approximately the same percentage of plants that were showing stress during the last monitoring event. Stress may be occurring as a result of 1) transplant shock 2) herbivory by rabbits or other wildlife, 3) competition from nonnative and invasive weeds, 4) misplaced emitters, or 5) recreational traffic through the mitigation areas. Formal mortality counts were taken for DG-W-1 during the 2021 quantitative monitoring and will be included in the 2021 annual reporting. Some of the container plants were noted as lacking well defined basins and should have their basins properly constructed and/or repaired. The irrigation line issues that were noted during the previous monitoring visit appear to have been resolved. The installation of plants in the DG-W-1 mitigation area appears to have been completed successfully. The current issues identified during the monitoring visit are not expected to have an effect on the continued growth of the plants in the mitigation area. Photos 1 through 3 in Attachment B document the mitigation area during the monitoring visit.

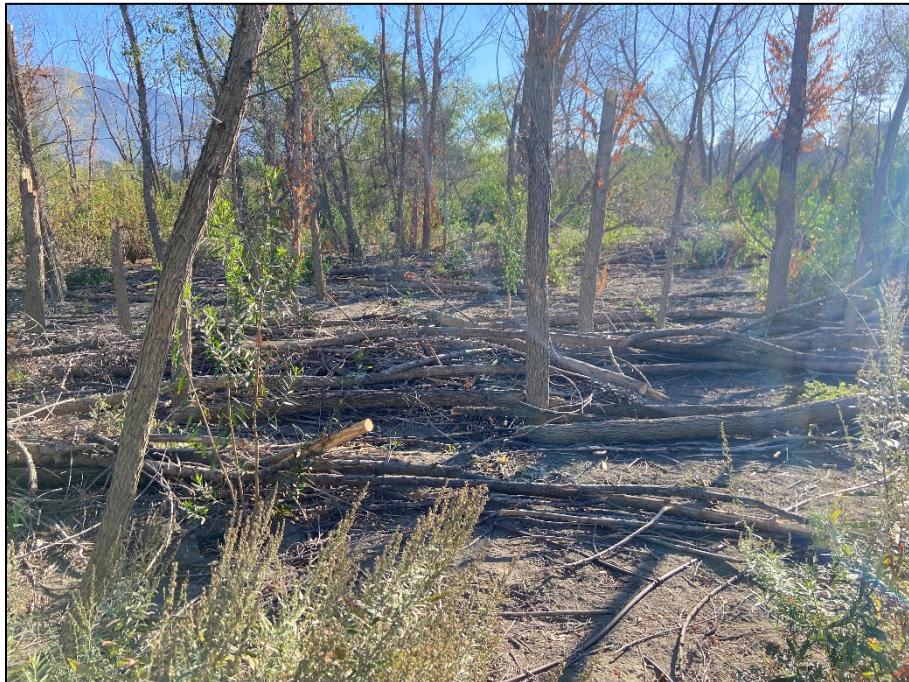
During the monitoring visit, it was noted that many of the existing mature black willow (*Salix gooddingii*) in this mitigation area that were showing signs of beetle infestation during previous monitoring visits had fallen over during recent high winds. Signs of infestation noted during previous monitoring visits included entry/exit holes, frass, galleries, fungal residue, and branch failure. Further investigation into this issue is being conducted with the help from the Los Angeles County Department of Agricultural Commissioner/Weights & Measures (ACWM). It should be noted that evidence of infestation was only noted on existing mature willows and not on any of the recently installed container plants.

Photo 8: Fallen Trees Mitigation Area DG-W-2 (Mining Pit)

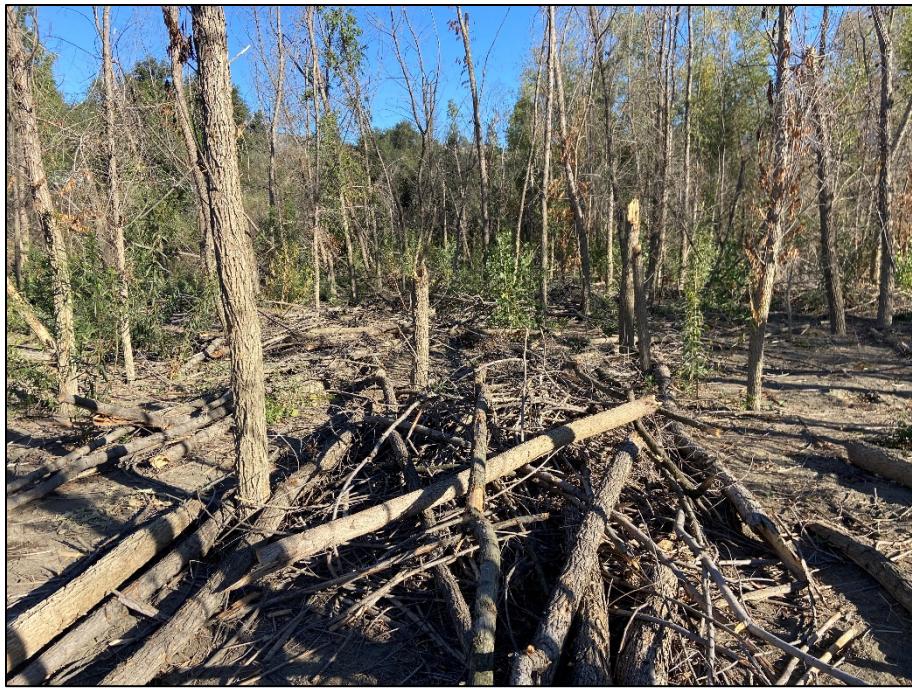
Photo 9: Fallen Trees Mitigation Area DG-W-2 (Mining Pit)
