Mr. Wayne Lee
Los Angeles County Public Works
900 South Fremont Avenue, 9th Floor
Alhambra, California 91803

Re: *Devil's Gate Reservoir Restoration Project – Phase 2 Restoration Qualitative Monitoring Conducted on May 19, 2022*

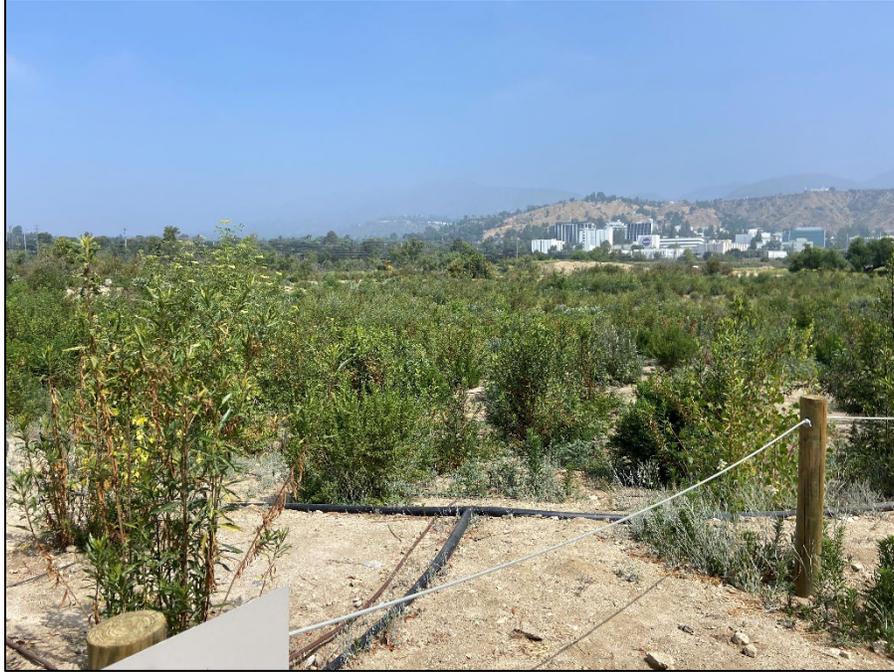
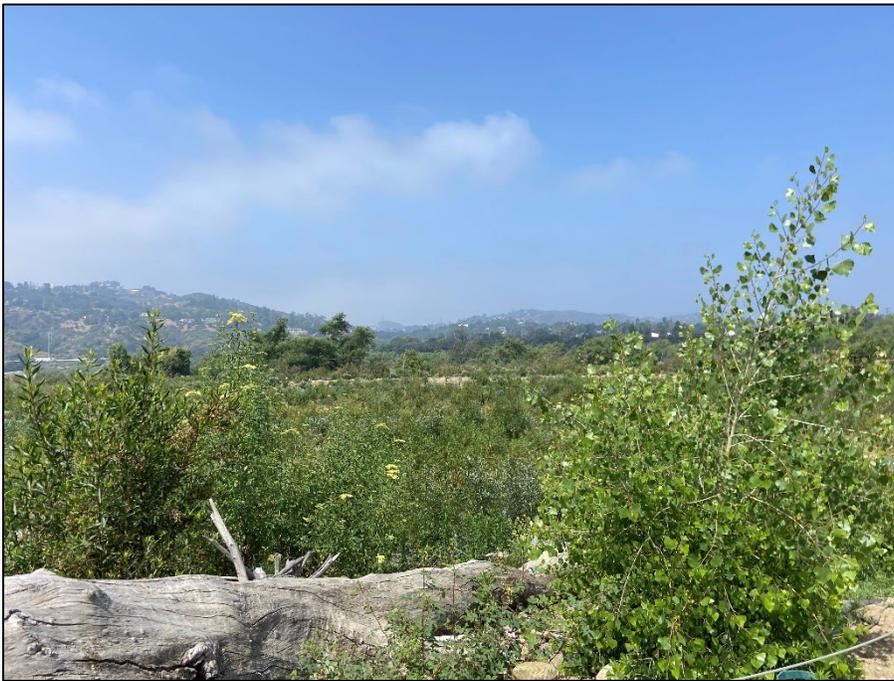
The overall health of the container plants in DG-W-1 was noted as being good. Approximately five to ten percent of the container plants in DG-W-1 were noted as showing varied levels of stress and a negligible number were noted as being dead or missing. This is approximately five percent more than the percentage of plants that were showing stress during the last monitoring event. Stress may be occurring as a result of 1) herbivory by rabbits or other wildlife, 2) competition from nonnative and invasive weeds, 3) misplaced emitters, or 4) recreational traffic through the mitigation areas. In addition, some of the mulefat (*Baccharis salicifolia*) in this mitigation area were showing signs of minor dieback that appeared to be the result of *Baccharis* leaf blister and/or dodder (*Cuscuta* sp.). A handful of Fremont's cottonwoods (*Populus fremontii*) were also showing minor dieback which appeared to be the result of natural recruitment of mulefat within their basins. Evidence of dieback from *Phytophthora cactorum*, including wilting, stunted growth, leaf spotting, and/or browning along leaf margins and tips, was not observed on any of the container plants. The willows (*Salix* sp.) and Fremont's cottonwoods (*Populus fremontii*) in this mitigation area were no longer showing signs of seasonal dieback. Formal mortality counts were taken for DG-W-1 during the 2021 quantitative monitoring and were included in the 2021 annual reporting. Some of the container plants were noted as lacking well defined basins and should have their basins properly constructed and/or repaired. The irrigation line appeared to be functioning properly for most areas of the mitigation area during the monitoring visit; however, some basins appeared to be dry and should be inspected for functionality. The installation of plants in the DG-W-1 mitigation area appears to have been completed successfully. The current issues identified during the monitoring visit are not expected to have an effect on the continued growth of the plants in the mitigation area. Photos 1 and 2 in Attachment B document the mitigation area during the monitoring visit.

Photo 1: Overview Mitigation Area DG-W-1 (Johnson Field)

Photo 2: Overview Mitigation Area Overview Mitigation Area DG-W-1 (Johnson Field)

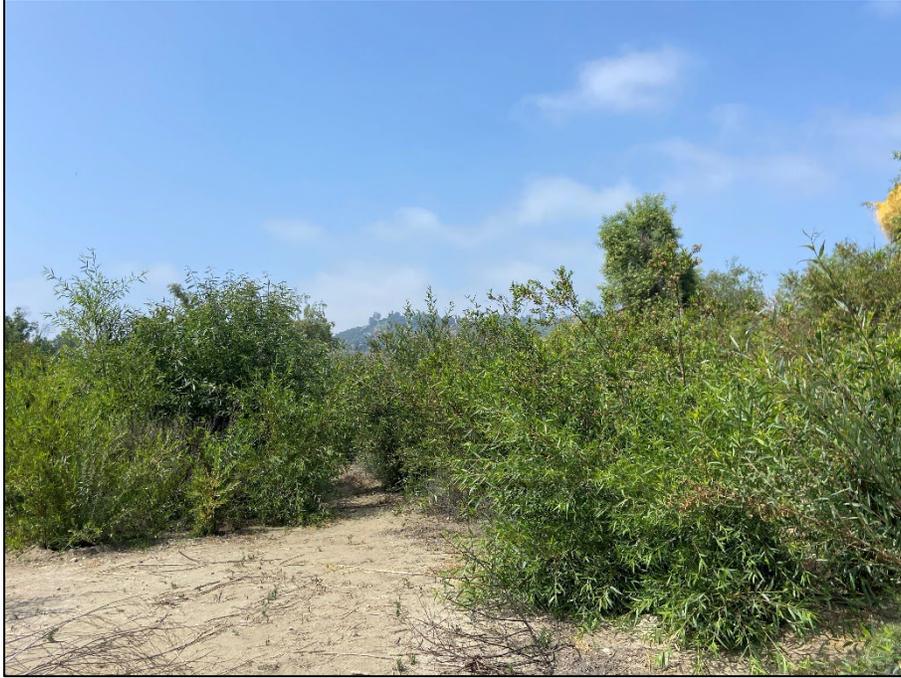
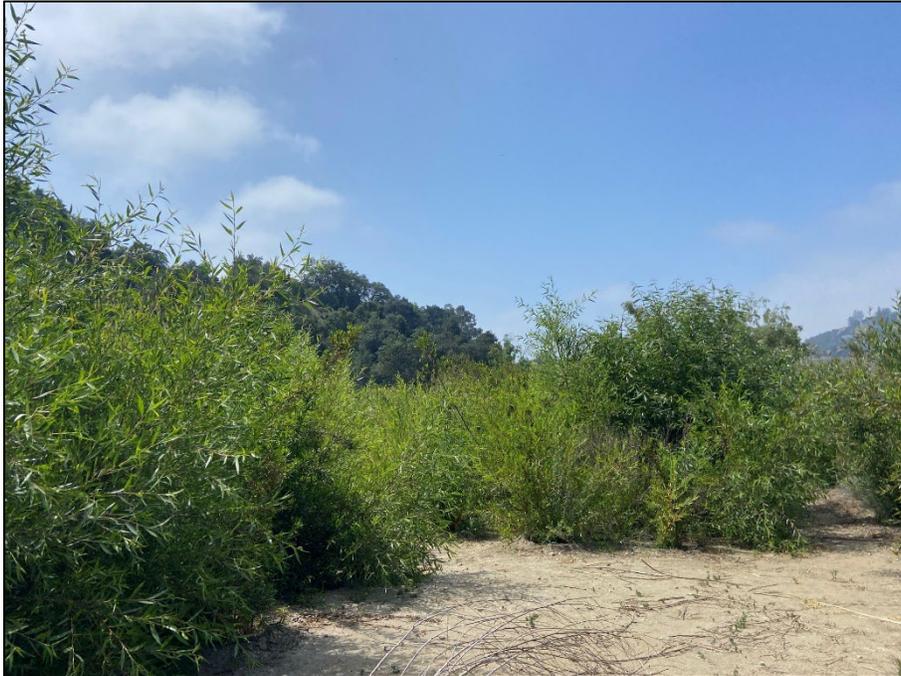
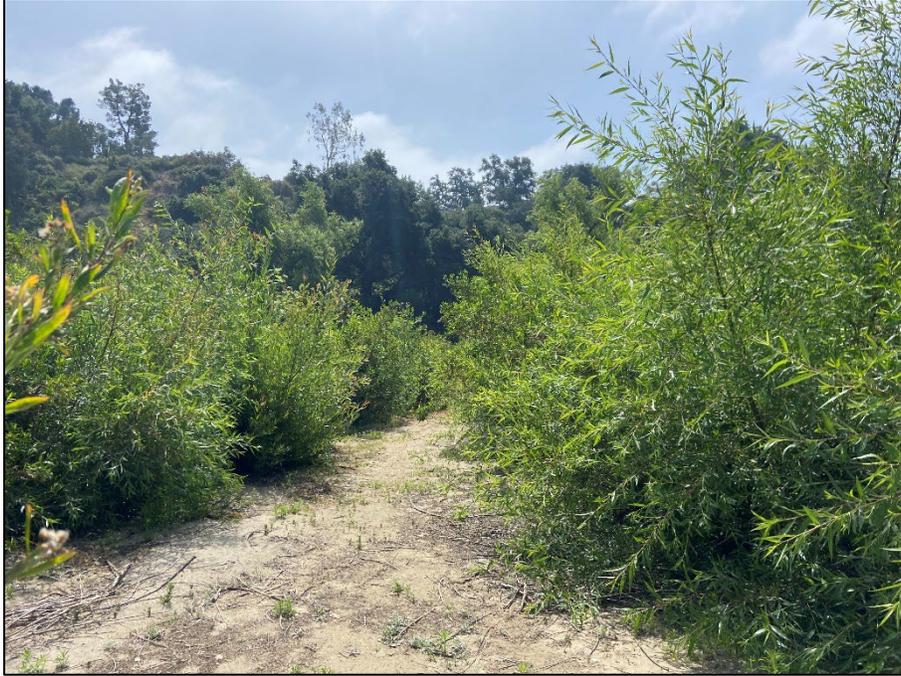
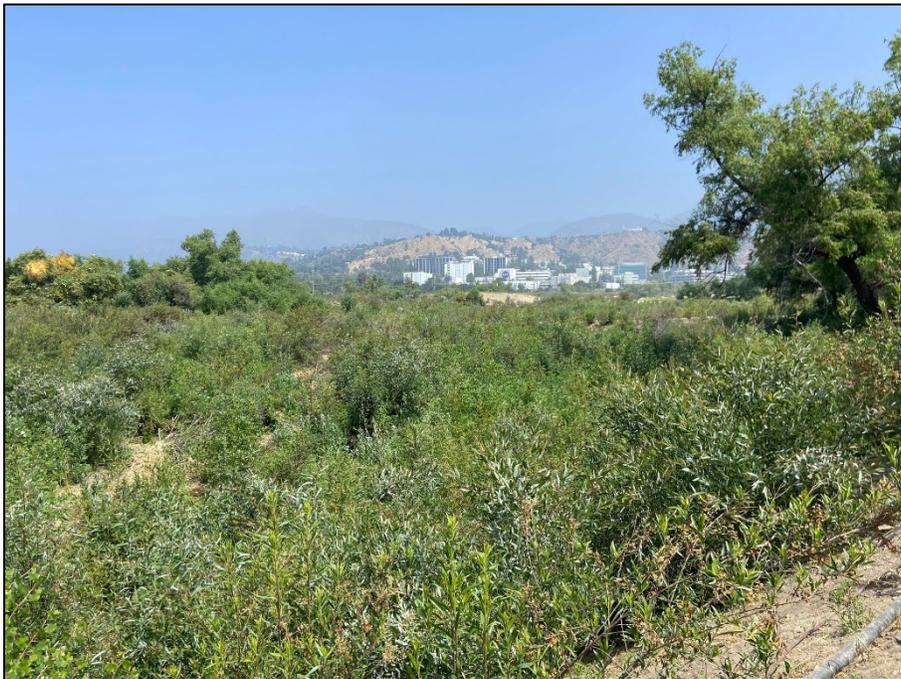
The overall health of the container plants in DG-2, DG-2 New Channels, and DG-2 WOUS was noted as being good. Approximately less than five percent of the container plants were noted as showing varied levels of stress and a negligible number were noted as being dead or missing. This is approximately the same percentage of plants that were showing stress during the last monitoring event. Stress may be occurring due to similar reasons described for DG-W-1. Evidence of dieback from *Phytophthora cactorum*, including wilting, stunted growth, leaf spotting, and/or browning along leaf margins and tips, was not observed on any of the container plants. Similar to DG-W-1, the willows and Fremont's cottonwoods in this mitigation area were no longer showing seasonal dieback. Formal mortality counts were taken for DG-2, DG-2 New Channels, and DG-2 WOUS during the 2021 quantitative monitoring and were included in the 2021 annual reporting. Some of the container plants were noted as lacking well defined basins and should have their basins properly constructed and/or repaired. The irrigation line appeared to be functioning properly during the monitoring visit. The installation of plants in the DG-2, DG-2 New Channels, and DG-2 WOUS mitigation areas appears to have been completed successfully. The current issues identified during the monitoring visit are not expected to have an effect on the continued growth of the plants in the mitigation area. Photos 3 through 6 in Attachment B document the mitigation areas during the monitoring visit.

Photo 3: Overview Mitigation Area Overview Mitigation Area DG-2 & DG-2 WOUS

Photo 4: Overview Mitigation Area DG-2 & DG-2 New Channels

Photo 5: Overview Mitigation Area DG-2 & DG-2 WOUS

Photo 6: Overview Mitigation Area DG-2, DG-2 New Channels, DG-2 WOUS

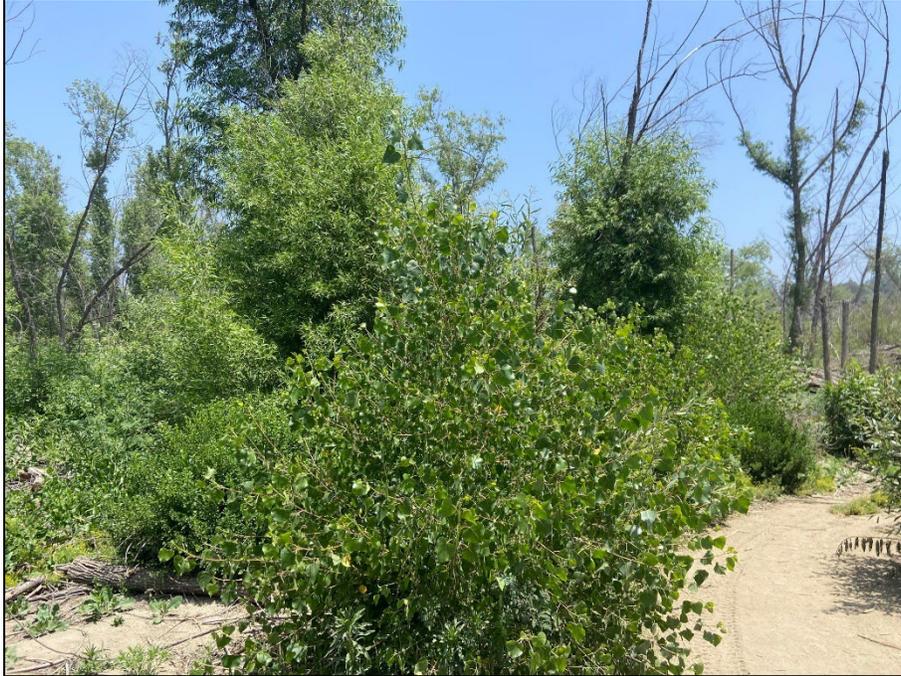
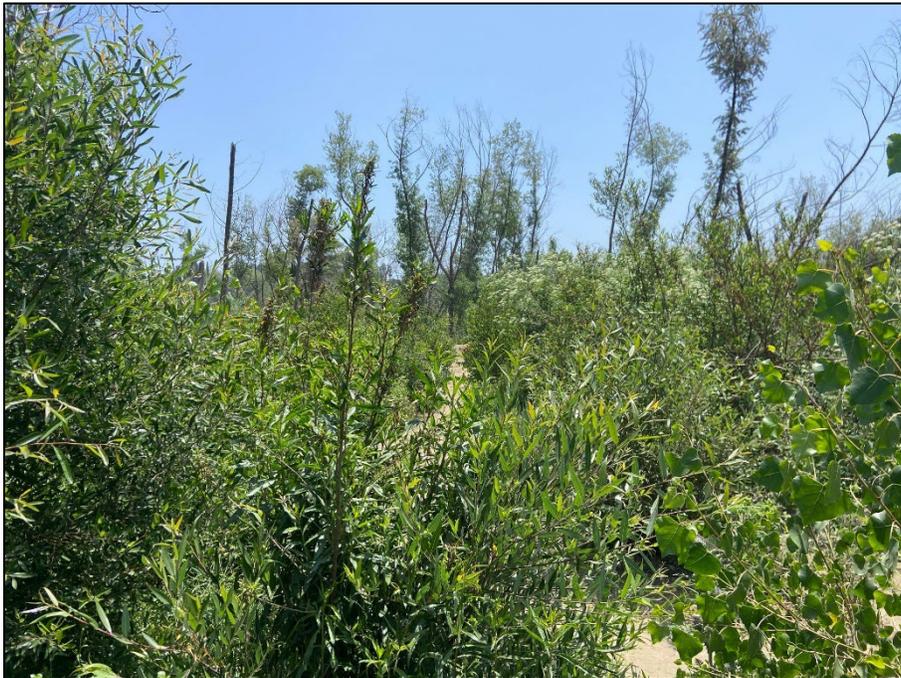
The overall health of the container plants in mitigation area DG-W-2 was noted as being good. Approximately five percent of the container plants were noted as showing varied levels of stress and a negligible number were noted as being dead or missing. This is approximately the same percentage of plants that were showing stress during the last monitoring event. Stress may be occurring due to similar reasons described for DG-W-1. Evidence of dieback from *Phytophthora cactorum*, including wilting, stunted growth, leaf spotting, and/or browning along leaf margins and tips, was not observed on any of the container plants. Formal mortality counts were taken for DG-W-2 during the 2021 quantitative monitoring and were included in the 2021 annual reporting. Some of the container plants were noted as lacking well defined basins and should have their basins properly constructed and/or repaired. The irrigation line appeared to be functioning properly during the monitoring visit. The installation of plants in the DG-W-2 mitigation area appears to have been completed successfully and the issues noted during the monitoring are not expected to have an impact on the continued growth of the plants. Photos 7 and 8 in Attachment B document the mitigation area during the monitoring visit.

During the monitoring visit, it was noted that many of the existing mature black willow (*Salix gooddingii*) in this mitigation area that were showing signs of beetle infestation during previous monitoring visits were no longer showing additional dieback and no additional branch failure was noted. Signs of infestation noted during previous monitoring visits included entry/exit holes, frass, galleries, fungal residue, and branch failure. Further investigation into this issue is being conducted with the help from the Los Angeles County Department of Agricultural Commissioner/Weights & Measures (ACWM) and preliminary surveys mostly showed only low to moderate infestation in these areas. It should be noted that evidence of infestation was only noted on existing mature willows and not on any of the recently installed container plants. It should also be noted that many of the existing willows showing dieback were starting to show significant new growth.

Photo 7: Overview Mitigation Area DG-W-2 (Mining Pit)

Photo 8: Overview Mitigation Area DG-W-2 (Mining Pit)

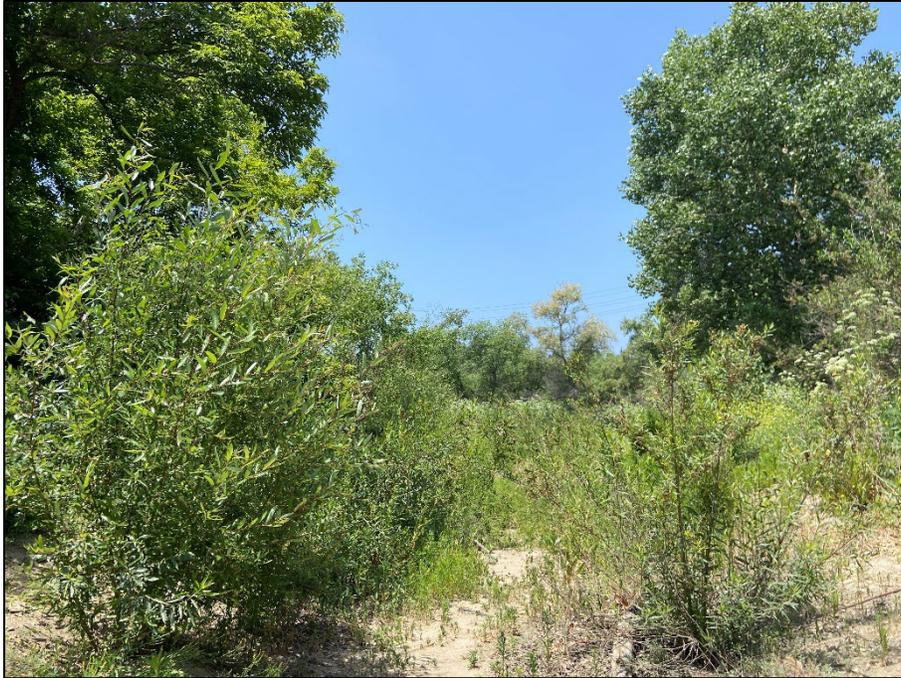
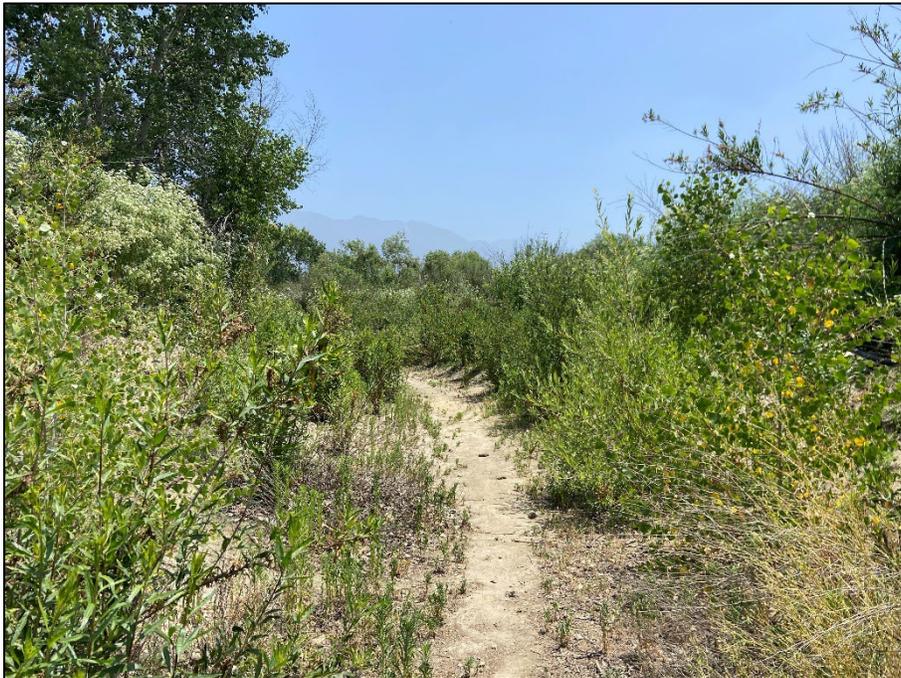
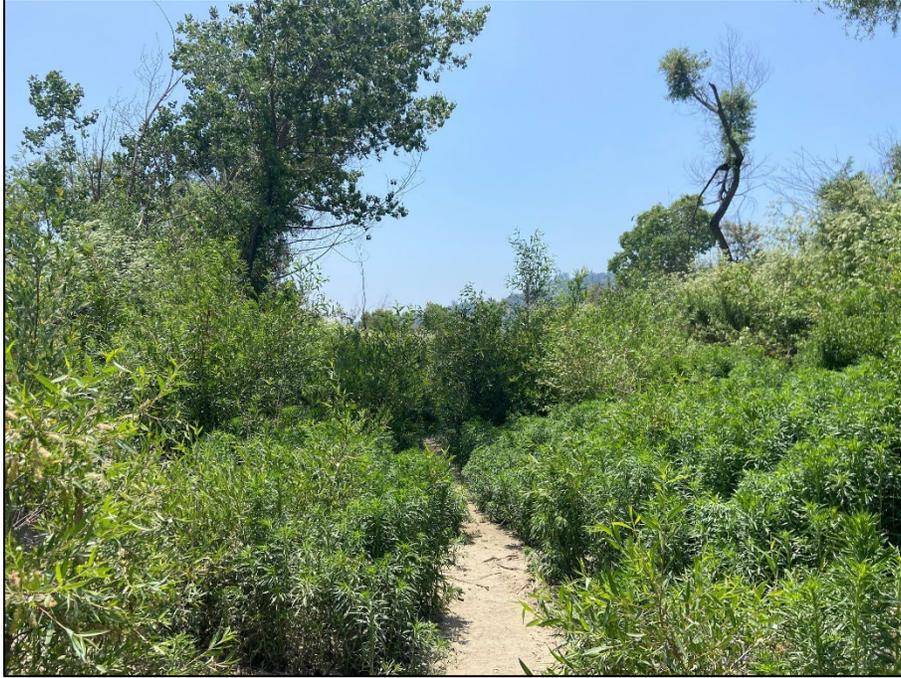
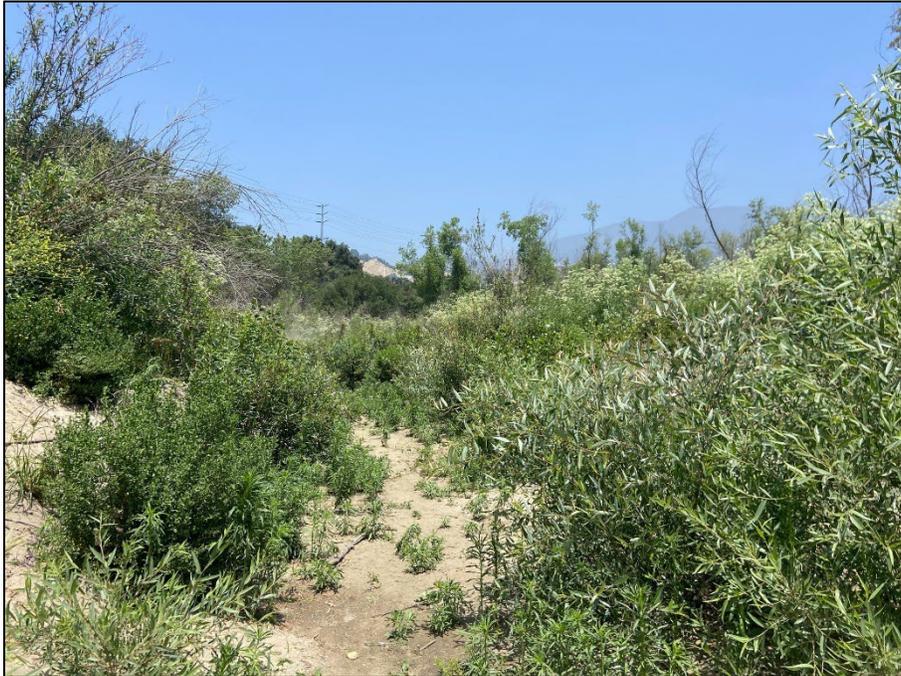
The overall health of the container plants in mitigation area DG-W-2 was noted as being good. Approximately less than five percent of the container plants were noted as showing varied levels of stress and a negligible number were noted as being dead or missing. This is approximately the same percentage of plants that were showing stress during the last monitoring event. Stress may be occurring due to similar reasons described for DG-W-1. Evidence of dieback from *Phytophthora cactorum*, including wilting, stunted growth, leaf spotting, and/or browning along leaf margins and tips, was not observed on any of the container plants. Formal mortality counts were taken for DG-W-2 Outlet during the 2021 quantitative monitoring and were included in the 2021 annual reporting. Some of the container plants were noted as lacking well defined basins and should have their basins properly constructed and/or repaired. In addition, mature willows in this area were noted as having branch failure, likely due to recent high winds. The irrigation line appeared to be functioning properly during the monitoring visit. The installation of plants in the DG-W-2 Outlet mitigation area appears to have been completed successfully and the issues noted during the monitoring are not expected to have an impact on the continued growth of the plants. Photos 9 through 12 in Attachment B document the mitigation area during the monitoring visit.

Photo 9: Overview Mitigation Area DG-W-2 (Mining Pit Outlet)

Photo 10: Overview Mitigation Area DG-W-2 (Mining Pit Outlet)

Photo 11: Overview Mitigation Area DG-W-2 (Mining Pit Outlet)

Photo 12: Overview Mitigation Area DG-W-2 (Mining Pit Outlet)
