**Re: *Devil's Gate Reservoir Restoration Project – Phase 2 Restoration Qualitative Monitoring Conducted on January 20, 2022***

## **1.0 INTRODUCTION**

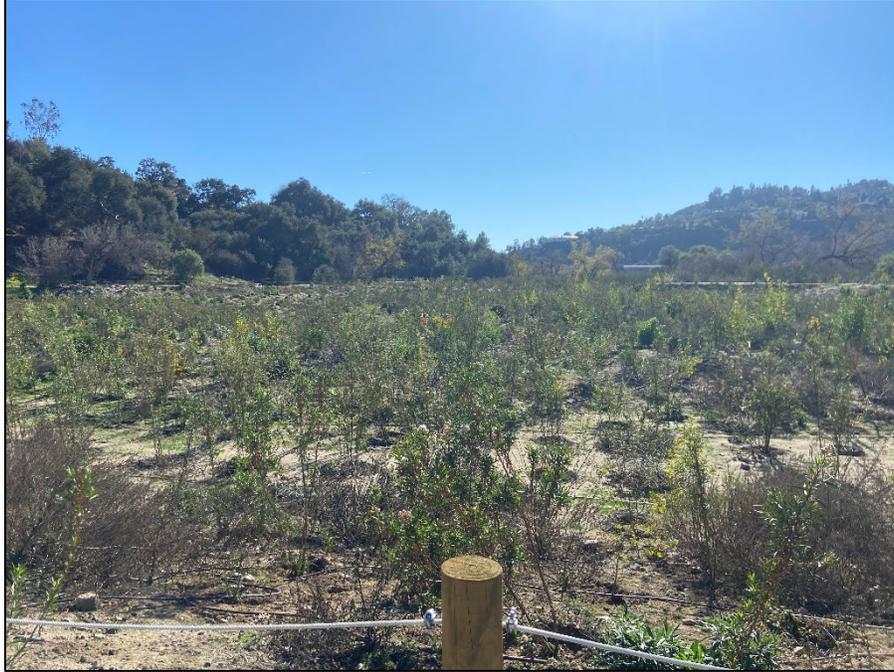
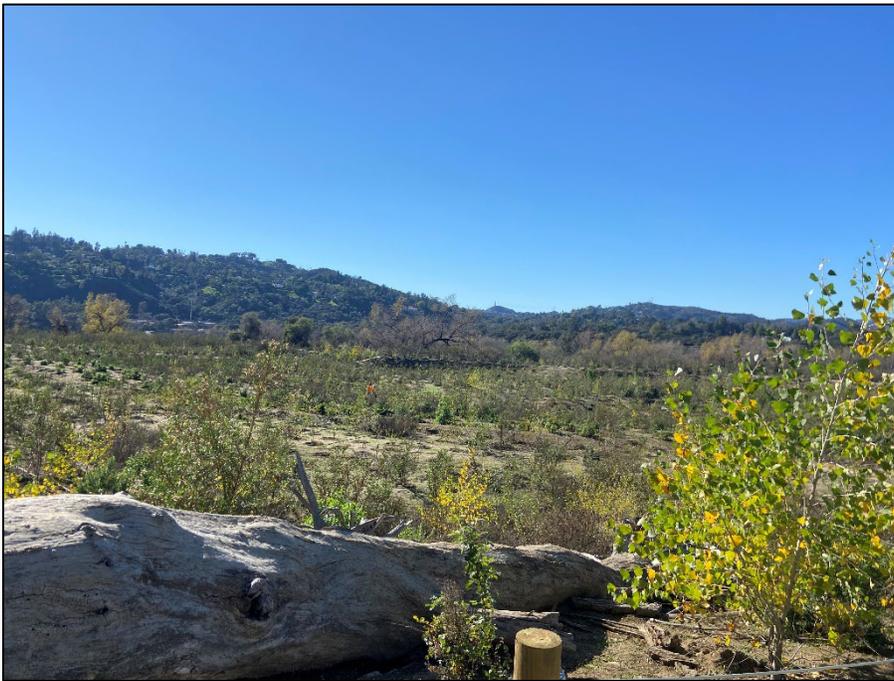
The overall health of the container plants in DG-W-1 was noted as being good. Approximately five percent of the container plants in DG-W-1 were noted as showing varied levels of stress and a negligible number were noted as being dead or missing. This is approximately the same percentage of plants that were showing stress during the last monitoring event. Stress may be occurring as a result of 1) transplant shock 2) herbivory by rabbits or other wildlife, 3) competition from nonnative and invasive weeds, 4) misplaced emitters, or 5) recreational traffic through the mitigation areas. Some of the willows (*Salix* sp.) and Fremont's cottonwoods (*Populus fremontii*) were showing signs of seasonal dieback. Formal mortality counts were taken for DG-W-1 during the 2021 quantitative monitoring and were included in the 2021 annual reporting. Some of the container plants were noted as lacking well defined basins and should have their basins properly constructed and/or repaired. The irrigation line appeared to be functioning properly during the monitoring visit. Evidence of pooling during the last storm event, including presence of heavily saturated soils, was observed in the northeast corner and the center of the DG-W-1 mitigation areas. The installation of plants in the DG-W-1 mitigation area appears to have been completed successfully. The current issues identified during the monitoring visit are not expected to have an effect on the continued growth of the plants in the mitigation area. Photos 1 and 2 in Attachment B document the mitigation area during the monitoring visit.

Photo 1: Overview Mitigation Area DG-W-1 (Johnson Field)

Photo 2: Overview Mitigation Area Overview Mitigation Area DG-W-1 (Johnson Field)

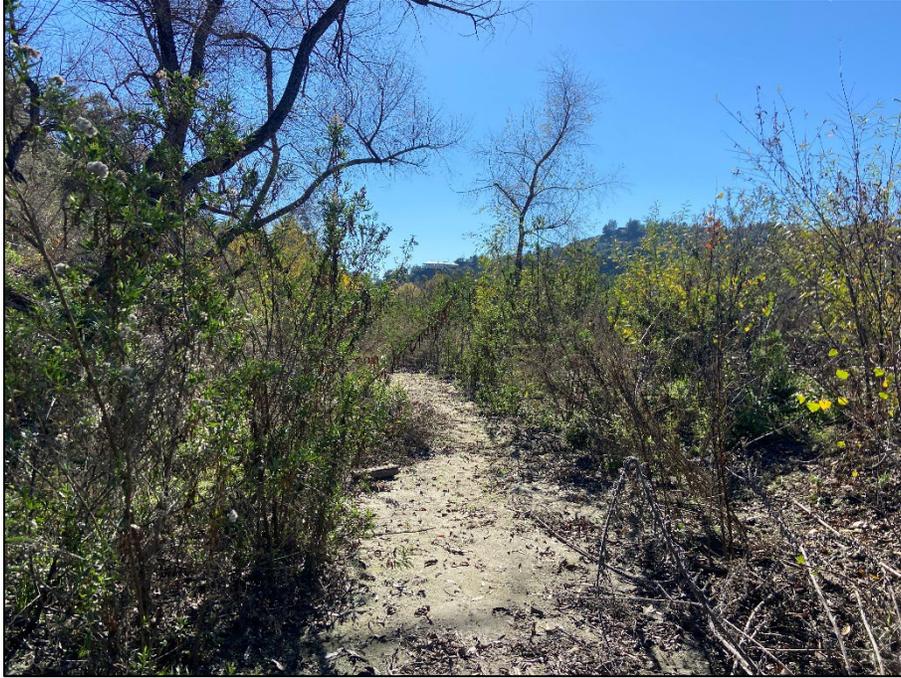
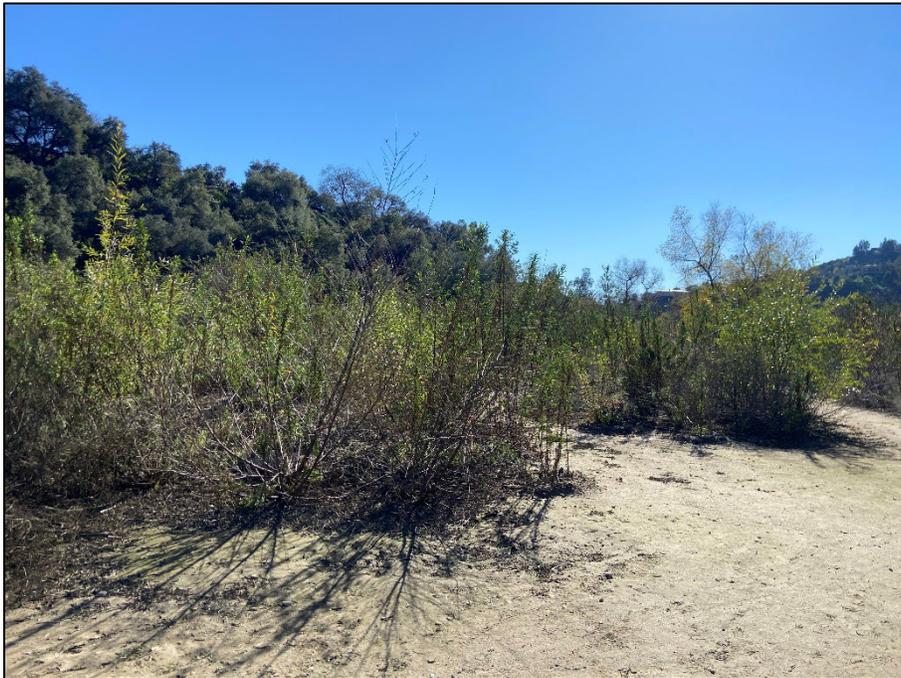
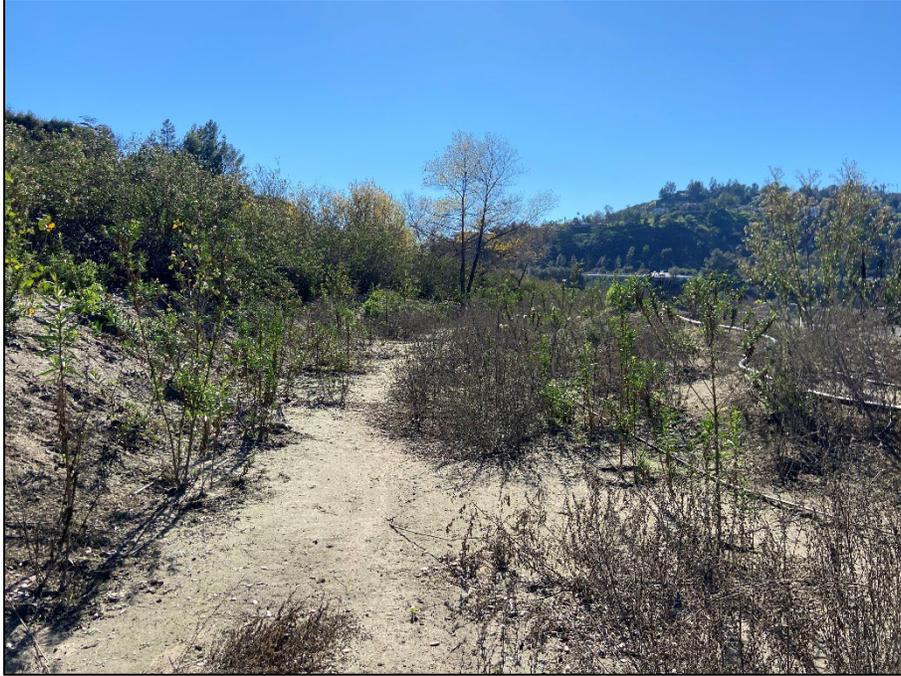
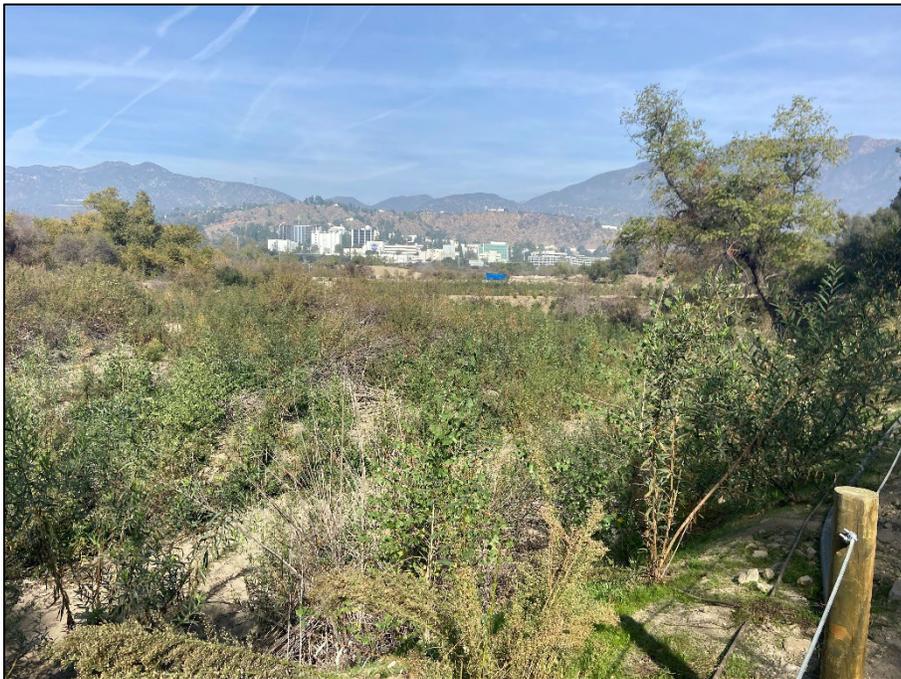
The overall health of the container plants in DG-2, DG-2 New Channels, and DG-2 WOUS was noted as being good. Approximately ten percent of the container plants were noted as showing varied levels of stress and a negligible number were noted as being dead or missing. This is approximately five percent more than the percentage of plants that were showing stress during the last monitoring event. Stress may be occurring due to similar reasons described for DG-W-1. Similar to DG-W-1, some of the willows and Fremont's cottonwoods were showing seasonal dieback. Formal mortality counts were taken for DG-2, DG-2 New Channels, and DG-2 WOUS during the 2021 quantitative monitoring and were included in the 2021 annual reporting. Some of the container plants were noted as lacking well defined basins and should have their basins properly constructed and/or repaired. The irrigation line appeared to be functioning properly during the monitoring visit. Evidence of flow during the last storm event, including heavily saturated soils, sediment deposits, and debris deposits, was observed in DG-2 New Channels and DG-2 WOUS during the monitoring event; however, evidence of inundation during water holding activities behind the Devil's Gate Dam (Dam) was not observed. Flow appeared to be most significant at the southern extent of DG-2 WOUS and the small amount of erosion that was noted during the previous monitoring event at the terminal end of DG-2 WOUS, where the channel connects to the reservoir, was observed to be worsening. The installation of plants in the DG-2, DG-2 New Channels, and DG-2 WOUS mitigation areas appears to have been completed successfully. The current issues identified during the monitoring visit are not expected to have an effect on the continued growth of the plants in the mitigation area. Photos 3 through 6 in Attachment B document the mitigation areas during the monitoring visit.

Photo 3: Overview Mitigation Area Overview Mitigation Area DG-2 & DG-2 WOUS

Photo 4: Overview Mitigation Area DG-2 & DG-2 New Channels

Photo 5: Overview Mitigation Area DG-2 & DG-2 WOUS

Photo 6: Overview Mitigation Area DG-2, DG-2 New Channels, DG-2 WOUS

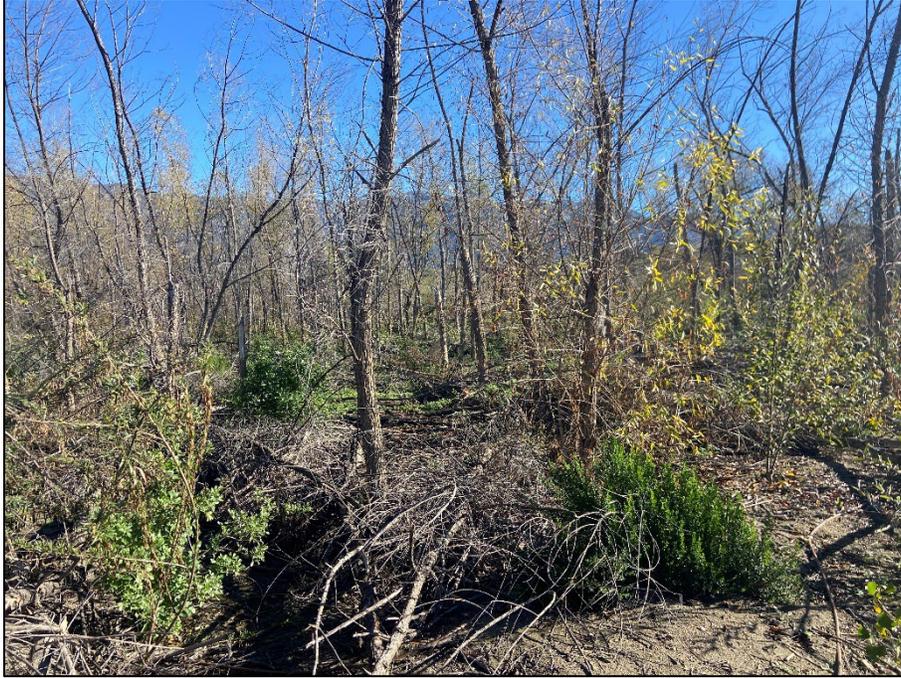
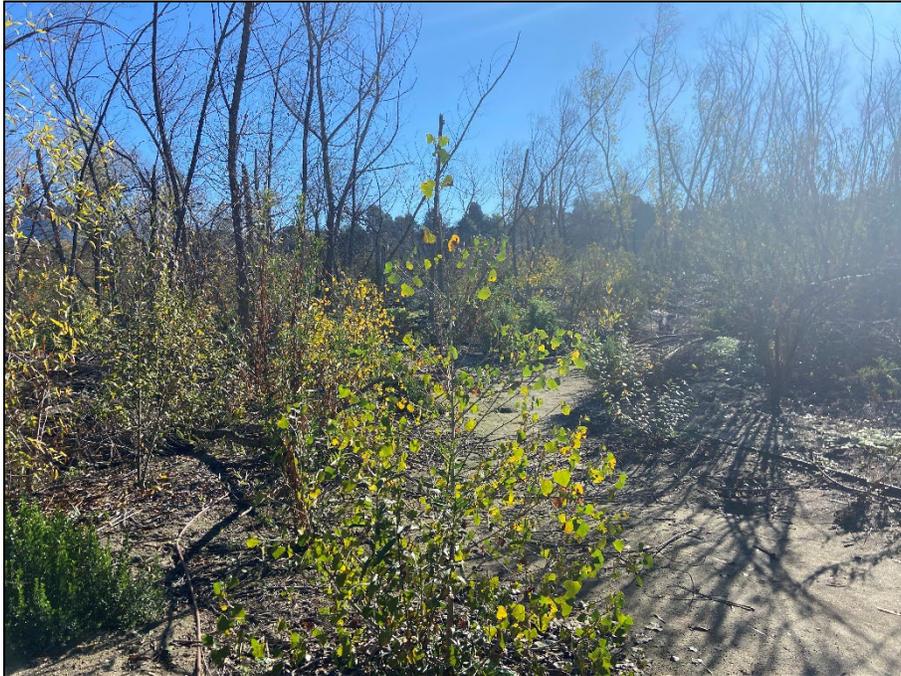
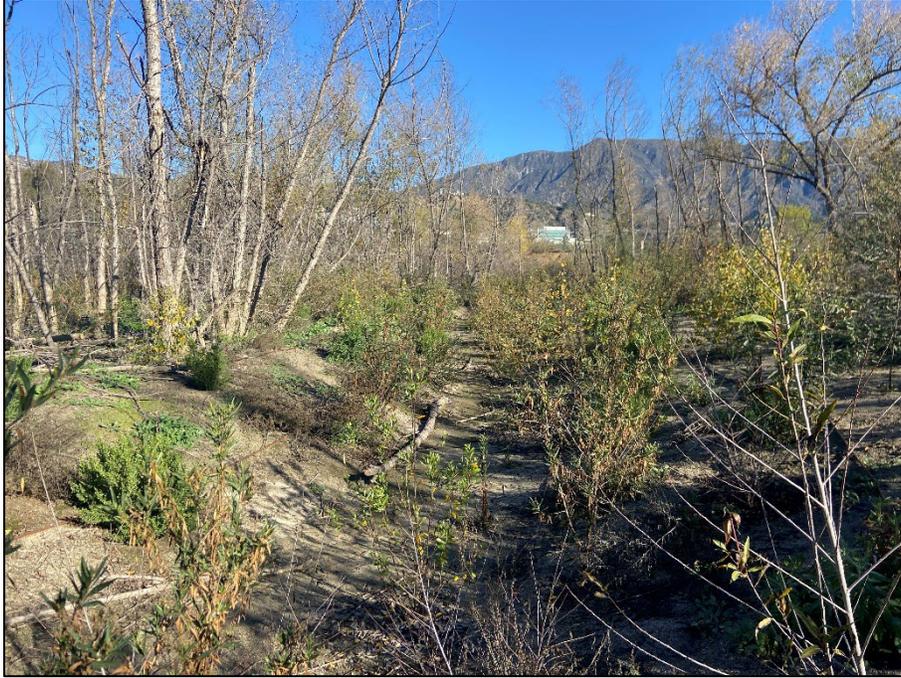
The overall health of the container plants in mitigation area DG-W-2 was noted as being good. Approximately ten percent of the container plants were noted as showing varied levels of stress and a negligible number were noted as being dead or missing. This is approximately the same percentage of plants that were showing stress during the last monitoring event. Stress may be occurring due to similar reasons described for DG-W-1. Formal mortality counts were taken for DG-W-2 during the 2021 quantitative monitoring and were included in the 2021 annual reporting. Some of the container plants were noted as lacking well defined basins and should have their basins properly constructed and/or repaired. The irrigation line appeared to be functioning properly during the monitoring visit. Evidence of flow through the channel in DG-W-2, including sediment deposits and debris buildup, was observed during the monitoring visit. In addition, Nature's Image indicated that the mining pit area was inundated to approximately one foot for approximately seven days following recent storm events and water holding activities behind the Dam. The installation of plants in the DG-W-2 mitigation area appears to have been completed successfully and the issues noted during the monitoring are not expected to have an impact on the continued growth of the plants. Photos 7 through 10 in Attachment B document the mitigation area during the monitoring visit.

During the monitoring visit, it was noted that many of the existing mature black willow (*Salix gooddingii*) in this mitigation area that were showing signs of beetle infestation during previous monitoring visits were impacted by the last storm event and additional trees were noted as having fallen over or experienced branch failure. Signs of infestation noted during previous monitoring visits included entry/exit holes, frass, galleries, fungal residue, and branch failure. Further investigation into this issue is being conducted with the help from the Los Angeles County Department of Agricultural Commissioner/Weights & Measures (ACWM) and preliminary surveys mostly showed only low to moderate infestation in these areas. It should be noted that evidence of infestation was only noted on existing mature willows and not on any of the recently installed container plants. It should also be noted that many of the existing willows showing dieback were beginning to sprout from the base.

Photo 7: Overview Mitigation Area DG-W-2 (Mining Pit)

Photo 8: Overview Mitigation Area DG-W-2 (Mining Pit)

Photo 9: Overview Mitigation Area DG-W-2 (Mining Pit)

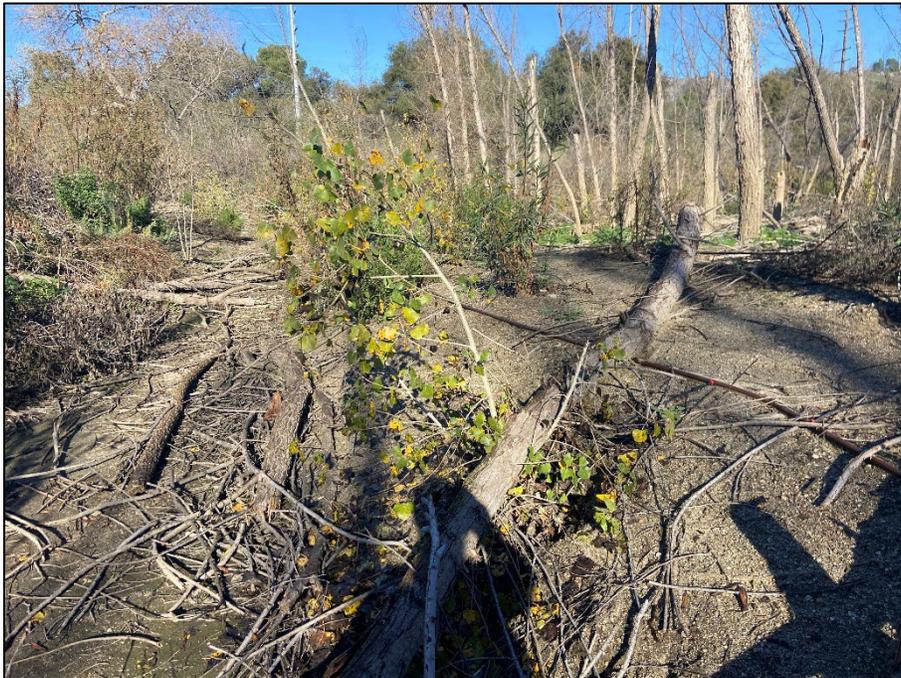
- Cont plants mostly healthy → some being crushed by woody debris. ~10% stressed
- Willows & POPTRE showing seasonal dieback
- Existing willows cont. to have branch failure or are falling in this area
- Native germ: SOLDON, ARTDON, BASAL, HELCUR ~35-40%.
- Nonnative germ: CONMAC, BRANIK, EROIC, LEPAT ~ ~~20-30%~~ 15-20%.
- Evidence of water flow through channel → inundation in Mining Pit?

Photo 10: Damage to Container Plants from Woody Debris in Mitigation Area DG-W-2 (Mining Pit)

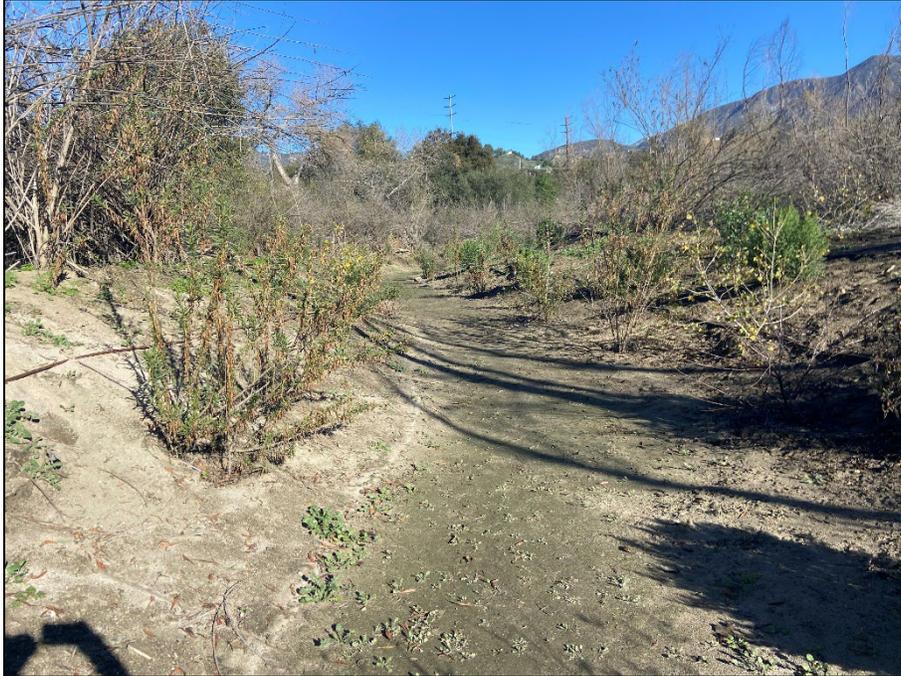
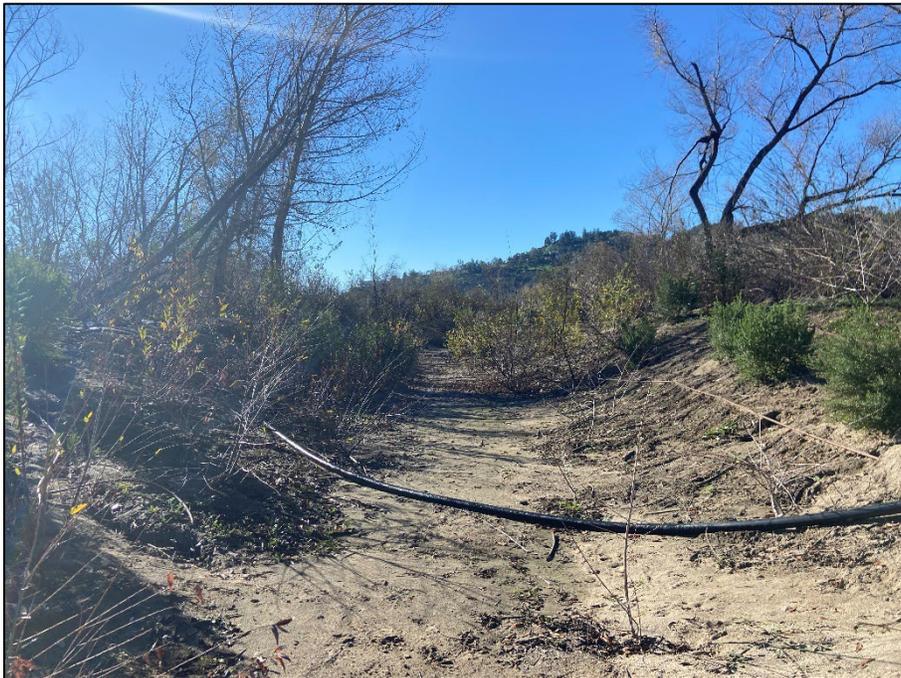
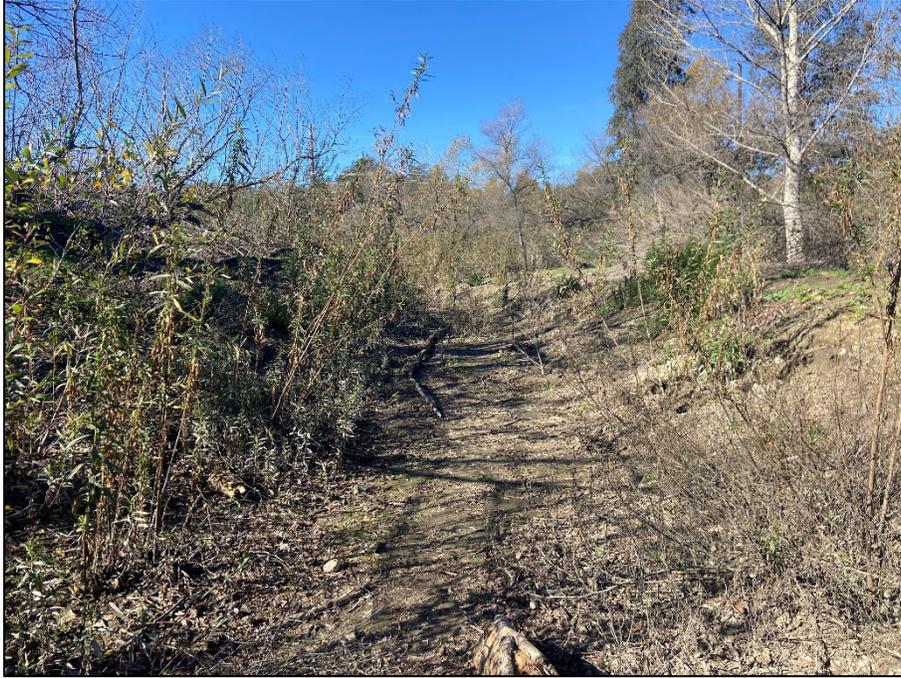
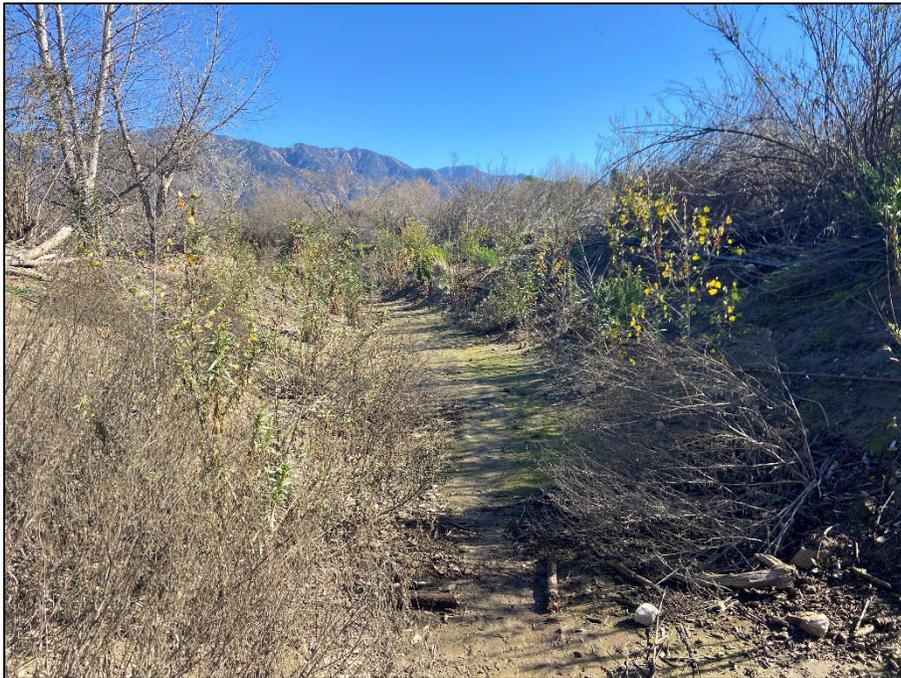
The overall health of the container plants in mitigation area DG-W-2 was noted as being good. Approximately five percent of the container plants were noted as showing varied levels of stress and a negligible number were noted as being dead or missing. This is approximately the same percentage of plants that were showing stress during the last monitoring event. Stress may be occurring due to similar reasons described for DG-W-1. Formal mortality counts were taken for DG-W-2 Outlet during the 2021 quantitative monitoring and were included in the 2021 annual reporting. Some of the container plants were noted as lacking well defined basins and should have their basins properly constructed and/or repaired. In addition, mature willows in this area were noted as having branch failure, likely due to recent high winds. The irrigation line appeared to be functioning properly during the monitoring visit. Evidence of flow during the last storm event, including sediment deposits and heavily saturated soils in the lower part of the channel were observed during the monitoring event. In addition, some of the woodchips from stockpiles belonging to the City of Pasadena that were observed to have flowed down stream and been deposited into DG-W-2 Outlet during the previous monitoring event were observed to still be present and should be removed. The installation of plants in the DG-W-2 Outlet mitigation area appears to have been completed successfully and the issues noted during the monitoring are not expected to have an impact on the continued growth of the plants. Photos 11 through 14 in Attachment B document the mitigation area during the monitoring visit.

Photo 11: Overview Mitigation Area DG-W-2 (Mining Pit Outlet)

Photo 12: Overview Mitigation Area DG-W-2 (Mining Pit Outlet)

Photo 13: Overview Mitigation Area DG-W-2 (Mining Pit Outlet)

Photo 14: Overview Mitigation Area DG-W-2 (Mining Pit Outlet)

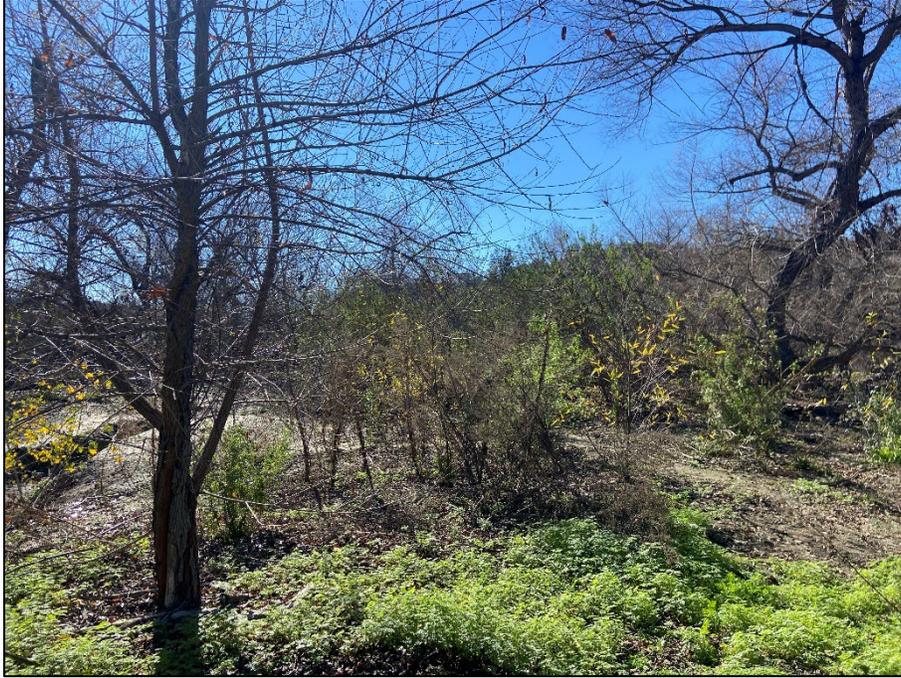
The overall health of the container plants in mitigation areas DG-4 Sheet Flow (northern) and DG-SF-1 was noted as being good. Approximately five percent of container plants were showing varied levels of stress which is approximately the same percentage of container plants that were showing stress during the previous monitoring event. Stress may be occurring due to similar reasons described for DG-W-1. Formal mortality counts were taken during the 2021 quantitative monitoring and were included in the 2021 annual reporting. Some of the container plants were noted as lacking well defined basins and should have their basins properly constructed and/or repaired. In addition, minor herbivory of young plants was observed within the DG-4 Sheet Flow and DG-SF-1 areas and should continue to be monitored. The irrigation line appeared to be functioning properly during the monitoring visit. The installation of plants in

the DG-4 Sheet Flow and DG-SF-1 mitigation areas appears to have been completed successfully and the issues noted during the monitoring are not expected to have an impact on the continued growth of the plants. Photo 15 in Attachment B documents the mitigation area during the monitoring visit.

Photo 15: Overview Mitigation Area DG-4 Sheet Flow & DG-SF-1
