WATER QUALITY SAMPLING OVERVIEW OF CURRENT PRACTICES UNDER THE WDR PERMIT

Waste Discharge Requirement Order No. R4-2015-0032-A1 WORKING GROUP MEETING #15

Los Angeles County Flood Control District JUNE 16, 2016

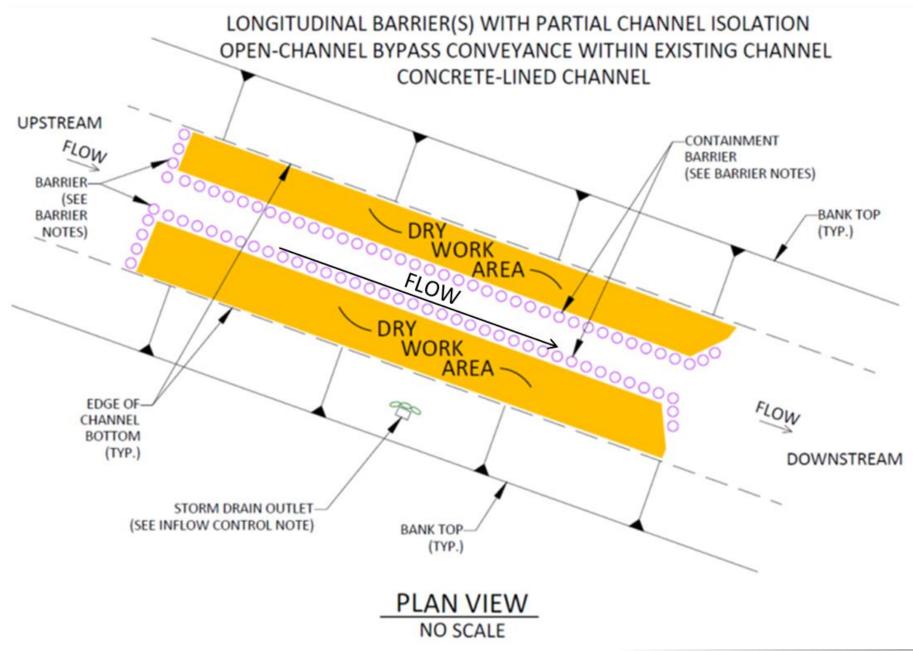
Three sampling locations are setup and samples are collected at:

- Upstream of work area
- Within the work area
- Downstream of work area

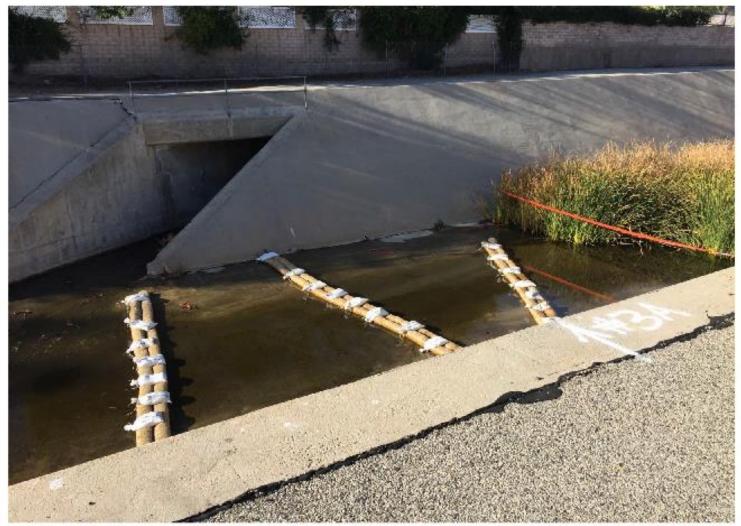
WQ SAMPLING POINTS AND BMPS

Medea Creek Reach 33 – Photo 3B: Final downstream sampling point (#3A) on December 2, 2015 showing installation of additional BMP along with realignment of original BMPs to reduce turbidity at sampling point.

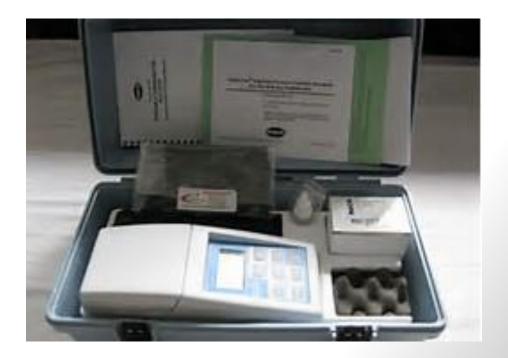
Turbidimeter

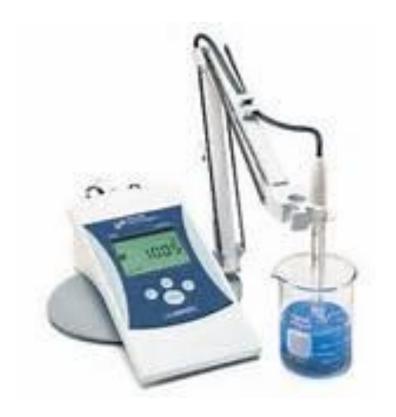
pH Meter

Digital Water Test Meter
