Re: *Devil's Gate Reservoir Restoration Project – Phase 1 Restoration Qualitative Monitoring Conducted on June 18, 2020*

1.0 INTRODUCTION

2.0 QUALITATIVE MONITORING IN THE PHASE 1 MITIGATION AREAS

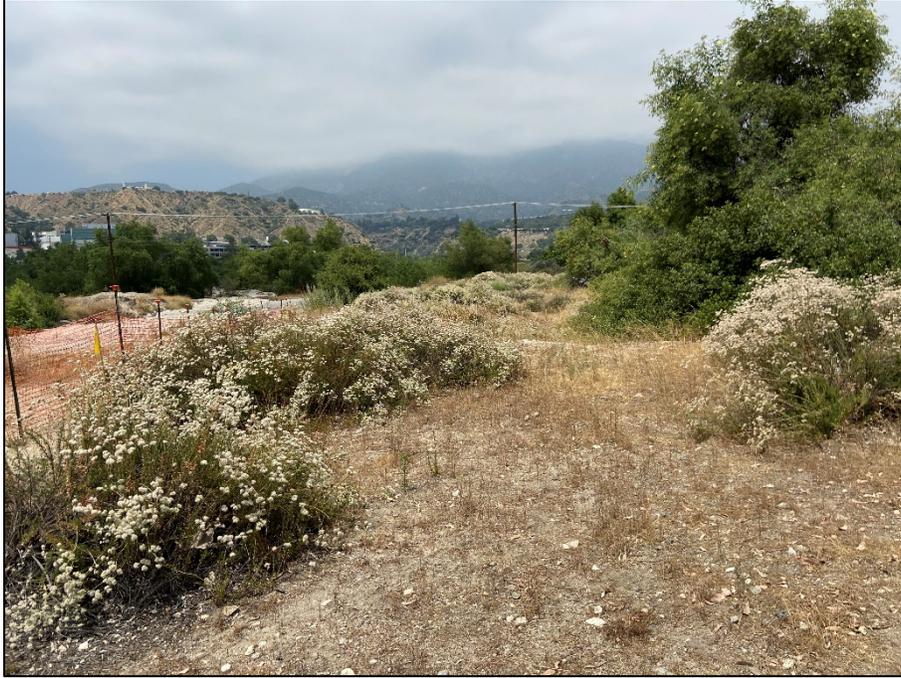
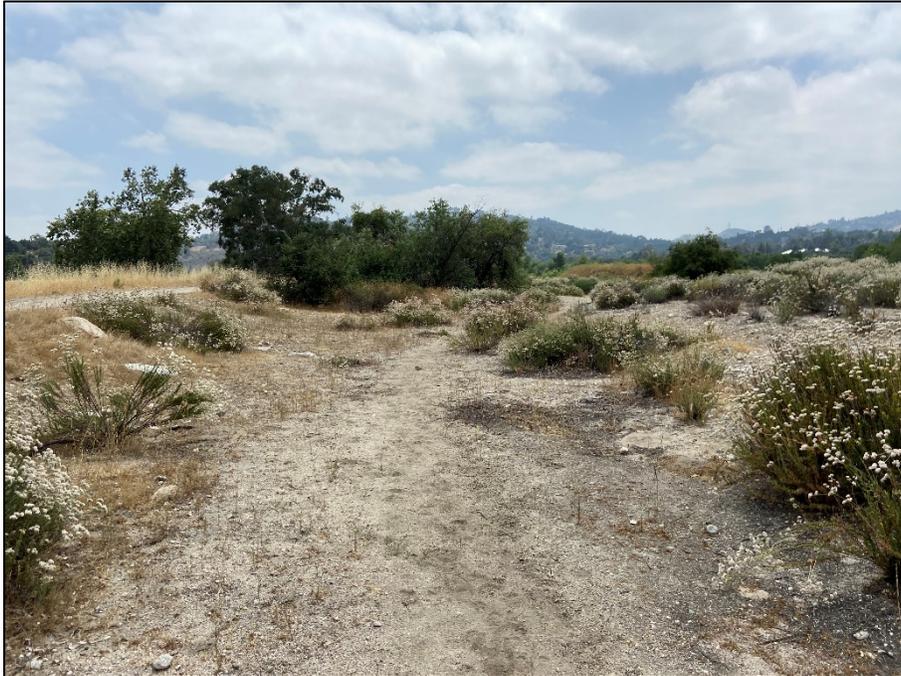
Container plants were not installed in the DG-1 or DG-1 WOUS mitigation areas, but these areas were seeded with native plant species. Native plant growth was noted throughout the DG-1 and DG-1 WOUS mitigation areas, likely both from natural recruitment and from seeding; however, germination was observed to be very minimal in the majority of these mitigation areas. Native germination was found to be higher closer to the reservoir in DG-1 where seed likely dispersed due to water flow. Native plants such as deerweed (*Acmispon glaber*), California sagebrush (*Artemisia californica*), mugwort (*Artemisia douglasiana*), California buckwheat (*Eriogonum fasciculatum*), grape-soda lupine (*Lupinus excubitus*), caterpillar phacelia (*Phacelia cicutaria*), and California everlasting (*Pseudognaphalium californicum*) were observed sprouting in the DG-1 and DG-1 WOUS mitigation areas. Photos 1 and 2 in Attachment B document the mitigation area during the monitoring visit.

Nonnative weed cover in DG-1 and DG-1 WOUS was estimated at approximately <10 percent, which is approximately 10 percent less than the level of weed cover that was observed during the final PEP monitoring event. Nonnative species observed in DG-1 and DG-1 WOUS included black mustard (*Brassica nigra*), red-stemmed filaree (*Erodium cicutarium*), and Indian plantain (*Plantago arenaria*).

Photo 1: Overview Mitigation Area DG-1

Photo 2: Overview Mitigation Area DG-1

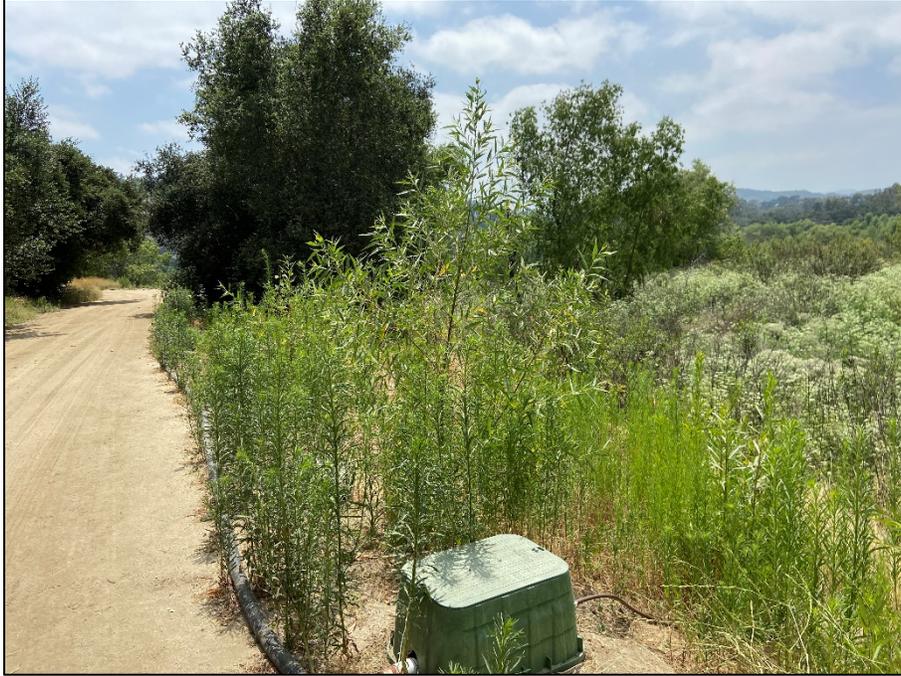
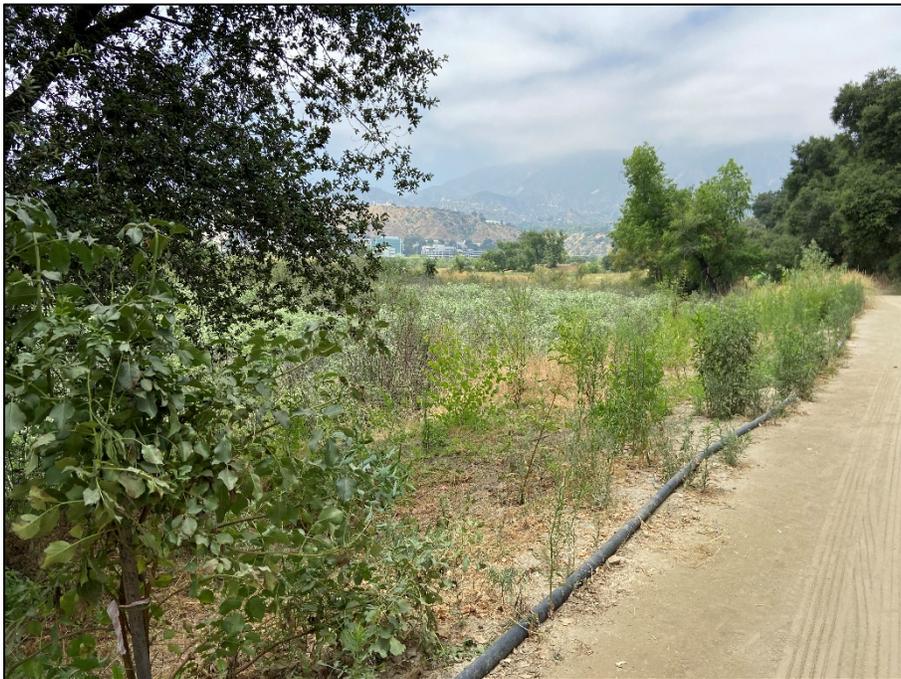
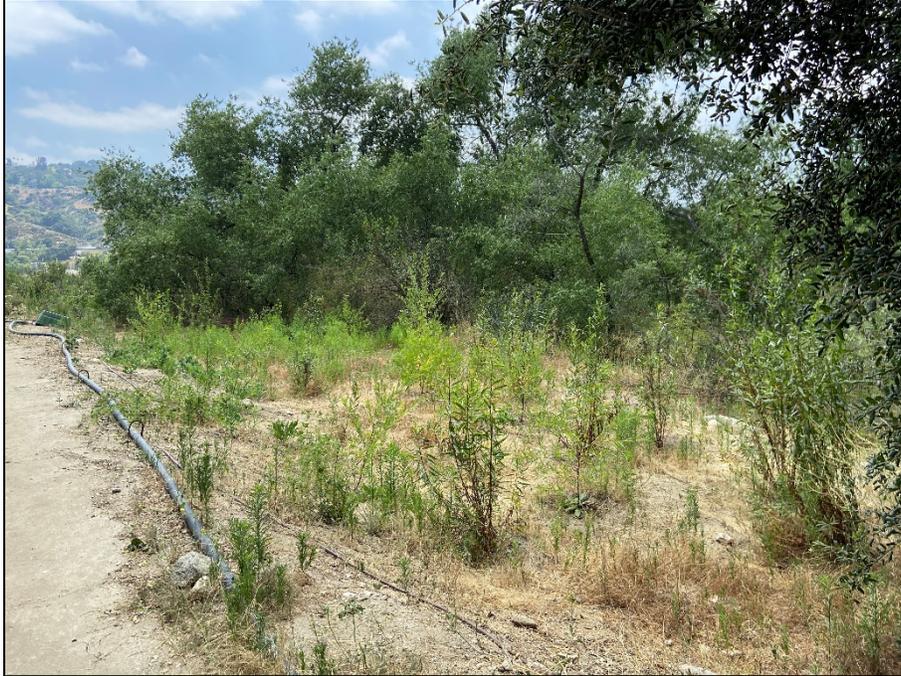
The overall health of the container plants in DG-2A was noted as being good. Approximately 5 percent of all container plants were showing varied levels of stress, which is the same percentage of plants that were showing stress during the final PEP monitoring. Stress may be occurring as a result of 1) drought stress from recent high temperatures, 2) herbivory by rabbits or other wildlife, or 3) competition from nonnative and invasive weeds. A negligible number of container plants were noted as being missing or dead. The willow species (*Salix sp.*) and mulefat (*Baccharis salicifolia*) planted in the mitigation areas were showing signs of vigorous growth. The installation of plants in the DG-2A mitigation area appears to have been

completed successfully. The current issues identified during the monitoring visit are not expected to have an effect on the continued growth of the plants in the mitigation area. Photos 3 through 5 in Attachment B document the mitigation area during the monitoring visit.

Nonnative weed cover in DG-2A was estimated at approximately <5 percent, which is approximately 10 percent less than the level of cover that was observed during the final PEP monitoring. Nonnative species observed in DG-2A included black mustard and prostrate knotweed (*Polygonum aviculare*).

Photo 3: Overview Mitigation Area DG-2A

Photo 4: Overview Mitigation Area DG-2A

Photo 5: Overview Mitigation Area DG-2A

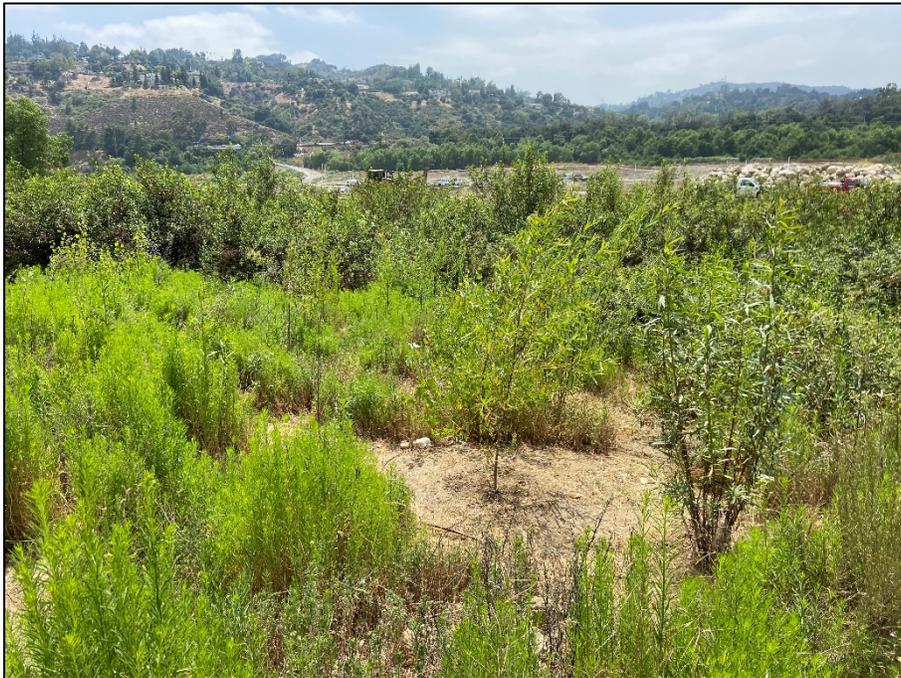
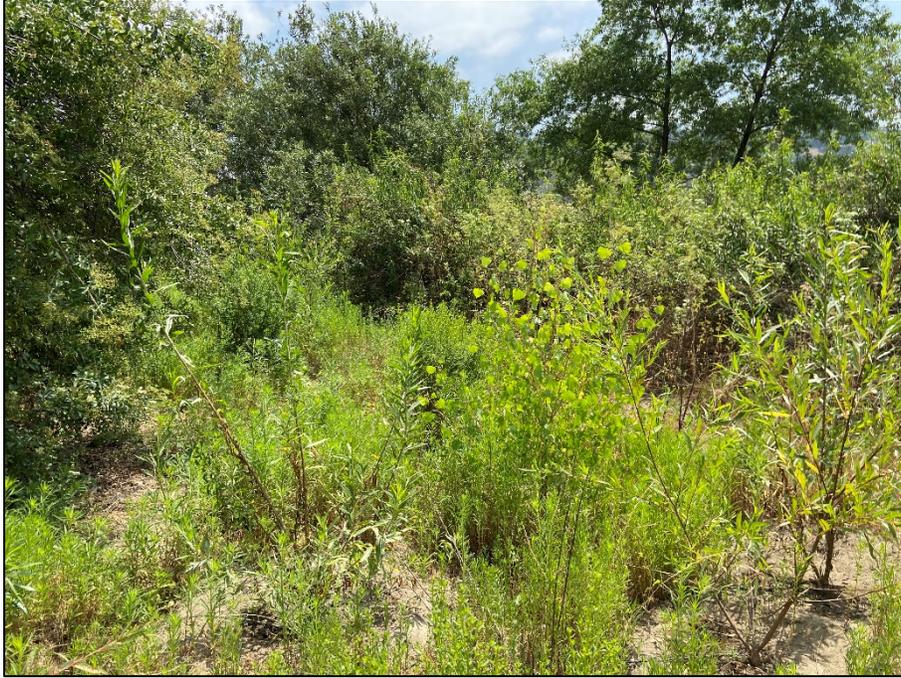
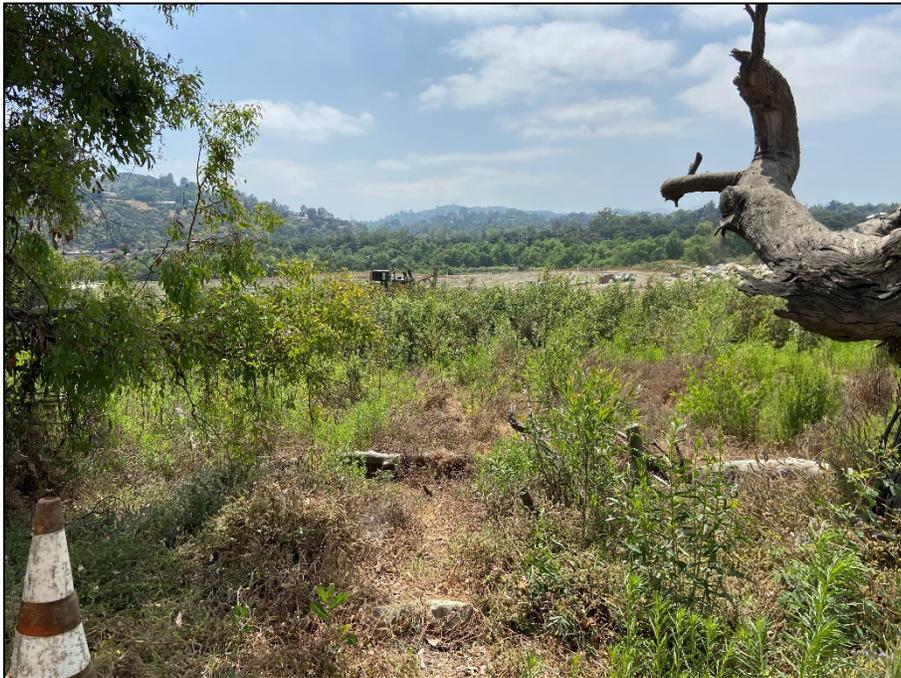
The overall health of the container plants in DG-2B was noted as being good. Approximately 5 percent of all container plants were showing varied levels of stress, which is 5 percent less than the percentage of plants that were showing stress during the final PEP monitoring. Stress was likely due to the same reasons as those described for DG-2A, including drought stress, herbivory, or competition with nonnatives. Approximately 5 percent of container plants were noted as being missing or dead, which appears to be the result of the heavy flows that were documented in the final PEP monitoring memo. Similar to DG-2A, the willow species and mulefat in the mitigation areas were exhibiting vigorous growth. The installation of the plants in the DG-2B mitigation area appears to have been successfully completed. The current issues identified during the monitoring visit are not expected to have an effect on the continued growth of plants in the mitigation area. Photos 6 through 8 in Attachment B document the mitigation area during the monitoring visit.

Nonnative weed cover in DG-2B was estimated at approximately <5 percent, which is approximately 10 percent less than what was observed during the final PEP monitoring. Nonnative species observed in DG-2B included black mustard and black nightshade (*Solanum nigrum*).

Photo 6: Overview Mitigation Area DG-2B

Photo 7: Overview Mitigation Area DG-2B

Photo 8: Overview Mitigation Area DG-2B

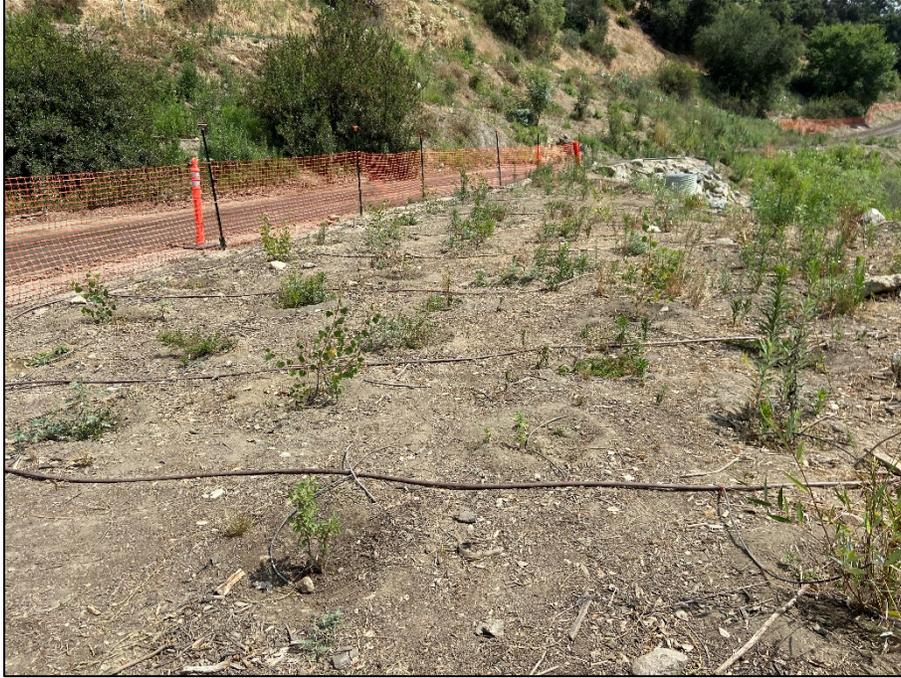
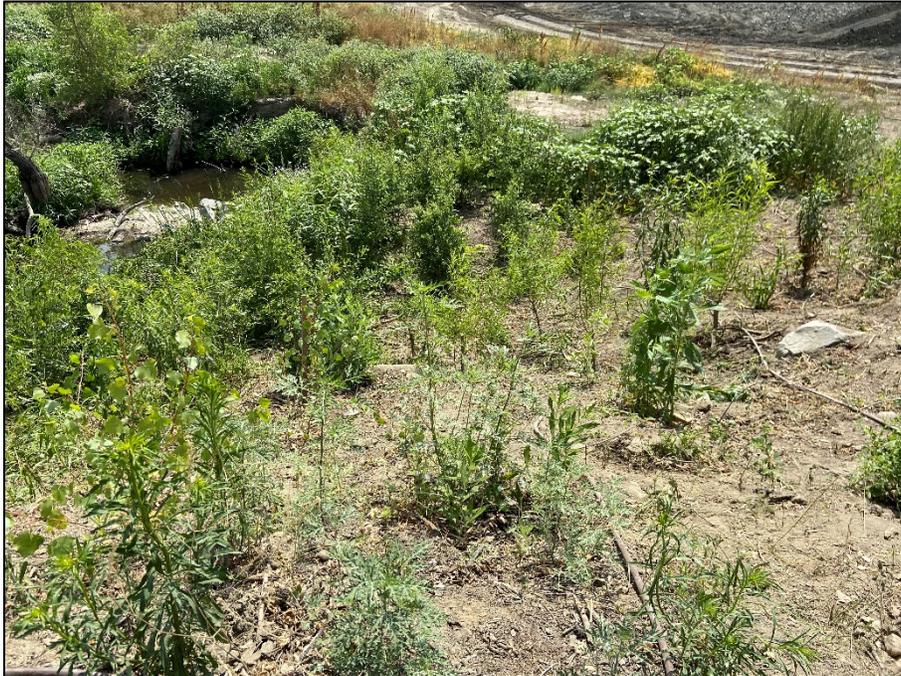
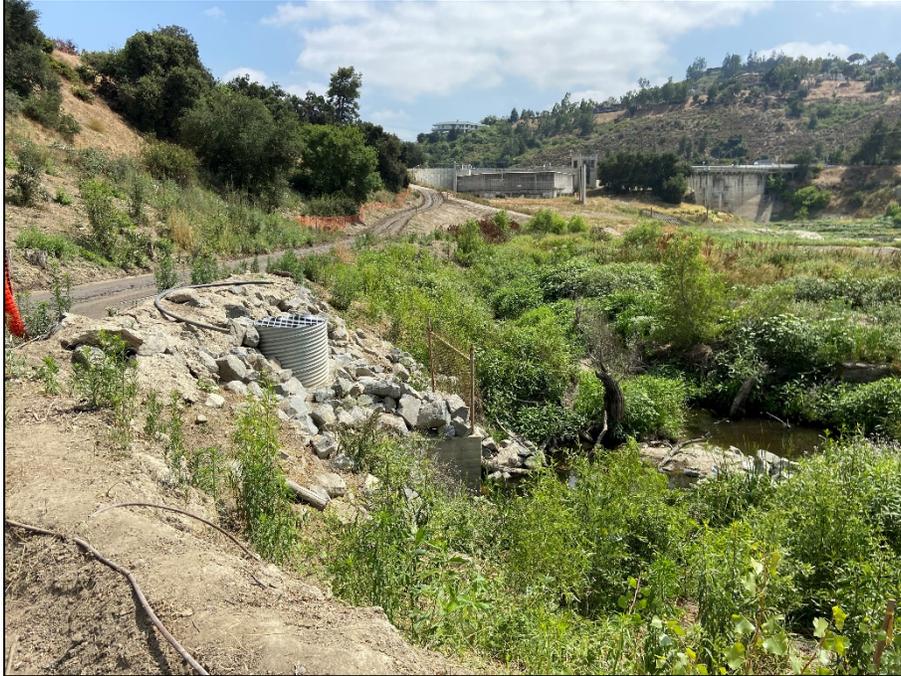
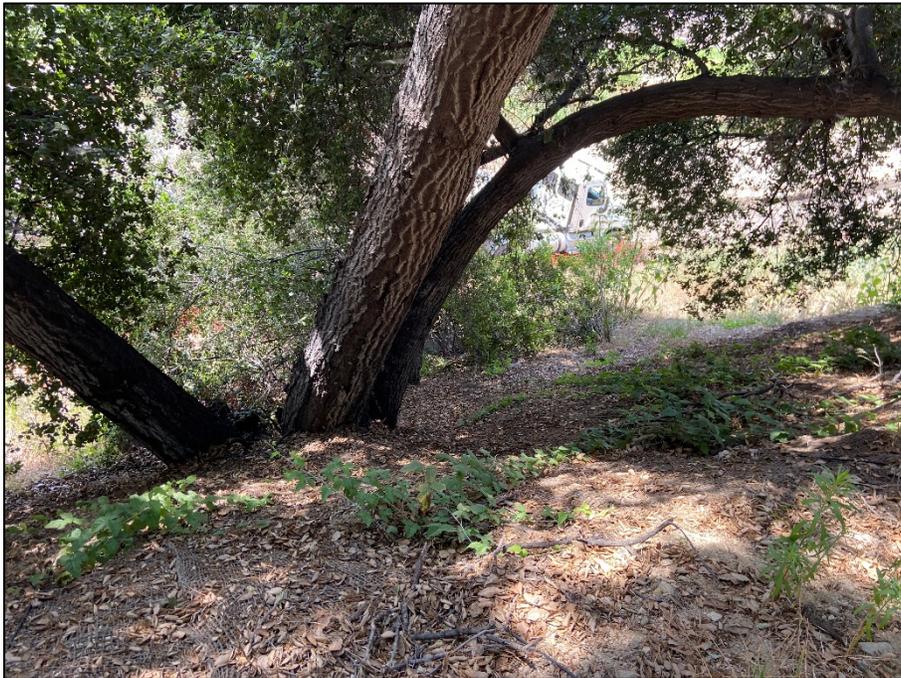
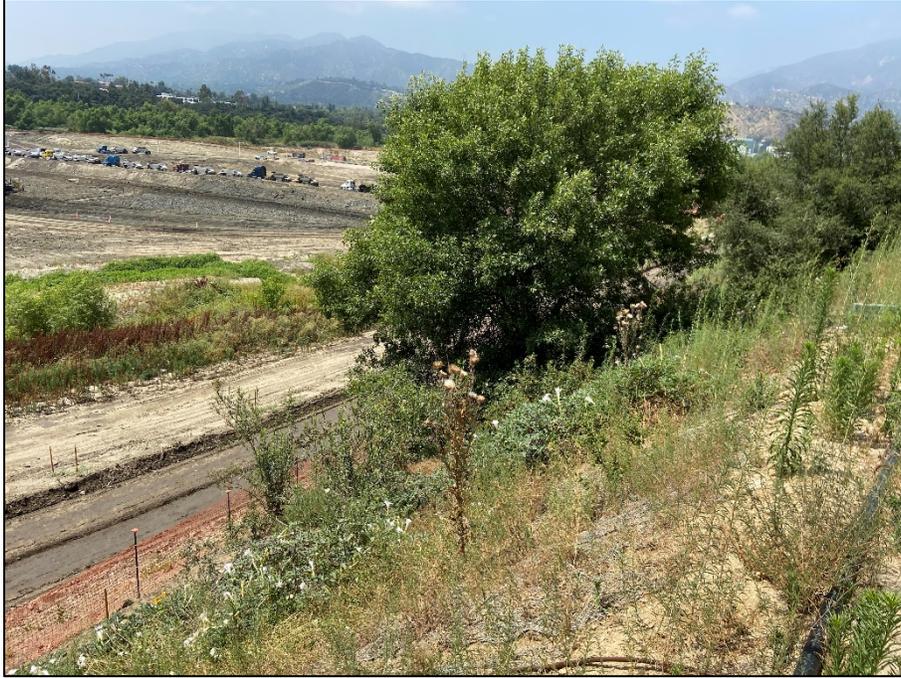
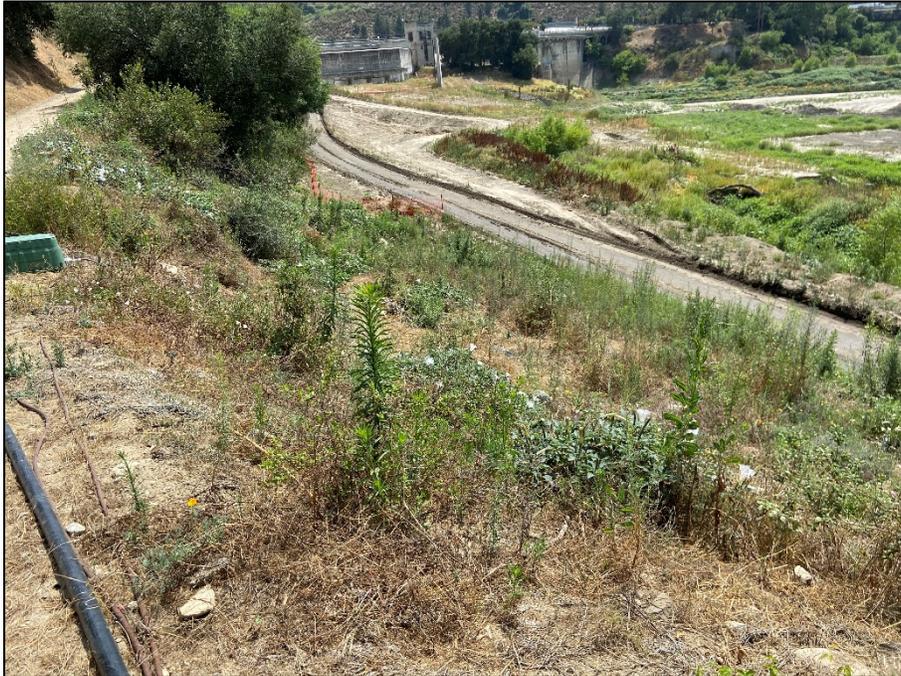
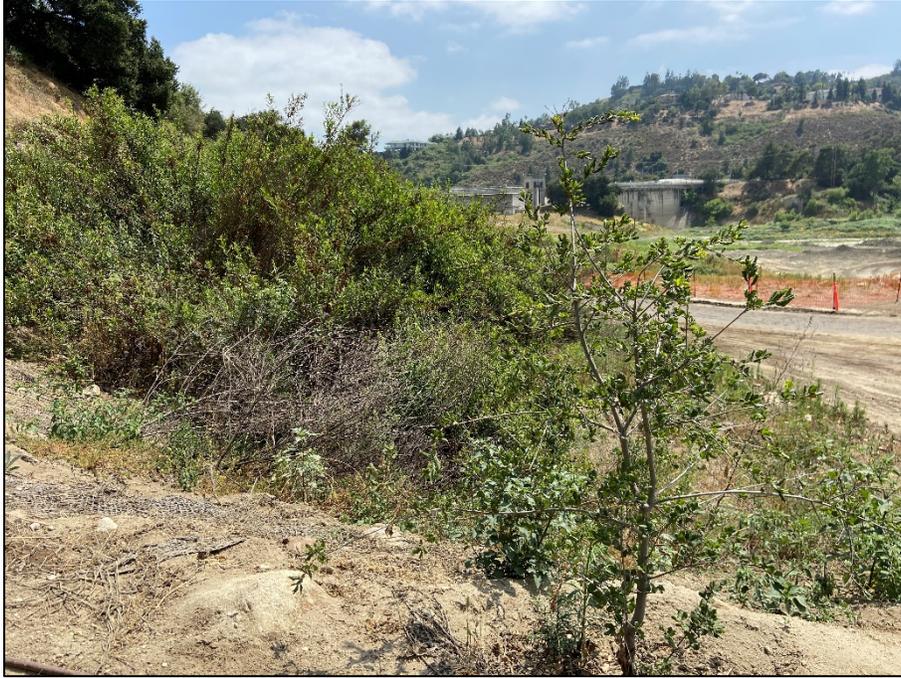
The overall health of the container plants in DG-3A was noted as being good. Approximately 20 percent of the container plants in the Coast Live Oak Woodland portions of DG-3A were noted as showing varied levels of stress, which is 5 percent more than the number plants that were showing stress during the final PEP monitoring. Approximately 15 percent of the container plants in the Mulefat Thickets portions of DG-3A were noted as showing varied levels of stress, which is the same as the percent of container plants that were showing stress during the final PEP monitoring. Approximately 10 percent of container plants were

noted as being dead or missing from the heavy flows that were noted during the PEP monitoring. The types of stress the plants were exhibiting are the same as those described for the plants in DG-2A. However, erosion is also a problem in some areas of DG-3A. In addition, the heavy water and debris flows noted during the previous PEP monitoring visit have contributed to plant mortality and stress in this mitigation area. Similar to DG-2A, the container planted willow species and mulefat were exhibiting vigorous growth. Additionally, the recently planted willow and mulefat cuttings were observed to be sprouting vigorously. During the monitoring visit, the planted coast live oak (*Quercus agrifolia*) acorns were inspected for survivorship and health. Approximately 30 germinated coast live oak acorns appear to still be present in DG-3A. The majority of the germinated acorns appear to be in good health; however, several appeared to be showing signs of drought stress. The installation of the plants in the DG-3A mitigation area appears to have been completed successfully. The current issues noted during the monitoring are not expected to have a negative effect on the continued growth of the plants in the mitigation area. Photos 9 through 15 in Attachment B document the mitigation area during the monitoring visit.

Nonnative weed cover in DG-3A was estimated at approximately <5 percent, which is approximately 10 to 45 percent less than what was observed during the final PEP monitoring. Nonnative species observed in DG-3A included black mustard, Italian thistle (*Carduus pycnocephalus*), prostrate knotweed, and black nightshade (*Solanum nigrum*). In addition, new growth was observed sprouting from the stumps of the eucalyptus trees (*Eucalyptus sp.*).

Photo 9: Overview Mitigation Area DG-3A Altadena Drain

Photo 10: Overview Mitigation Area DG-3A Altadena Drain

Photo 11: Overview Mitigation Area DG-3A Altadena Drain

Photo 12: Overview Mitigation Area DG-3A Oak Woodland

Photo 13: Overview Mitigation Area DG-3A Oak Woodland

Photo 14: Overview Mitigation Area DG-3A Oak Woodland

Photo 15: Overview Mitigation Area DG-3A Oak Woodland

Erosion in the Phase 1 mitigation areas was only observed in DG-3A and was minor in severity. Due to the steepness of the slope in the Coast Live Oak Woodland portion of the DG-3A mitigation area, erosion will likely continue to be somewhat of an issue in this area; however, jute nettings are currently in place on the slope and will help to lessen the severity of erosion issues. As native cover increases in this area, erosion issues should lessen. The severity of the erosion should continue to be monitored in all planted areas and if warranted, erosion Best Management Practices (BMPs) should be installed in appropriate areas. This may only require the installation of straw wattles at select sites to prevent existing rills from becoming larger. However, until more native perennial plants become established in these areas, there is the potential that intense rainfall may create additional erosion problems.

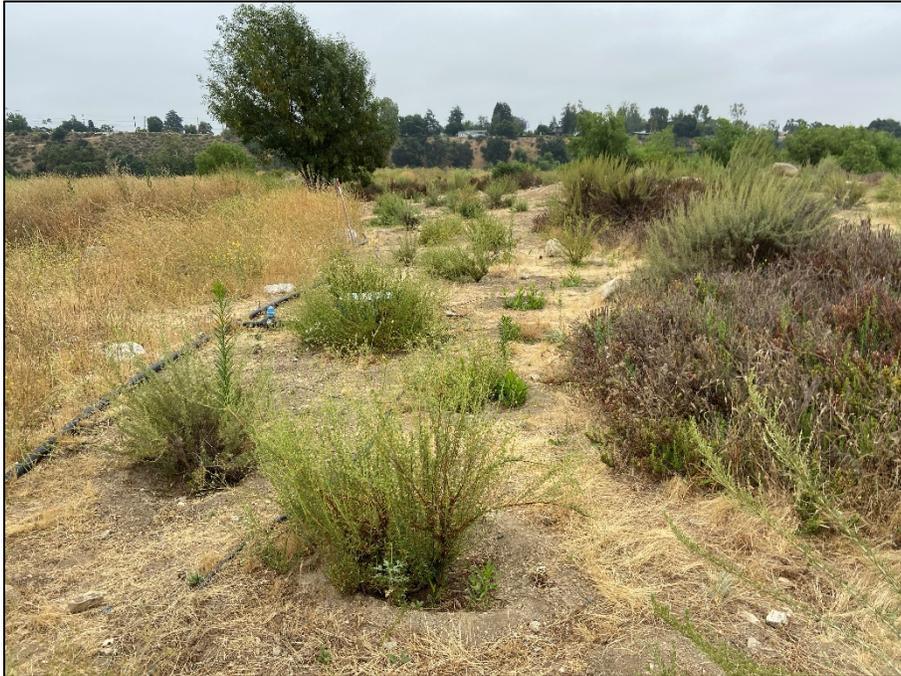
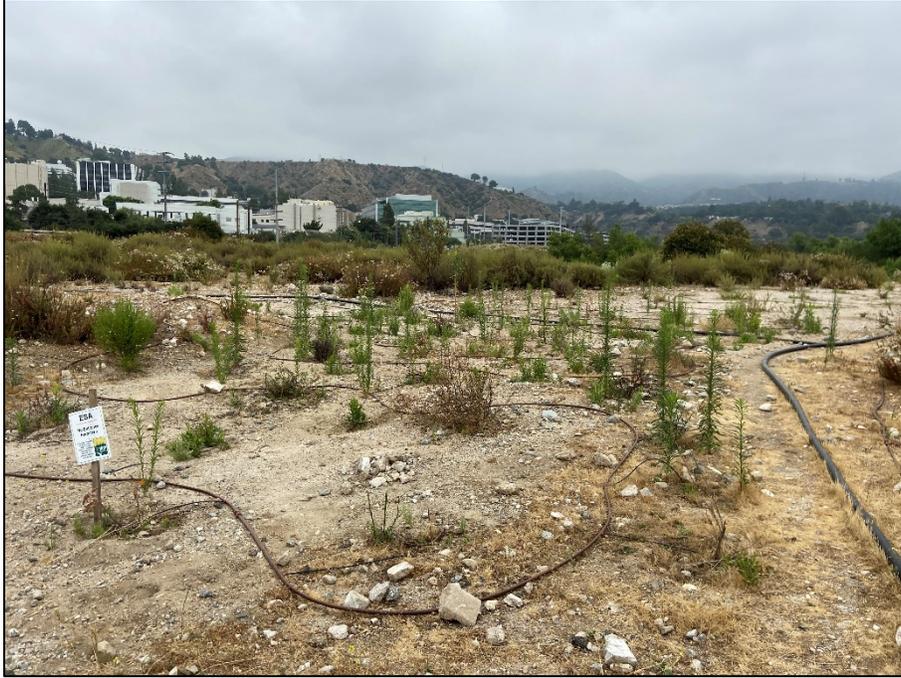
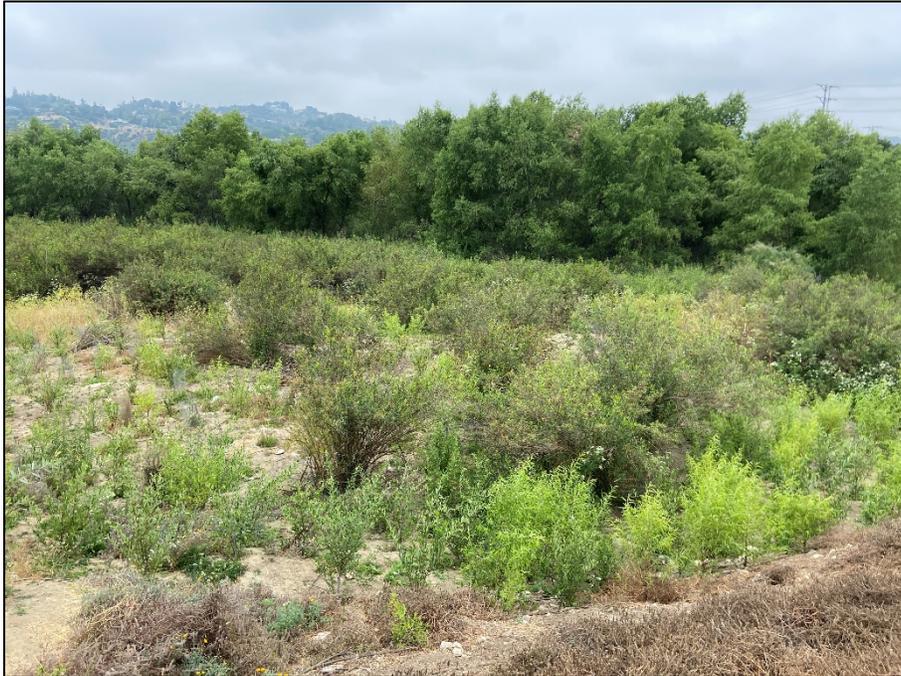
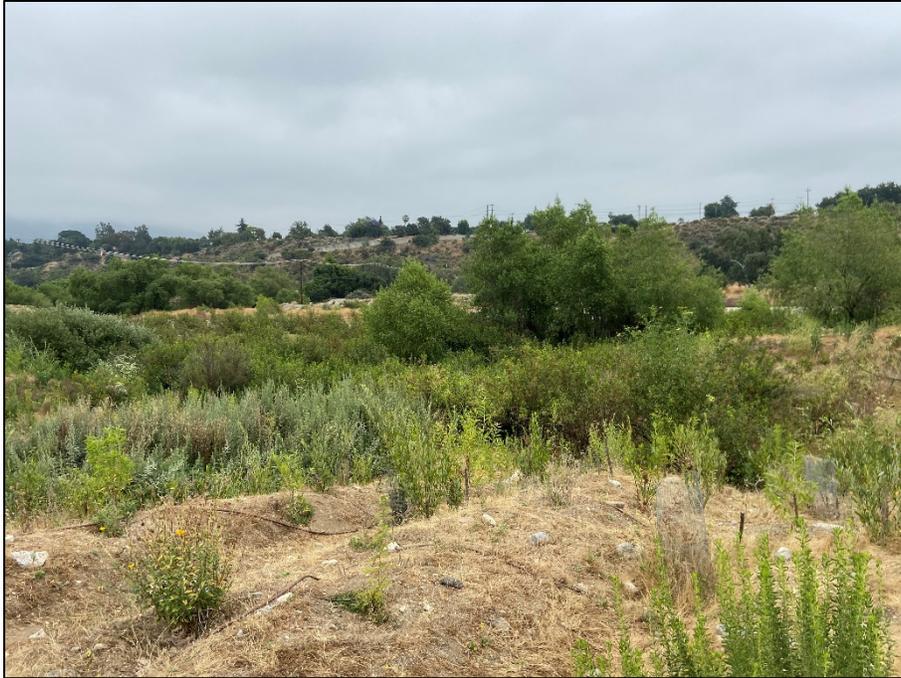
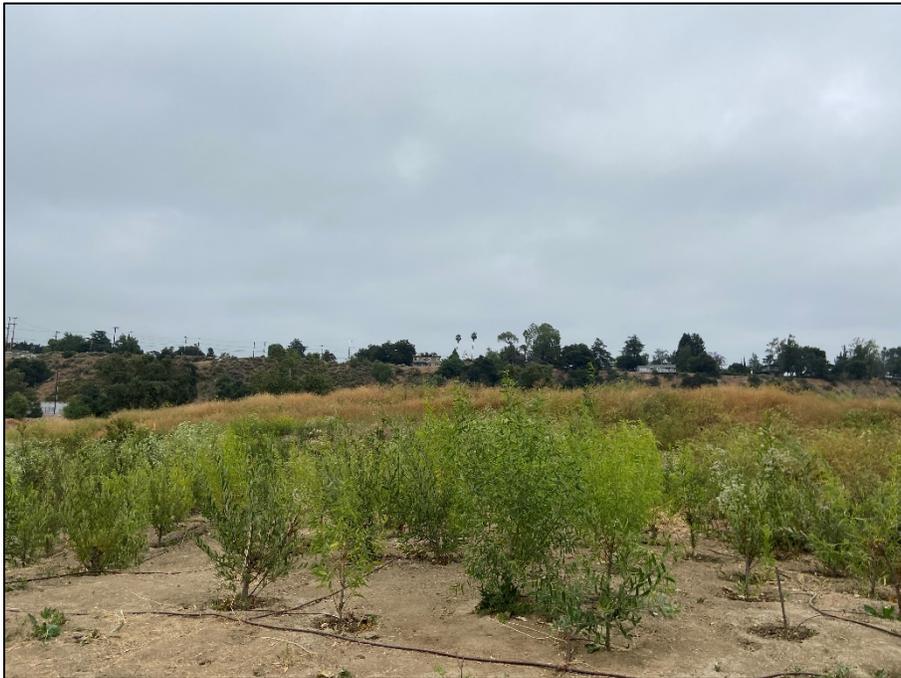
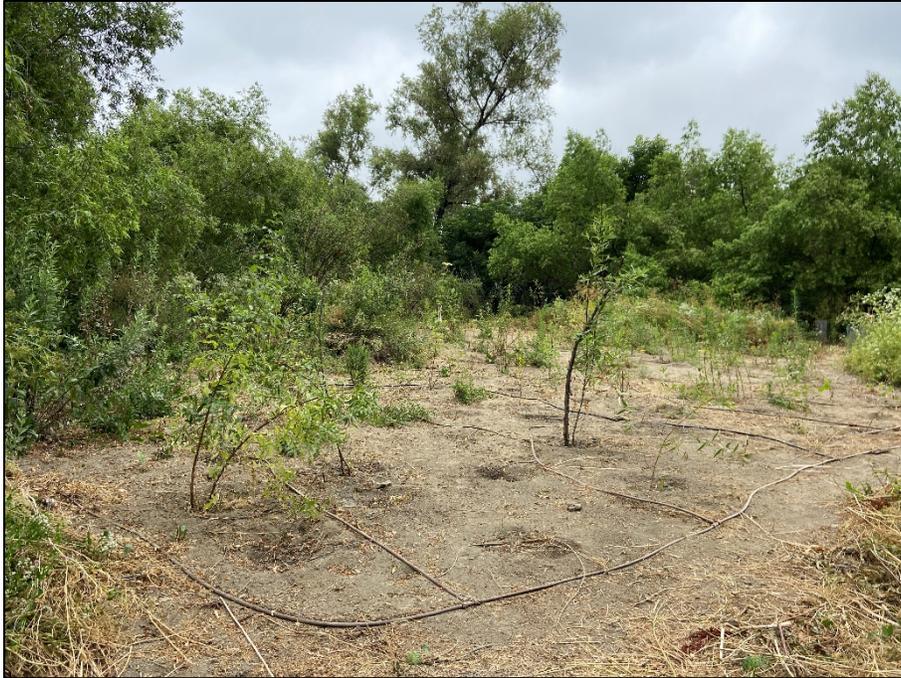
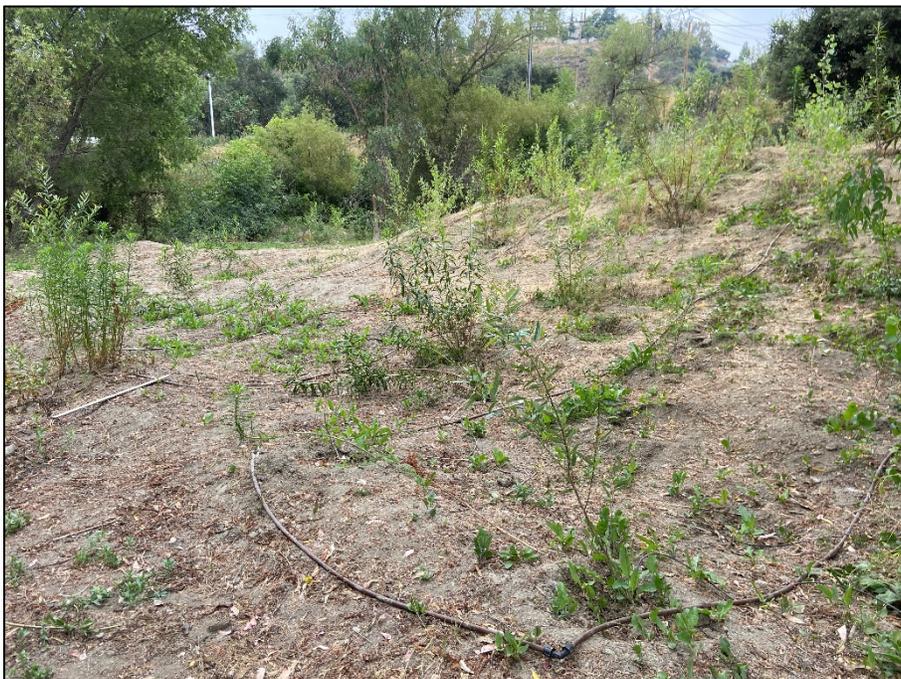
The overall health of the container plants in mitigation area DG-4 was noted as being good. Approximately 10 to 15 percent of all container plants were showing varied levels of stress, which is approximately 5 to 10 percent less than the percentage of plants that were showing stress during the final PEP monitoring; however, the middle portions of DG-4, where weeds have been an issue in the past, are being overrun with weed cover due to the presence of a 300 foot buffer around a least Bell's vireo (*Vireo bellii pusillus*) nest and these areas could not be properly assessed during the first qualitative monitoring event. Weed abatement activities have been temporarily suspended in this area until the nest fledges, or becomes inactive, as determined by an approved least Bell's vireo monitor and it is confirmed by the appropriate agencies that the buffer can be removed. These portions of DG-4 were monitored from a distance using binoculars; however, the abundant weed growth made it difficult to determine the level of stress to container plants in these areas. The types of stress the plants were exhibiting are the same as those described for the plants in DG-2A. For most portions of DG-4, only a negligible number of container plants were noted as being missing or dead. However, in portions of DG-4 that are infested with perennial pepperweed (*Lepidium latifolium*), container plant mortality was found to be higher. In addition,

approximately 20 percent of container plants in the southern portion of DG-4 appeared to be dead or missing. A small number of container plants also appeared to be missing in the northern and middle portions of this mitigation area due to heavy water flow. Wildlife damage to irrigation lines in the northern portion of DG-4 appeared to have been fixed and no additional mortalities were noted. The container planted willow species and mulefat were showing signs of vigorous growth. In addition, the recently planted willow and mulefat cuttings were also observed to be sprouting vigorously. The installation of plants in the DG-4 mitigation area appears to have been completed successfully and the issues noted during the monitoring are not expected to have an impact on the continued growth of the plants. Photos 16 through 22 in Attachment B document the mitigation area during the monitoring visit.

Nonnative weed cover in DG-4 was estimated at approximately <5 percent, which is approximately 5 to 70 percent less than what was observed during the final PEP monitoring; however, portions of DG-4 where weed abatement has been delayed, due to the least Bell's vireo nest, are being overrun with nonnative weed cover. Nonnative species observed in DG-4 included pigweed (*Amaranthus albus*), dog fennel (*Anthemis cotula*), black mustard, poison hemlock (*Conium maculatum*), tocalote (*Centaurea melitensis*), red-stemmed filaree, perennial pepperweed, horehound (*Marrubium vulgare*), annual yellow sweetclover (*Melilotus indicus*), Indian plantain, and curly dock (*Rumex crispus*). Nonnative weed cover, especially perennial pepperweed, is a significant problem in the DG-4 mitigation area. Because perennial pepperweed can produce dense colonies through seed germination and underground rhizomes (rhizomatous roots), removal of this species without the use of systemic herbicide is very difficult.

Photo 16: Overview Mitigation Area DG-4

Photo 17: Overview Mitigation Area DG-3A

Photo 18: Overview Mitigation Area DG-4

Photo 19: Overview Mitigation Area DG-4

Photo 20: Overview Mitigation Area DG-4

Photo 21: Overview Mitigation Area DG-4

Photo 22: Overview Mitigation Area DG-4

Nonnative weed cover ranged from approximately <5 percent to <10 percent in the various mitigation areas that are outside of the least Bell's vireo nest buffer; however, portions of the Phase 1 mitigation areas where weed abatement has been suspended due to the nest buffer were noted as having significant weed proliferation, including from perennial pepperweed. Once this nest buffer has been removed, these areas should be weeded immediately to minimize competition with native plants. Weed abatement activities, including hand pulling and removal of material, were observed in mitigation area DG-4B during the monitoring visit and weed cover was observed to be greatly reduced in those areas. Regular maintenance and removal of nonnative weeds is of the highest priority for all of the mitigation areas to reduce competition between native and nonnative plants. A focus should be placed on removing the weeds and nonnatives from the basins of each of the container plants and cuttings. Nonnative plants and weeds that have gone to seed should be bagged and removed from the mitigation area. Without the use of herbicides, control of the nonnatives will be extremely difficult so the frequency and level of effort will need to be increased to provide control until the native plants and seedlings have a chance to grow and outcompete the nonnatives. In particular, it is important to maintain long-term perennial pepperweed management to reduce competition and allow for native plants to germinate.

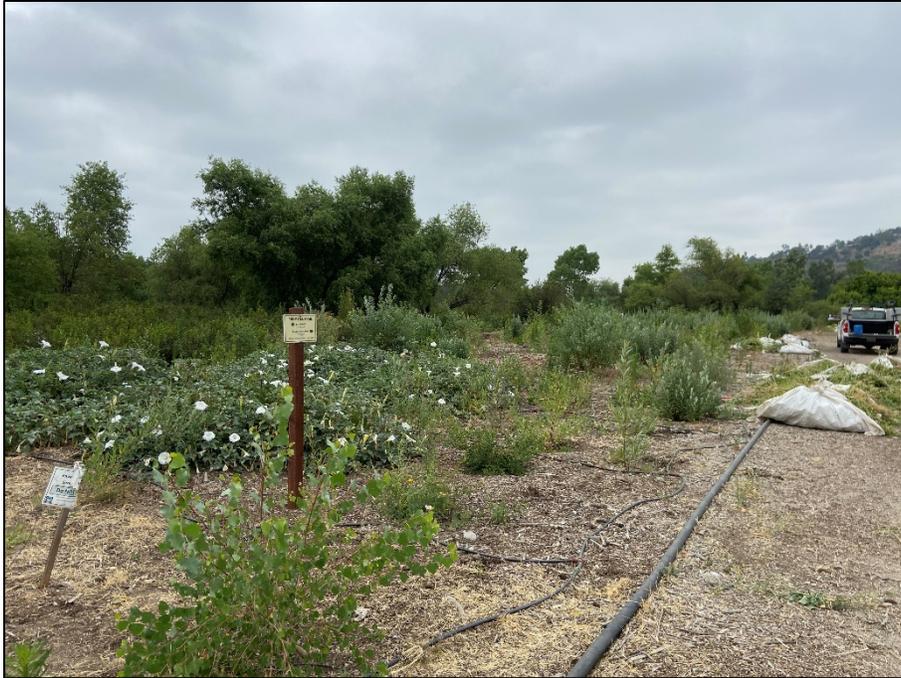
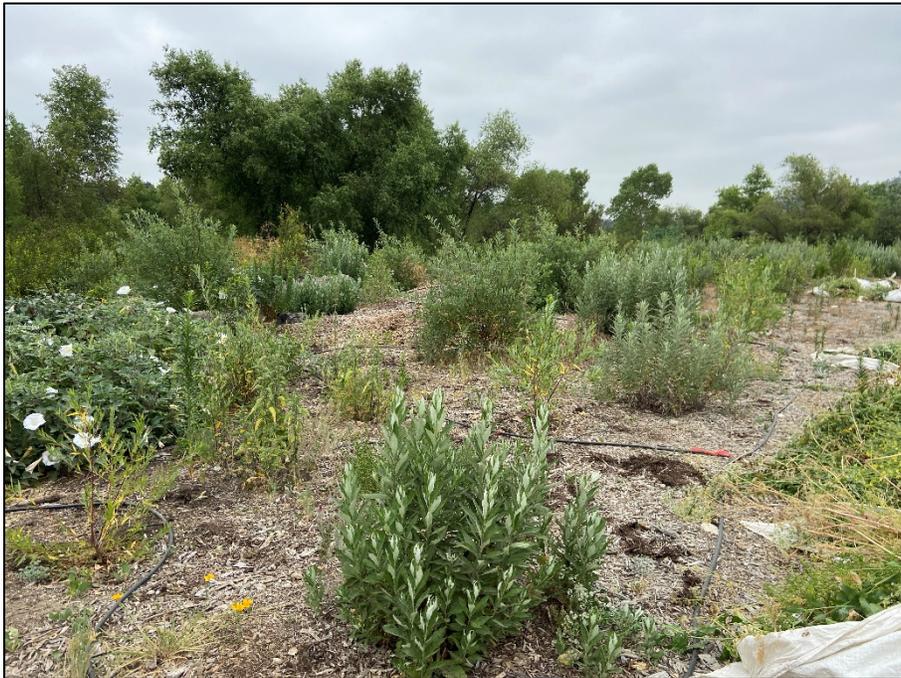
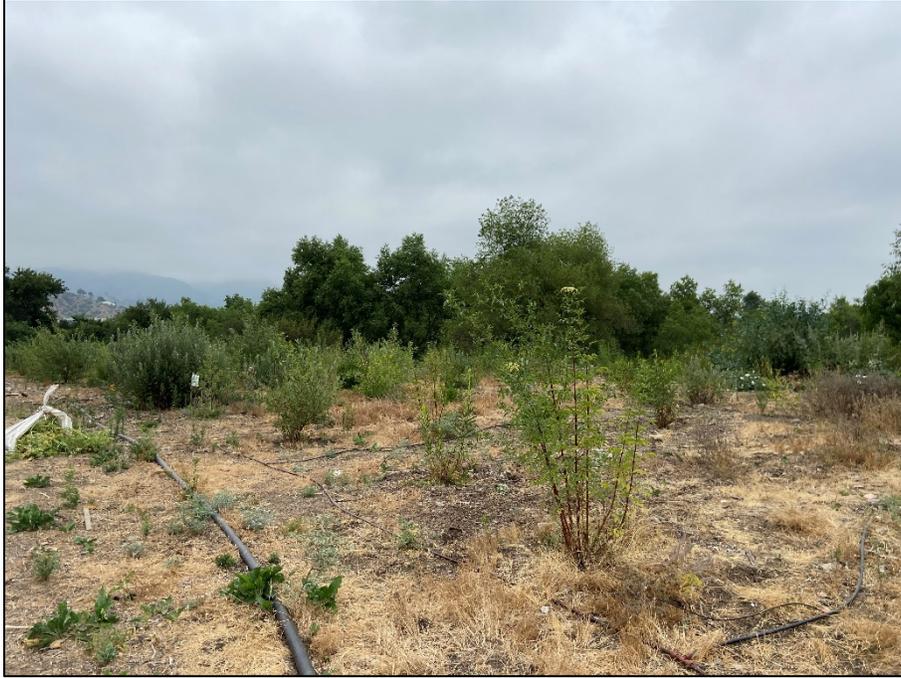
The overall health of the container plants in mitigation area DG-4B was noted as being good. Approximately 5 percent of all container plants were noted as showing varied levels of stress, which is the same percentage of plants that were showing stress during the final PEP monitoring. The types of stress the plants were exhibiting are the same as those described for the plants in DG-2A. A negligible number of container plants were noted as being missing or dead. Similar to DG-4, the container planted willow species and mulefat were showing signs of vigorous growth. The installation of plants in the DG-4B mitigation area appears to have been completed successfully and the issues noted during the monitoring are not expected to have an impact on the continued growth of the plants. Photos 23 through 25 in Attachment B document the mitigation area during the monitoring visit.

Nonnative weed cover in DG-4B was estimated at approximately <5 percent, which is the same percentage of nonnative cover that was observed during the final PEP monitoring. Nonnative species observed in DG-4B included poison hemlock, prickly lettuce (*Lactuca serriola*), annual yellow sweetclover, and perennial pepperweed.

Photo 23: Overview Mitigation Area DG-4B

Photo 24: Overview Mitigation Area DG-4B

Photo 25: Overview Mitigation Area DG-4B

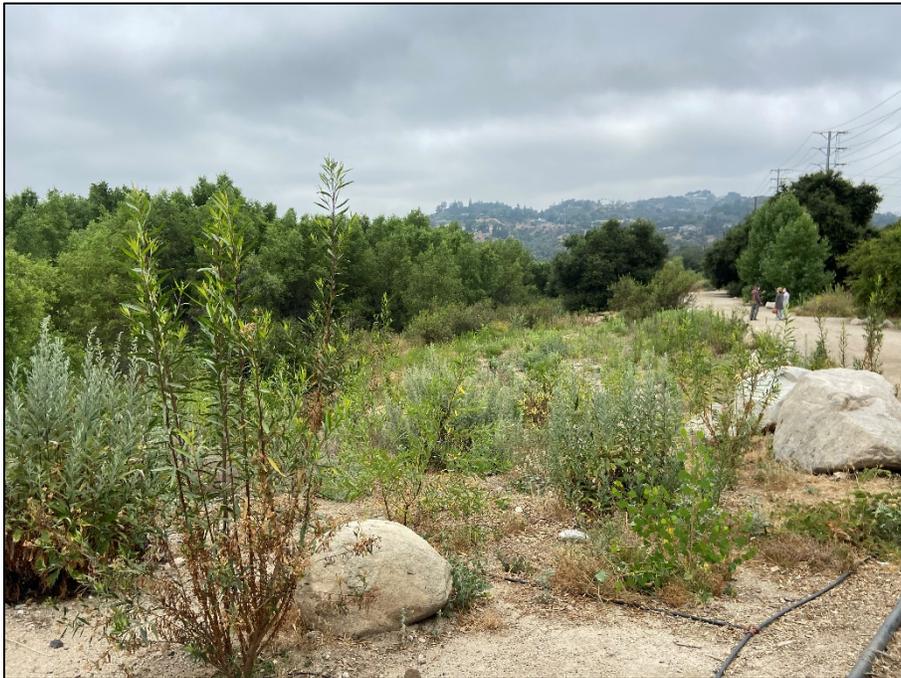
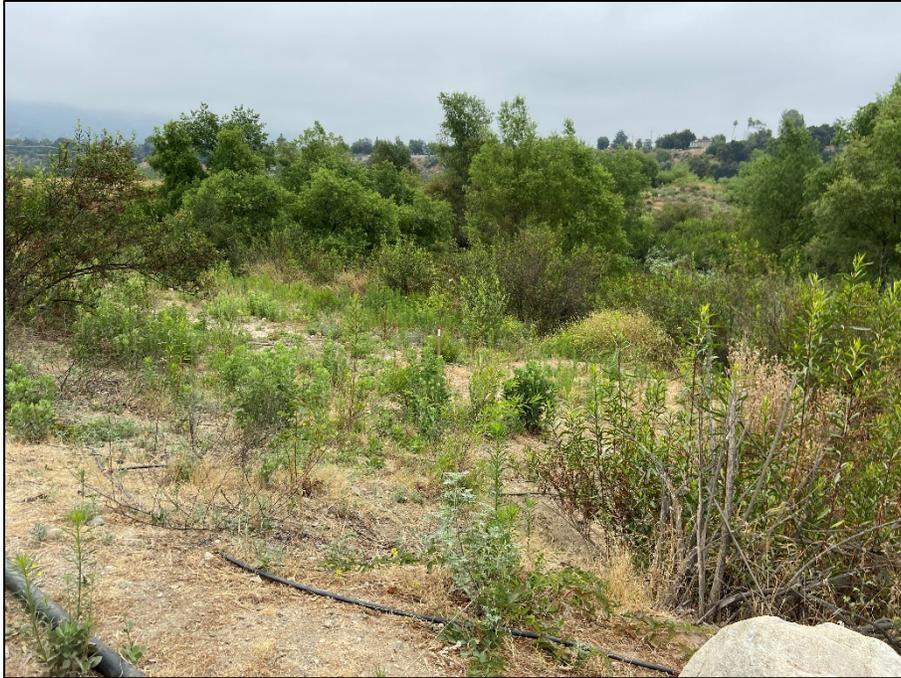
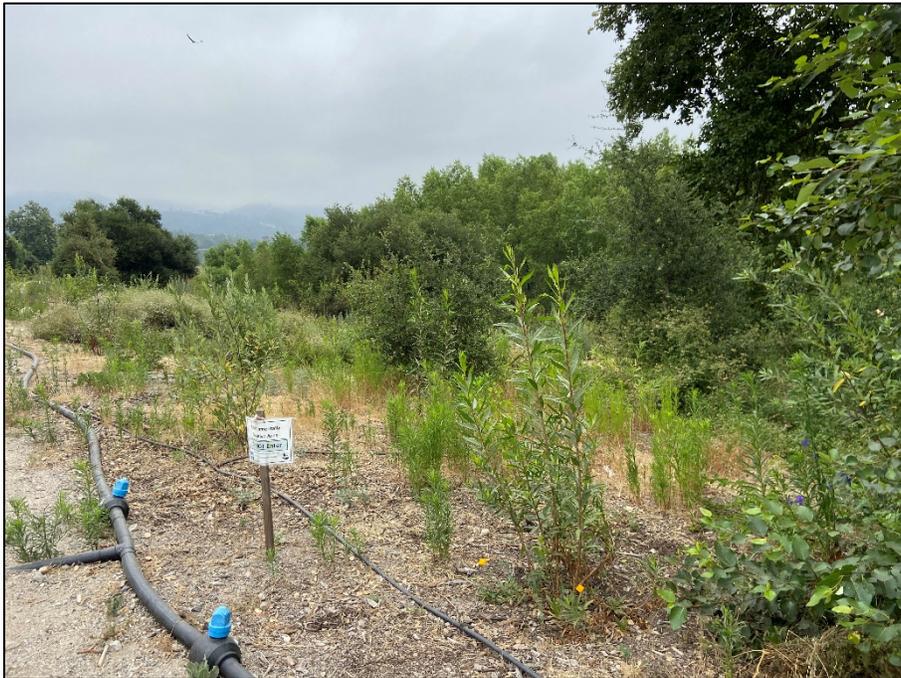
The overall health of the container plants in mitigation area DG-4C was noted as being good. Approximately <5 percent of all container plants were noted as showing varied levels of stress, which is the same percentage of plants that were showing stress during the final PEP monitoring. The types of stress the plants were exhibiting are the same as those described for the plants in DG-2A. A negligible number of container plants were noted as being missing or dead. Similar to DG-4, the container planted willow species and mulefat in the mitigation areas were showing signs of vigorous growth. The installation of plants in the DG-4C mitigation area appears to have been completed successfully and the issues noted during the monitoring are not expected to have an impact on the continued growth of the plants. Photos 26 through 28 in Attachment B document the mitigation area during the monitoring visit.

Nonnative weed cover in DG-4C was estimated at approximately <5 percent, which is the same percentage of nonnative cover that was observed during the final PEP monitoring. Nonnative species observed in DG-4C included black mustard, red-stemmed filaree, and prickly lettuce.

Photo 26: Overview Mitigation Area DG-4C

Photo 27: Overview Mitigation Area DG-4C

Photo 28: Overview Mitigation Area DG-4C
