Re: *Devil's Gate Reservoir Restoration Project – Phase 1 Restoration Qualitative Monitoring Conducted on June 18, 2020*

1.0 INTRODUCTION

2.0 QUALITATIVE MONITORING IN THE PHASE 1 MITIGATION AREAS

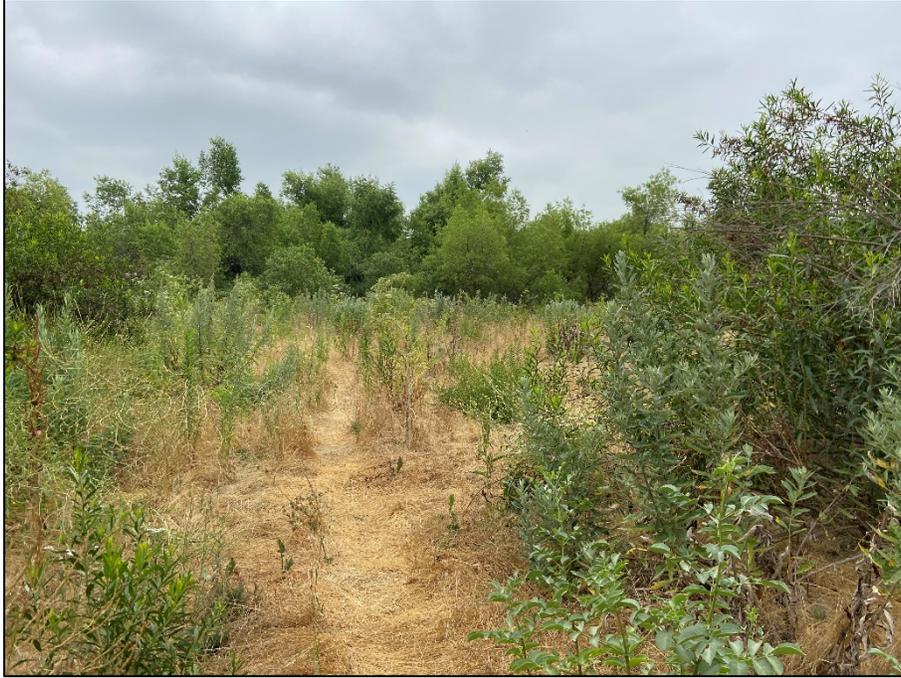
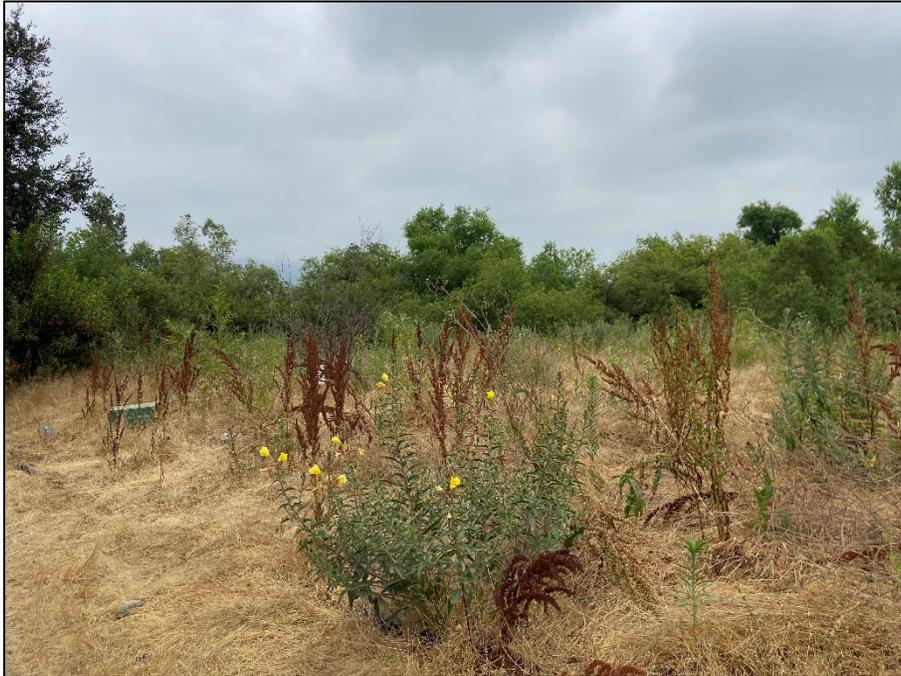
The overall health of the container plants in the DG-5 mitigation area was noted as being good; however, due to this mitigation area being located within the least Bell's vireo buffer, DG-5 was monitored with binoculars from the trail. Approximately 15 percent of all container plants were noted as showing varied levels of stress, which is the same percentage of plants that were showing stress during the final PEP monitoring. No additional mortalities were observed; however, due to the level of nonnative cover and inaccessibility, this could not be confirmed. The types of stress the plants were exhibiting are the same as those described for the plants in DG-2A. In addition, gopher herbivory is a significant problem in DG-5 and accounts for the majority of the missing container plants. Similar to DG-4, the container planted willow species and mulefat were exhibiting vigorous growth. The installation of plants in the DG-5 mitigation area appears to have been completed successfully and the issues noted during the monitoring are not expected to have a negative impact on the continued growth of the plants. Photos 29 and 30 in Attachment B document the mitigation area during the monitoring visit.

Nonnative weed cover in DG-5 was estimated at approximately 30 to 35 percent, which is approximately 5 percent less than what was observed during the final PEP monitoring. The decrease in weed cover appears to be attributed to several species of annual nonnative grasses being dead for the season. The presence of the least Bell's vireo nest buffer is currently preventing weed abatement in this area and weeds will likely continue to proliferate until the buffer has been removed. Nonnative species observed in DG-5 included black mustard, Italian thistle, curly dock, and perennial pepperweed. Nonnative weed cover, especially nonnative grasses and perennial pepperweed, is a major problem in the DG-5 mitigation area.

Photo 29: Overview Mitigation Area DG-5

Photo 30: Overview Mitigation Area DG-5

Nonnative weed cover ranged from approximately <5 percent to <10 percent in the various mitigation areas that are outside of the least Bell's vireo nest buffer; however, portions of the Phase 1 mitigation areas where weed abatement has been suspended due to the nest buffer were noted as having significant weed proliferation, including from perennial pepperweed. Once this nest buffer has been removed, these areas should be weeded immediately to minimize competition with native plants. Weed abatement activities, including hand pulling and removal of material, were observed in mitigation area DG-4B during the monitoring visit and weed cover was observed to be greatly reduced in those areas. Regular maintenance and removal of nonnative weeds is of the highest priority for all of the mitigation areas to reduce competition between native and nonnative plants. A focus should be placed on removing the weeds and nonnatives from the basins of each of the container plants and cuttings. Nonnative plants and weeds that have gone to seed should be bagged and removed from the mitigation area. Without the use of herbicides, control of the nonnatives will be extremely difficult so the frequency and level of effort will need to be increased to provide control until the native plants and seedlings have a chance to grow and outcompete the nonnatives. In particular, it is important to maintain long-term perennial pepperweed management to reduce competition and allow for native plants to germinate.
