Mr. Mark Gim  
Los Angeles County Public Works  
900 South Fremont Avenue, 9th Floor  
Alhambra, California 91803

**Re: *Devil's Gate Reservoir Restoration Project – Phase 1 Restoration Qualitative Monitoring Conducted on January 28, 2021***

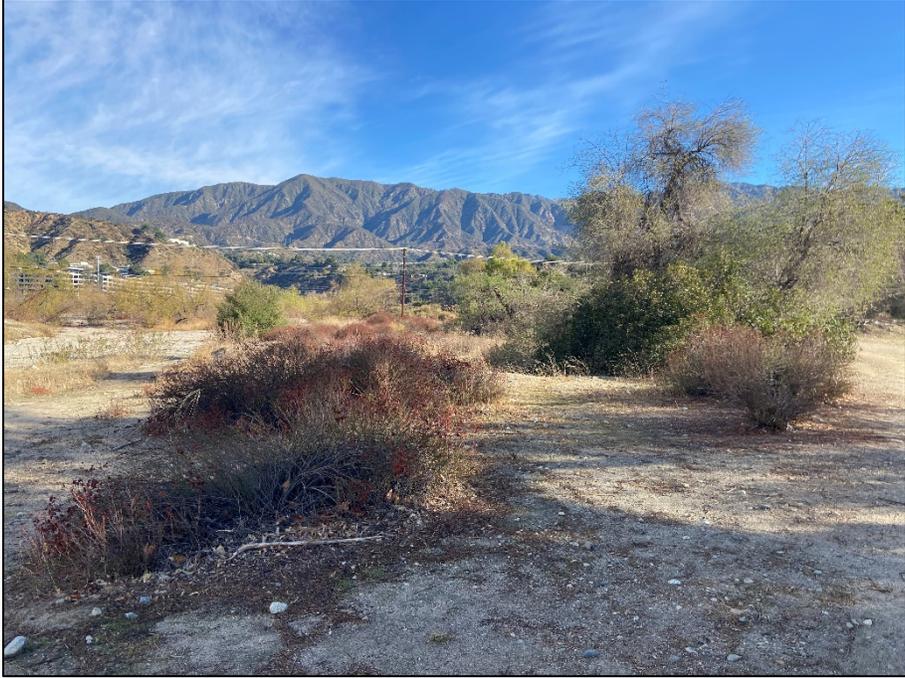
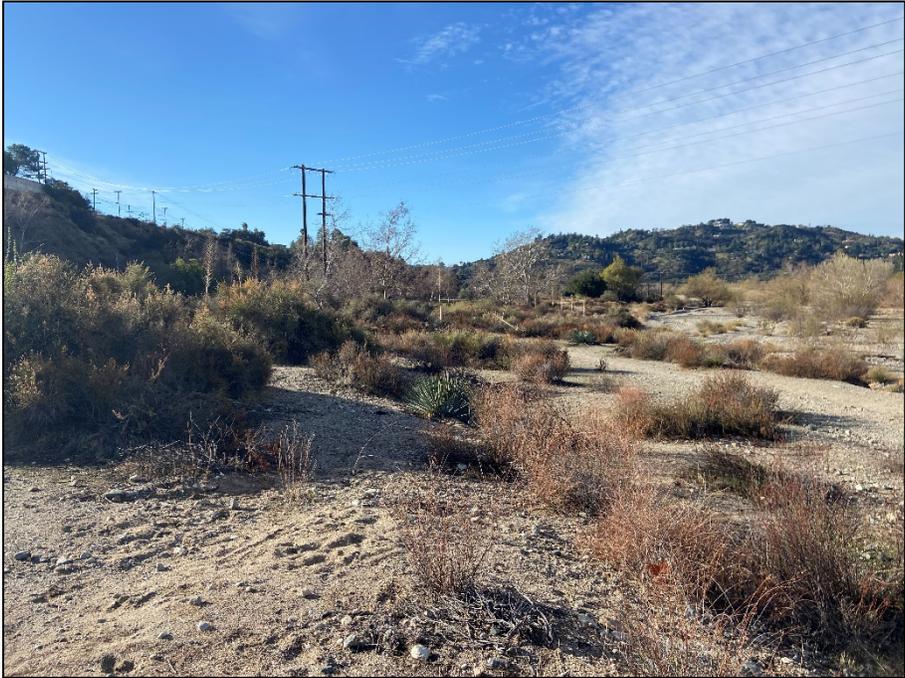
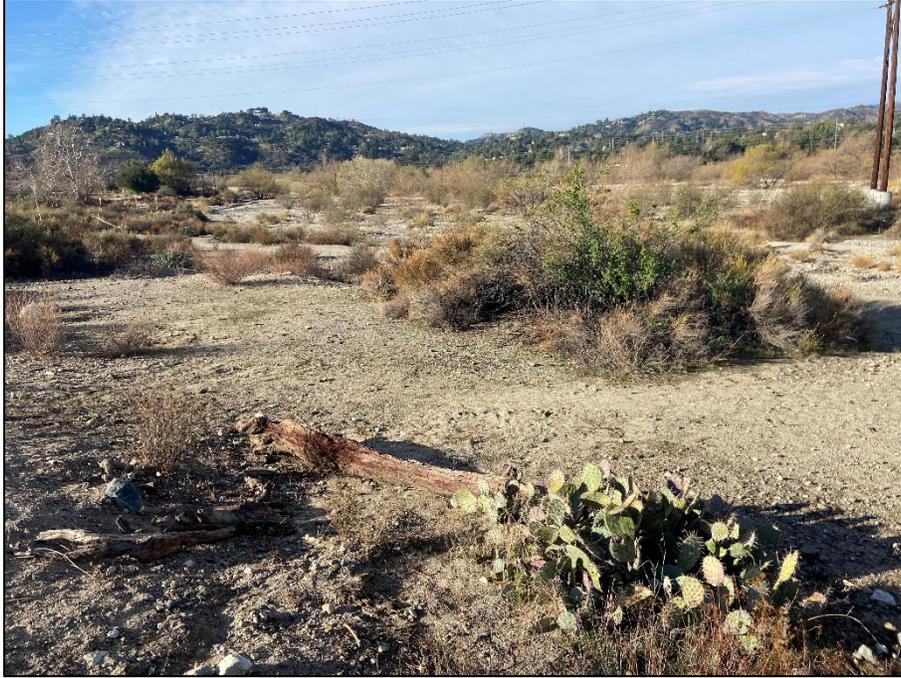
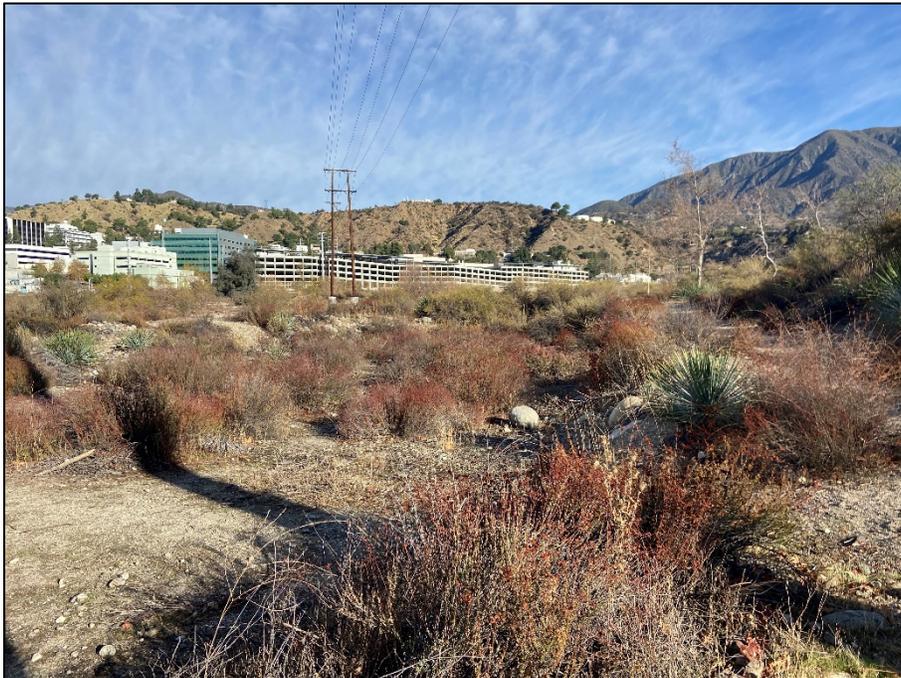
Container plants were not installed in the DG-1 or DG-1 WOUS mitigation areas, but these areas were seeded with native plant species. Native plant growth was noted throughout the DG-1 and DG-1 WOUS mitigation areas, likely both from natural recruitment and from seeding; however, germination was observed to be very minimal in the majority of these mitigation areas. Portions of DG-1 WOUS were noted as being scoured during the wet season and had minimal plant growth. Most native annuals were noted as being dead for the season; however, some new germination was observed. Native plants such as California sagebrush (*Artemisia californica*), mulefat (*Baccharis salicifolia*), California buckwheat (*Eriogonum fasciculatum*), scale broom (*Lepidospartum squamatum*), cliff brake (*Pellaea sp.*), and caterpillar phacelia (*Phacelia cicutaria*) were observed sprouting in the DG-1 and DG-1 WOUS mitigation areas. In addition, dodder (*Cuscuta sp.*) was observed growing on some of the shrubs in this mitigation area, which could lead to future decline of these shrubs; however, the dodder was noted as being mostly dead for the season. Photos 1 through 4 in Attachment B document the mitigation area during the monitoring visit.

Nonnative weed cover in DG-1 and DG-1 WOUS was estimated at approximately <1 percent, if the dead annual weeds are excluded, which is approximately the same level of weed cover that was observed during the previous qualitative monitoring event. Nonnative species observed in DG-1 and DG-1 WOUS included black mustard (*Brassica nigra*), red brome (*Bromus madritensis ssp. rubens*), cheatgrass (*Bromus tectorum*), tocalote (*Centaurea melitensis*), tree tobacco (*Nicotiana glauca*), and Mediterranean grass (*Schismus barbatus*); however, most individuals were observed to be dead for the season.

Photo 1: Overview Mitigation Area DG-1

Photo 2: Overview Mitigation Area DG-1

Photo 3: Overview Mitigation Area DG-1

Photo 4: Overview Mitigation Area DG-1

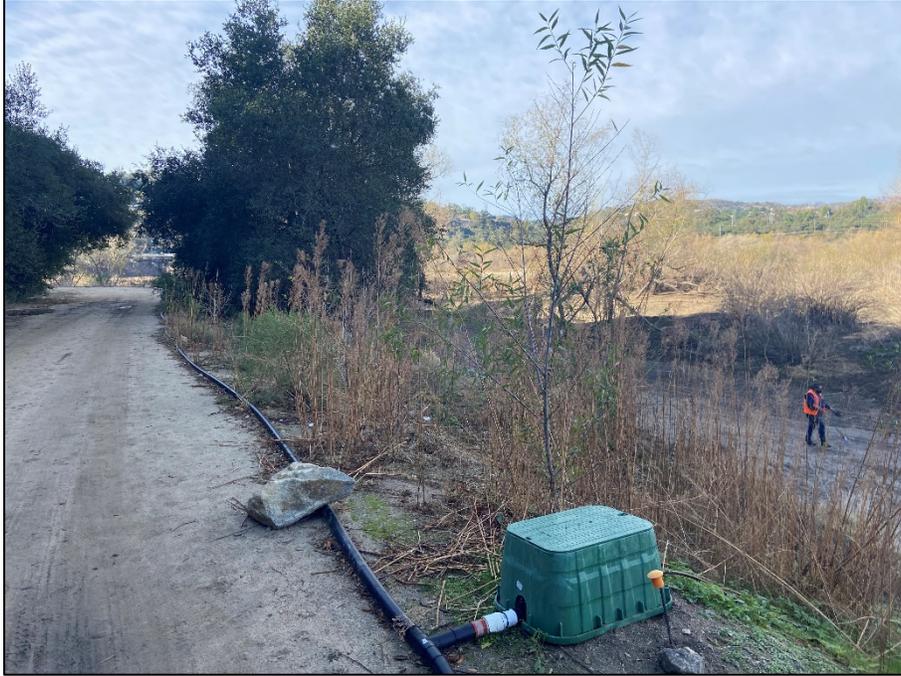
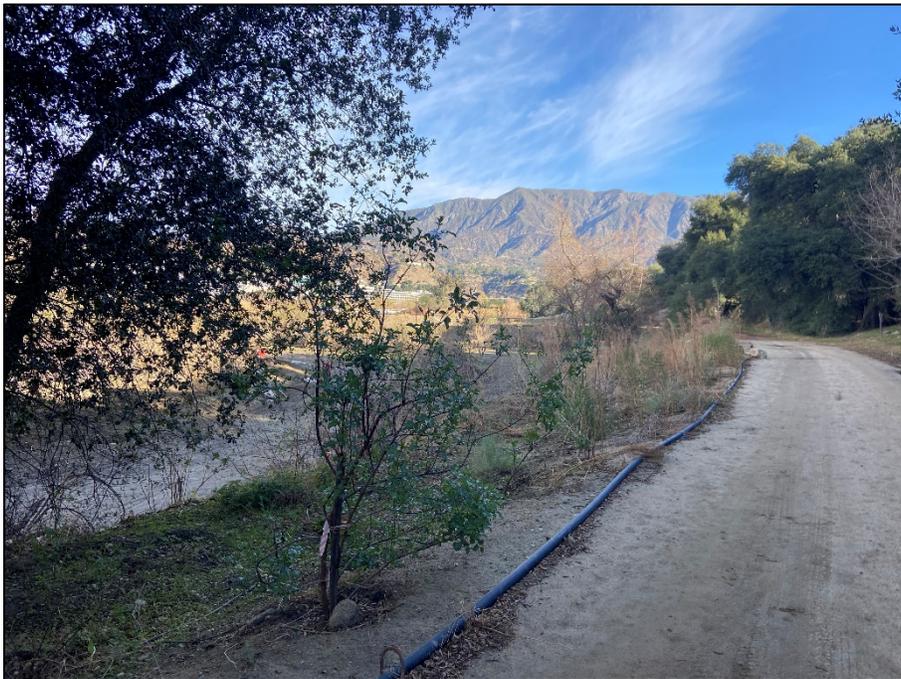
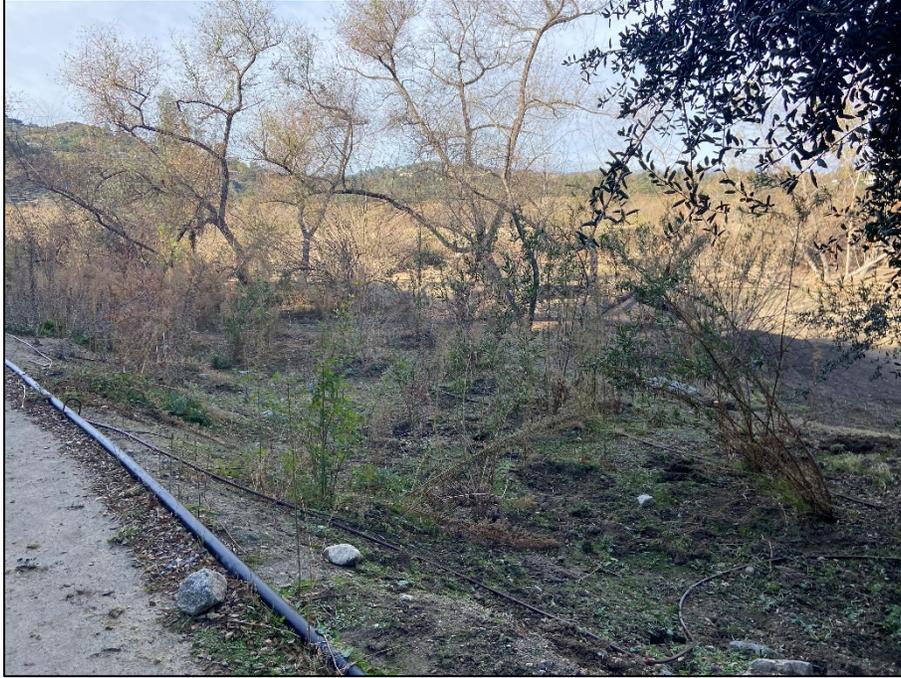
The overall health of the container plants in DG-2A was noted as being good. Only minimal stress was observed, and the majority of the remaining container plants are becoming well established. Approximately 10 percent of all container plants were showing varied levels of stress, which is the same

percentage of plants that were showing stress during the previous qualitative monitoring event. Stress may be occurring as a result of 1) herbivory by rabbits or other wildlife or 2) competition from nonnative and invasive weeds. There were no additional container plants noted as being missing or dead. Formal mortality counts were taken for DG-2A during the quantitative monitoring and will be included in the annual reporting. The willow species (*Salix sp.*) and Fremont's cottonwoods (*Populus fremontii*) in the mitigation areas were showing signs of seasonal dieback. Some of the planting basins were observed to have minor erosion and should be repaired. In addition, a small number of container plants appeared to have been recently trampled. The installation of plants in the DG-2A mitigation area appears to have been completed successfully. The current issues identified during the monitoring visit are not expected to have an effect on the continued growth of the plants in the mitigation area. Photos 5 through 7 in Attachment B document the mitigation area during the monitoring visit.

Native plant growth was noted throughout the DG-2A mitigation area, likely both from natural recruitment and from seeding. Native plants such as mugwort (*Artemisia douglasiana*), mulefat, cobweb thistle (*Cirsium occidentale*), telegraph weed (*Heterotheca grandiflora*), caterpillar phacelia, ladies' tobacco (*Pseudognaphalium californicum*), California rose (*Rosa californica*) and stinging nettle (*Urtica dioica*) were observed sprouting in the DG-2A mitigation area.

Nonnative weed cover in DG-2A was estimated at approximately 15 percent, which is approximately 5 percent more than the level of weed cover that was observed during the previous qualitative monitoring event. Nonnative species observed in DG-2A included black mustard, poison hemlock (*Conium maculatum*), perennial pepperweed (*Lepidium latifolium*), and white horehound (*Marrubium vulgare*). While nonnative annuals were observed to be mostly dead, new germination of nonnative weeds was also observed.

Photo 5: Overview Mitigation Area DG-2A

Photo 6: Overview Mitigation Area DG-2A

Photo 7: Overview Mitigation Area DG-2A

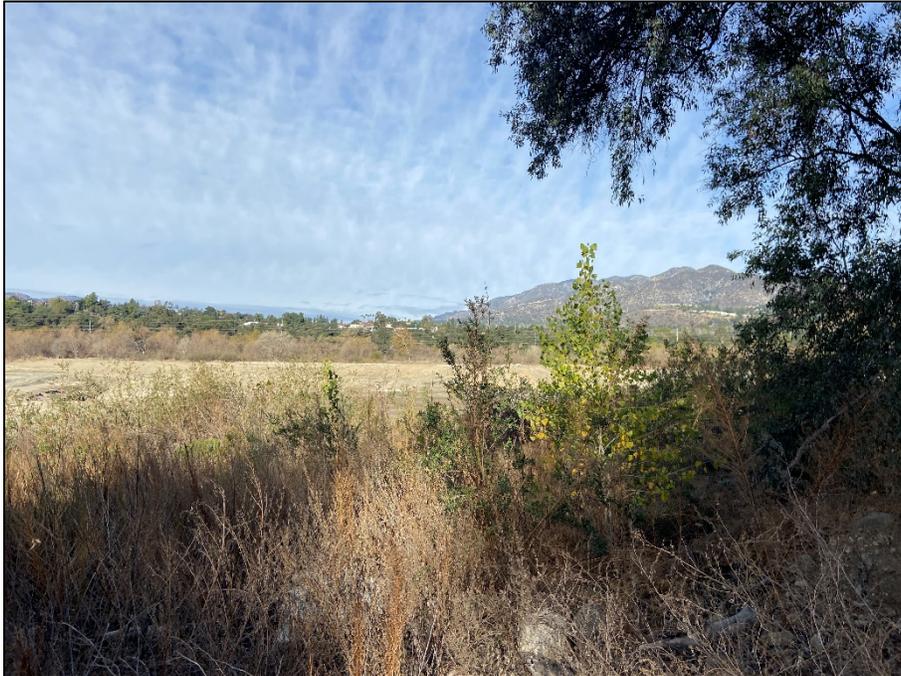
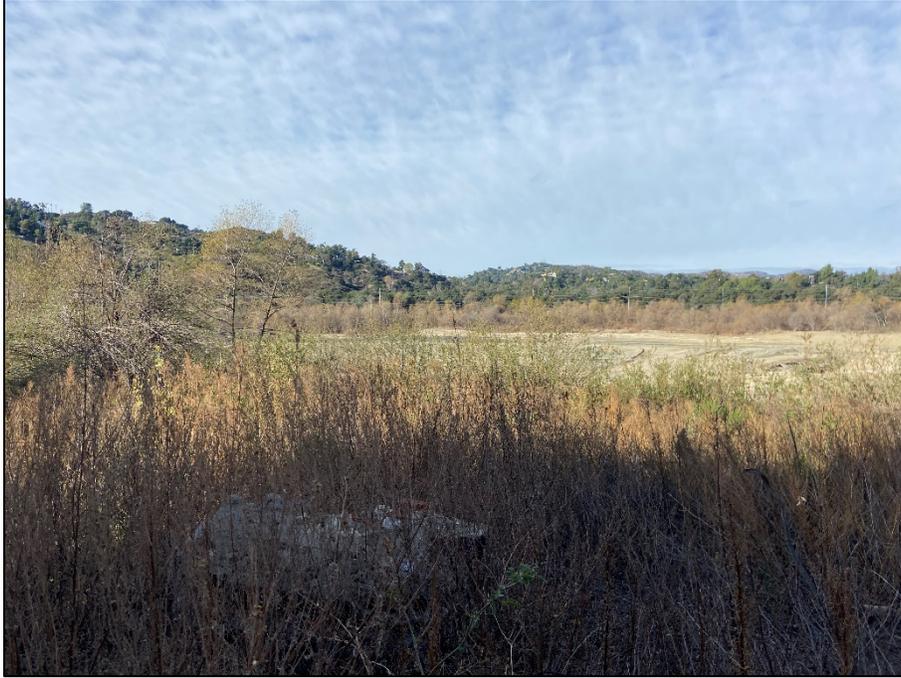
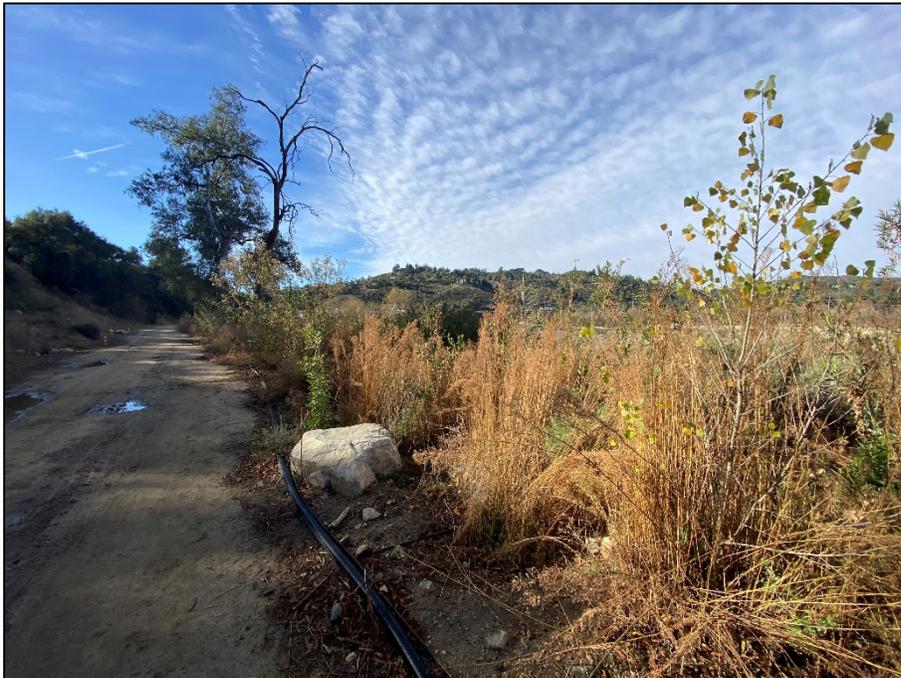
The overall health of the container plants in DG-2B was noted as being good. Approximately 10 percent of all container plants were showing varied levels of stress, which is the same percentage of plants that were showing stress during the previous qualitative monitoring event. Stress was likely due to the same reasons as those described for DG-2A. In addition, insect galls were observed on several of the willow species. Formal mortality counts were taken for DG-2B during the quantitative monitoring and will be included in the annual reporting. Similar to DG-2A, the willow species and Fremont's cottonwoods were showing signs of seasonal dieback. Some of the planting basins were observed to have minor erosion and should be repaired. The installation of the plants in the DG-2B mitigation area appears to have been successfully completed. The current issues identified during the monitoring visit are not expected to have an effect on the continued growth of plants in the mitigation area. Photos 8 through 10 in Attachment B document the mitigation area during the monitoring visit.

Native plant growth was noted throughout the DG-2B mitigation area, likely both from natural recruitment and from seeding. Native plants such as mugwort, mulefat, cobweb thistle, and stinging nettle were observed sprouting in the DG-2B mitigation area. In addition, dodder was observed growing on some of the shrub and tree species in this mitigation area which could lead to future decline of these shrubs; however, the dodder was observed to be mostly dead for the season.

Nonnative weed cover in DG-2B was estimated at approximately 15 percent, if the dead annual weeds are excluded, which is approximately 5 percent more than what was observed during the previous qualitative monitoring event. Nonnative species observed in DG-2B included black mustard, poison hemlock, white horehound, perennial pepperweed, Russian thistle (*Salsola tragus*), and black nightshade (*Solanum nigrum*); however, most black mustard individuals were observed to be dead for the season.

Photo 8: Overview Mitigation Area DG-2B

Photo 9: Overview Mitigation Area DG-2B

Photo 10: Overview Mitigation Area DG-2B

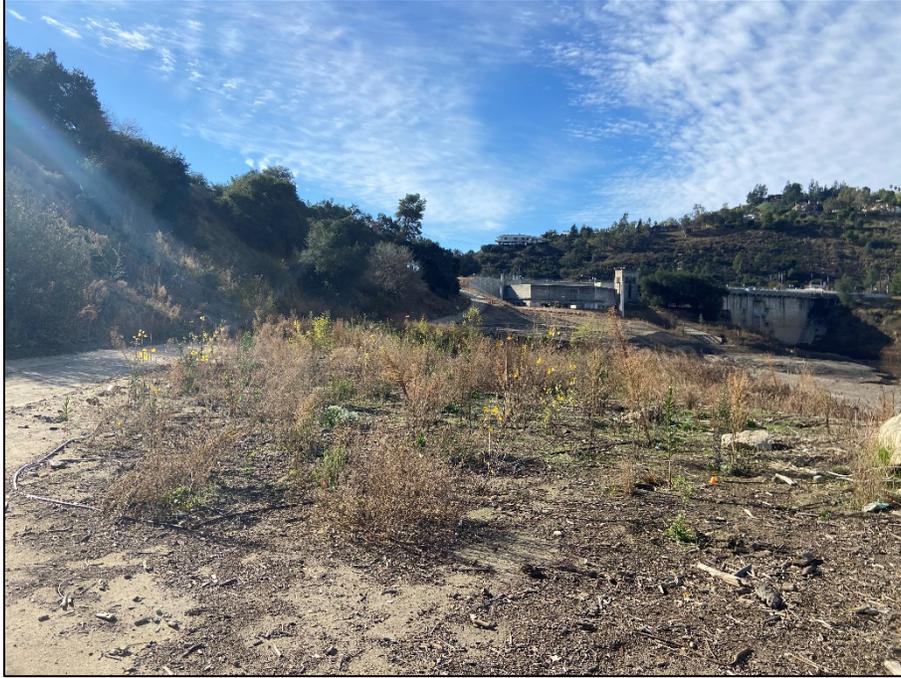
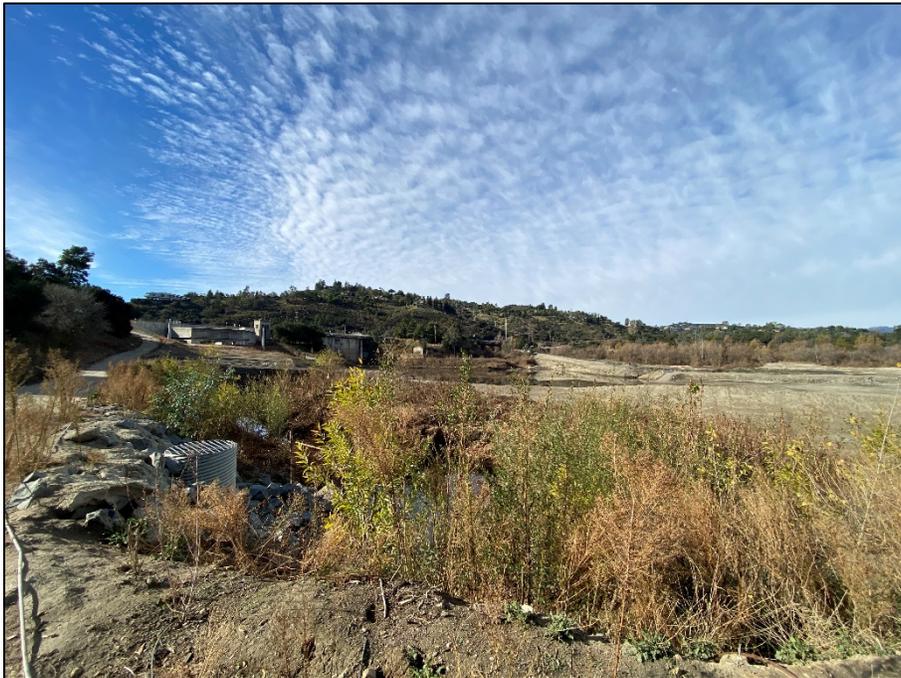
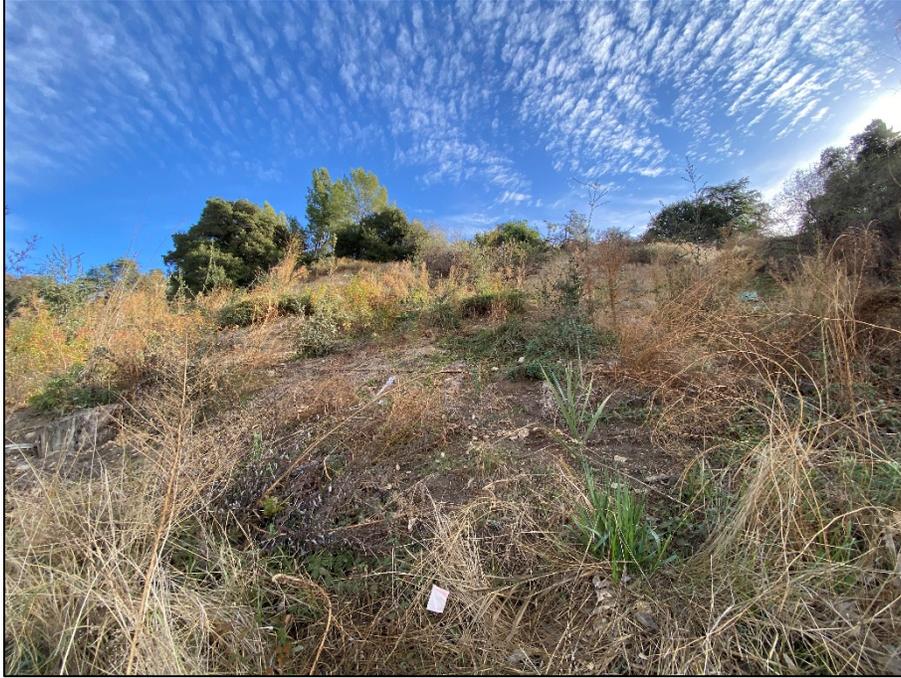
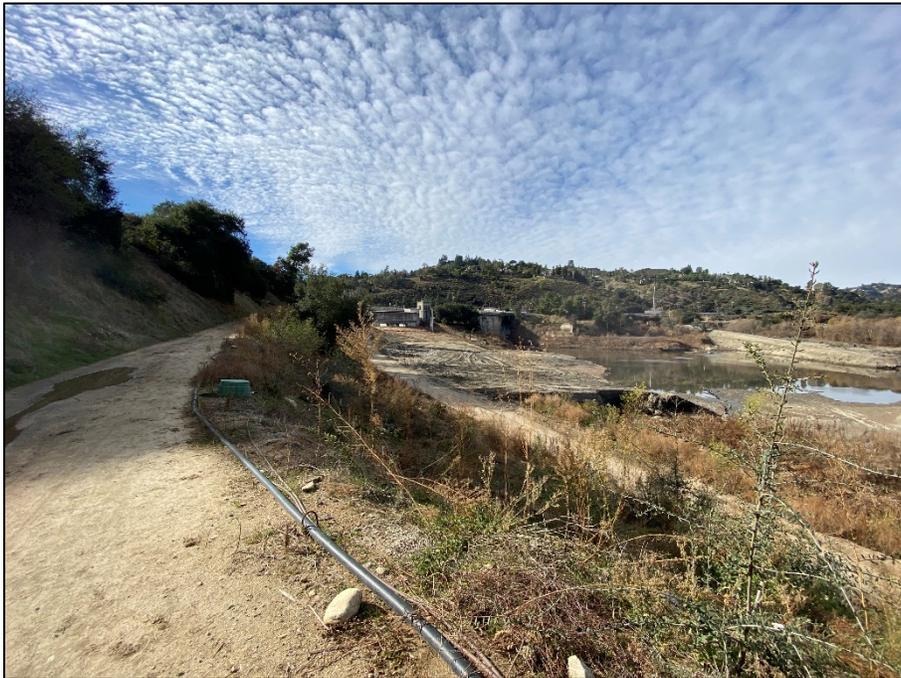
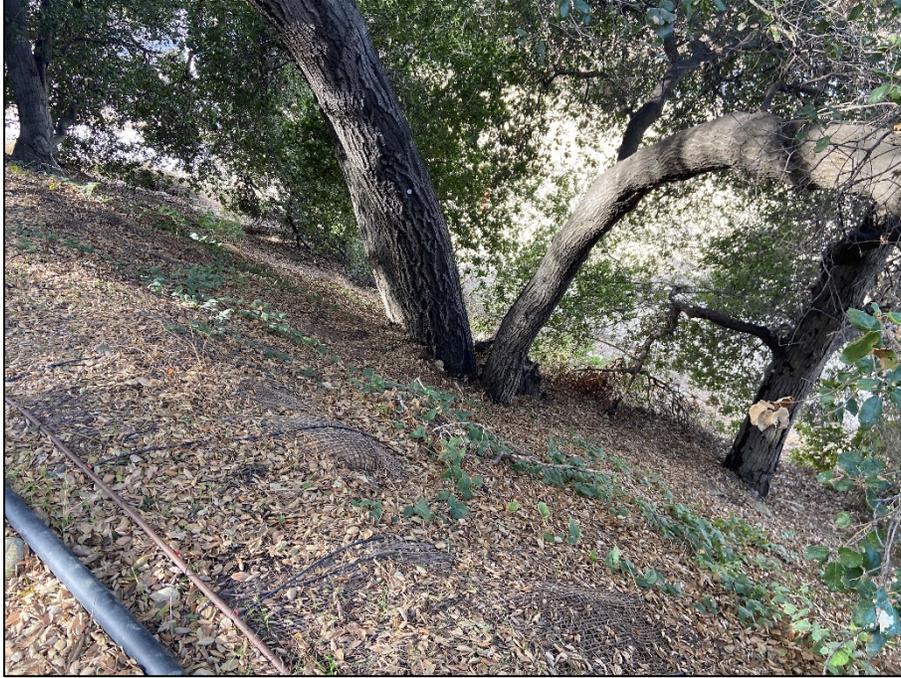
The overall health of the container plants in DG-3A was noted as being good. Approximately 15 percent of the container plants in the Coast Live Oak Woodland portions of DG-3A were noted as showing varied levels of stress, which is five percent more than the percentage of container plants that were showing stress during the previous qualitative monitoring event. In addition, several oaks appeared to have been knocked over during recent storm events. Approximately 5 to 10 percent of the container plants in the Mulefat Thickets portions of DG-3A were noted as showing varied levels of stress, which is approximately the same number of container plants that were showing stress during the previous qualitative monitoring event. Formal mortality counts were taken for DG-3A during the quantitative monitoring and will be included in the annual reporting. The types of stress the plants were exhibiting are the same as those described for the plants in DG-2A. However, erosion is also a problem in some areas of DG-3A. Some of the planting basins were observed to have minor erosion and should be repaired. In addition, the heavy water and debris flows noted during previous monitoring visits have contributed to plant mortality and stress in this mitigation area. Similar to DG-2A, the container planted willow species and Fremont's cottonwoods were exhibiting seasonal dieback; however, the planted willow and mulefat cuttings were observed to be sprouting vigorously. During the monitoring visit, the planted coast live oak (*Quercus agrifolia*) acorns were inspected for survivorship and health. Approximately 20 germinated coast live oak acorns appear to still be present in DG-3A. The majority of the germinated acorns appear to be in good health. The installation of the plants in the DG-3A mitigation area appears to have been completed successfully. The current issues noted during the monitoring are not expected to have a negative effect on the continued growth of the plants in the mitigation area. Photos 11 through 15 in Attachment B document the mitigation area during the monitoring visit.

Native plant growth was noted throughout the DG-3A mitigation area, likely both from natural recruitment and from seeding. Native plants such as mugwort, mulefat, cobweb thistle, tall flatsedge (*Cyperus eragrostis*), jimsonweed (*Datura wrightii*), beardless wild rye (*Elymus triticoides*), California poppy (*Eschscholzia californica*), stinging nettle, and rough cocklebur (*Xanthium strumarium*) were observed sprouting in the DG-3A mitigation area.

Nonnative weed cover in DG-3A was estimated at approximately 10 to 15 percent, if the dead annual weeds are excluded, which is approximately five percent more than the level of nonnative cover that was observed during the previous qualitative monitoring event. Nonnative species observed in DG-3A included black mustard, poison hemlock, perennial pepperweed, sweet alyssum (*Lobularia maritima*), tree tobacco (*Nicotiana glauca*), and castor bean (*Ricinus communis*).

Photo 11: Overview Mitigation Area DG-3A Altadena Drain

Photo 12: Overview Mitigation Area DG-3A Altadena Drain

Photo 13: Overview Mitigation Area DG-3A Oak Woodland

Photo 14: Overview Mitigation Area DG-3A Oak Woodland

Photo 15: Overview Mitigation Area DG-3A Oak Woodland

Minor erosion to planting basins was observed throughout the Phase 1 mitigation areas, likely from recent storm events. In addition, severe erosion in DG-3A near Altadena Drain was observed. Recent rainfall has created a channel that flows to the south of Altadena Drain before connecting to the reservoir where severe berm erosion has occurred. Erosion to the upper slope in DG-3A was also observed. Due to the steepness of the slope in the Coast Live Oak Woodland portion of the DG-3A mitigation area, erosion will

likely continue to be somewhat of an issue in this area; however, jute nettings are currently in place on the slope and will help to lessen the severity of erosion issues. As native cover increases in this area, erosion issues should lessen. The severity of the erosion should continue to be monitored in all planted areas and if warranted, erosion Best Management Practices (BMPs) should be installed in appropriate areas. This may only require the installation of straw wattles at select sites to prevent existing rills from becoming larger. However, until more native perennial plants become established in these areas, there is the potential that intense rainfall may create additional erosion problems.

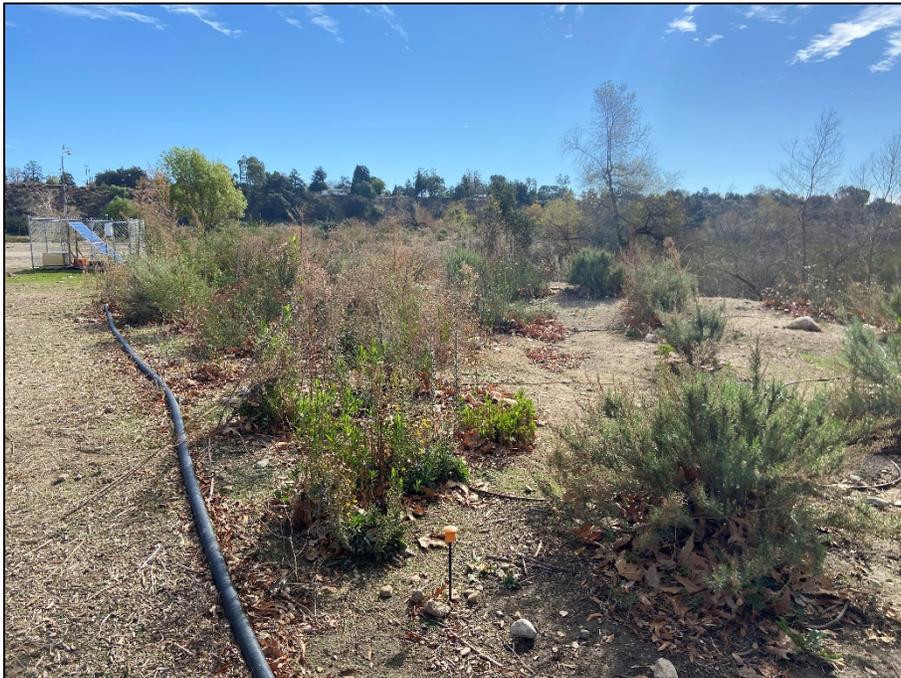
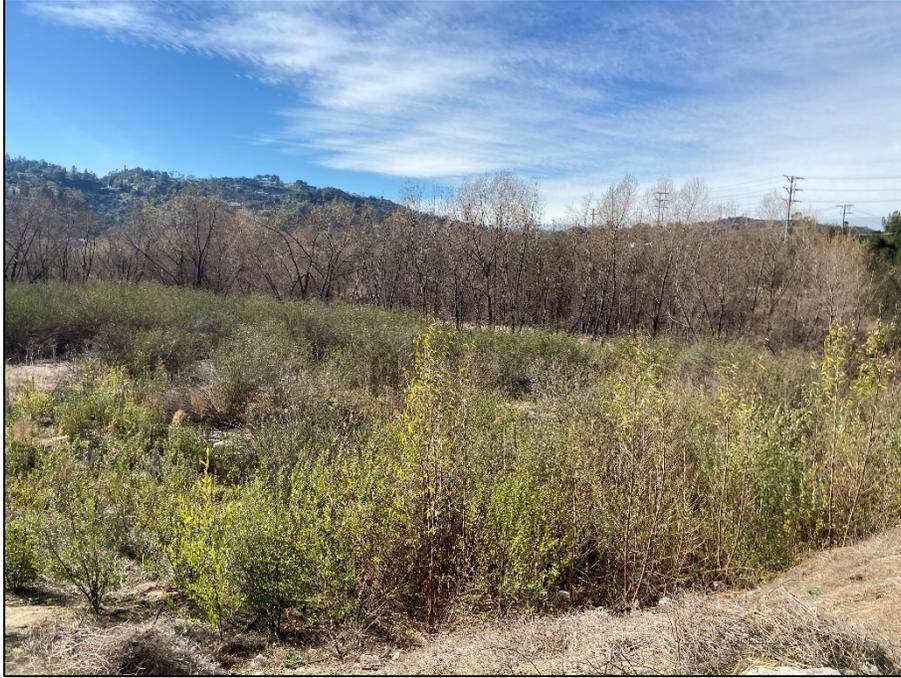
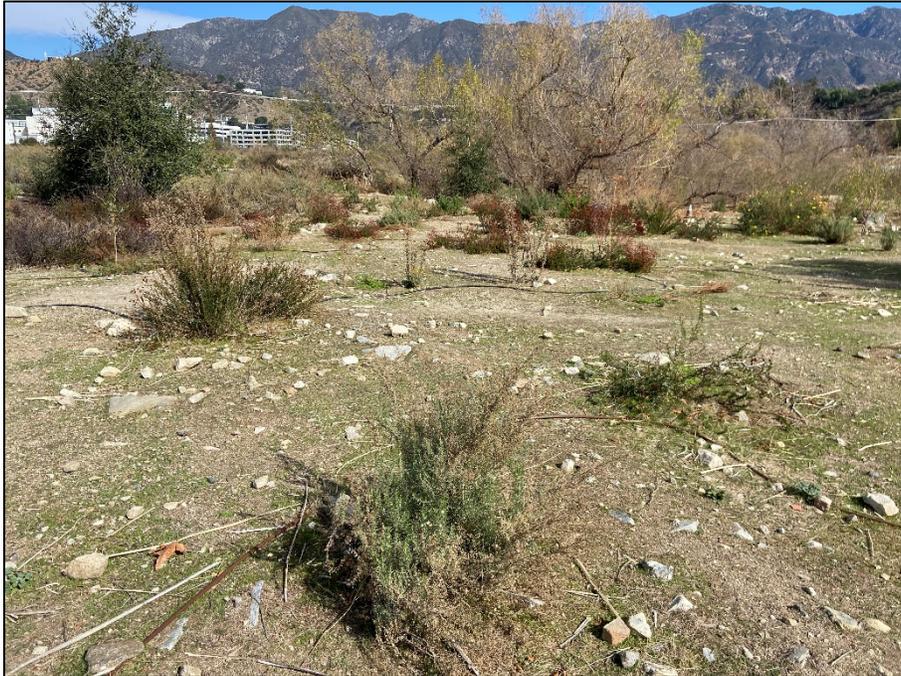
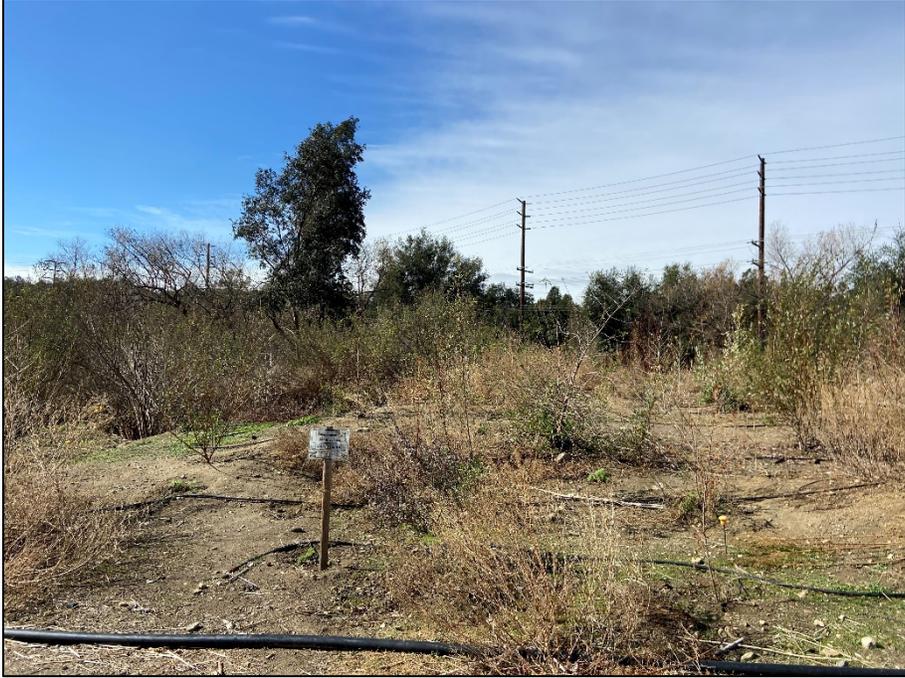
The overall health of the container plants in mitigation area DG-4 was noted as being good. Approximately 10 percent of container plants in the coastal sage scrub portions of DG-4 were showing varied levels of stress which is approximately five percent less than the percentage of plants showing stress during the previous qualitative monitoring event. Approximately 15 percent of container plants in the riparian portions of DG-4 were showing varied levels of stress, which is approximately the same percentage of container plants that were showing stress during the previous qualitative monitoring visit. The stress appears to be mostly due to the same reasons described in DG-2A. Many plants that appeared to be stressed during previous qualitative monitoring events, due to high temperatures and drought stress, appeared to be recovering. In addition, the 300-foot buffer around a least Bell's vireo (*Vireo bellii pusillus*) nest that affected middle portions of DG-4 has been removed; however, weed proliferation in this area prior to buffer removal likely contributed to plant stress and mortality. For most portions of DG-4, only a negligible number of container plants were noted as being missing or dead. Formal mortality counts were taken for DG-4 during the quantitative monitoring and will be included in the annual reporting. The container planted willow species and Fremont's cottonwood were showing signs of seasonal dieback; however, the planted willow and mulefat cuttings were also observed to be sprouting vigorously. Some of the planting basins were observed to have minor erosion and should be repaired. The installation of plants in the DG-4 mitigation area appears to have been completed successfully and the issues noted during the monitoring are not expected to have an impact on the continued growth of the plants. Photos 16 through 19 in Attachment B document the mitigation area during the monitoring visit.

Native plant growth was noted throughout the DG-4 mitigation area, likely both from natural recruitment and from seeding. Native plants such as California sagebrush, mugwort, mulefat, tall flatsedge, California buckwheat, California poppy, jimsonweed, telegraph weed, ladies' tobacco, and stinging nettle were observed sprouting in the DG-4 mitigation area.

Nonnative weed cover in DG-4 was estimated at approximately 10 to 20 percent for most areas, which is approximately 5 percent more than what was observed during the previous qualitative monitoring event. It should be noted that portions of DG-4 that are adjacent to weed infested portions of Phase 2 (i.e., DG-4A) were observed to have new germination of perennial pepperweed. Nonnative species observed in DG-4 included black mustard, poison hemlock, perennial pepperweed, and white horehound. Nonnative weed cover, especially perennial pepperweed, is a significant problem in portions of the DG-4 mitigation area. Because perennial pepperweed can produce dense colonies through seed germination and underground rhizomes (rhizomatous roots), removal of this species without the use of systemic herbicide is very difficult.

Photo 16: Overview Mitigation Area DG-4

Photo 17: Overview Mitigation Area DG-4

Photo 18: Overview Mitigation Area DG-4

Photo 19: Overview Mitigation Area DG-4

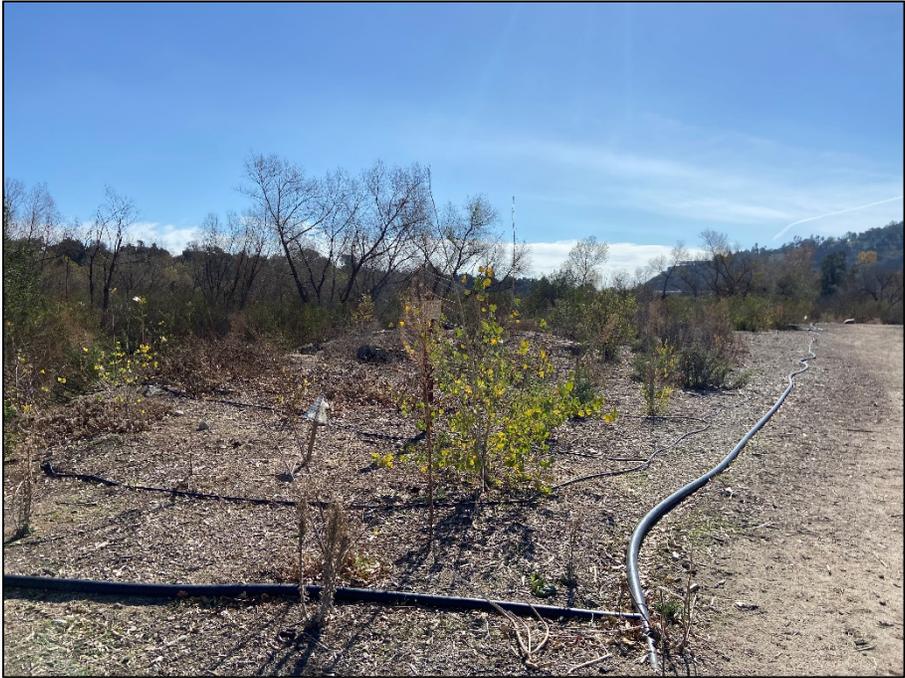
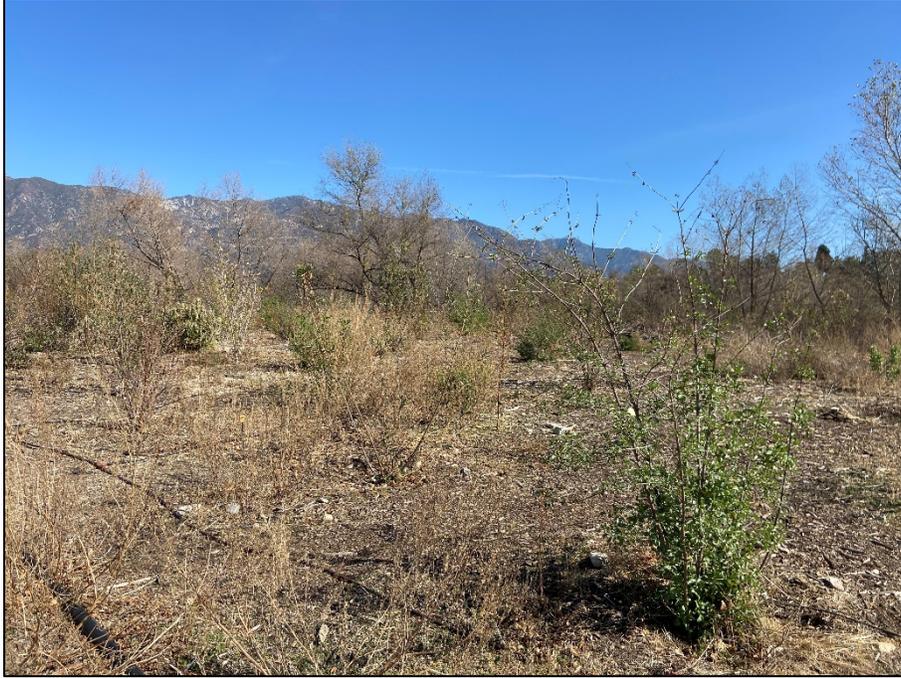
The overall health of the container plants in mitigation area DG-4B was noted as being good and this mitigation area is becoming well established. Approximately 5 to 10 percent of all container plants were noted as showing varied levels of stress, which is approximately the same percentage of plants that were showing stress during the previous qualitative monitoring visit. The types of stress the plants were exhibiting are the same as those described for the plants in DG-2A. A negligible number of container

plants were noted as being missing or dead. Formal mortality counts were taken for DG-4B during the quantitative monitoring and will be included in the annual reporting. Similar to DG-4, the container planted willow species and Fremont's cottonwoods were showing signs of seasonal dieback. Some of the planting basins were observed to have minor erosion and should be repaired. The installation of plants in the DG-4B mitigation area appears to have been completed successfully and the issues noted during the monitoring are not expected to have an impact on the continued growth of the plants. Photos 20 and 21 in Attachment B document the mitigation area during the monitoring visit.

Native plant growth was noted throughout the DG-4B mitigation area, likely both from natural recruitment and from seeding. Native plants such as tarragon (*Artemisia dracunculus*), mugwort, mulefat, cobweb thistle, tall flatsedge, California poppy, and stinging nettle were observed sprouting in the DG-4B mitigation area.

Nonnative weed cover in DG-4B was estimated to be approximately 5 to 10 percent, which is approximately five percent more than the percentage of nonnative cover that was observed during the previous qualitative monitoring event. Most nonnative annuals were observed to be dead for the season; however, some new germination was observed. Nonnative species observed in DG-4B included black mustard, poison hemlock and perennial pepperweed.

Photo 20: Overview Mitigation Area DG-4B

Photo 21: Overview Mitigation Area DG-4B

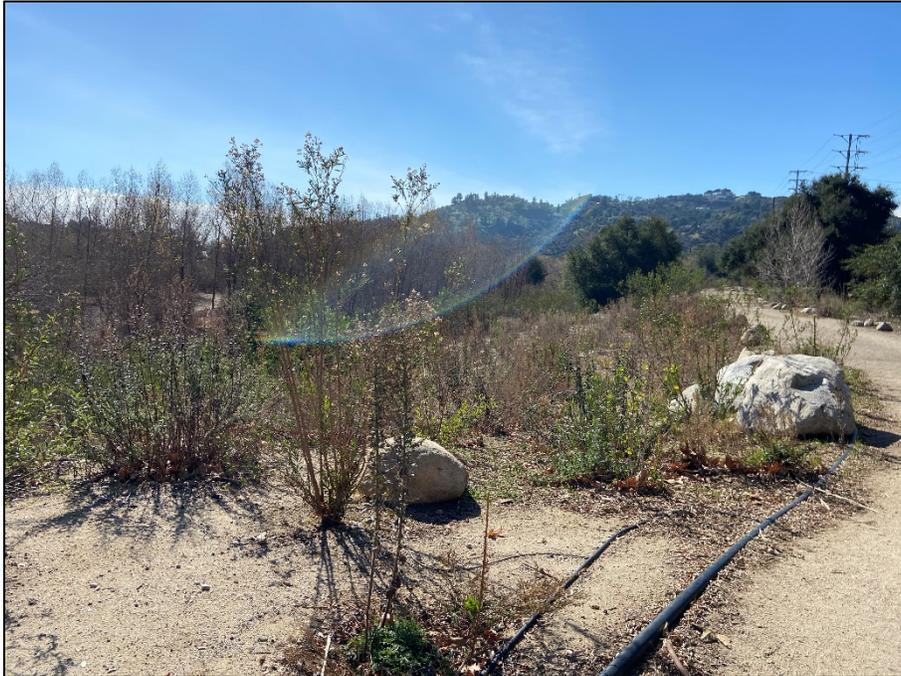
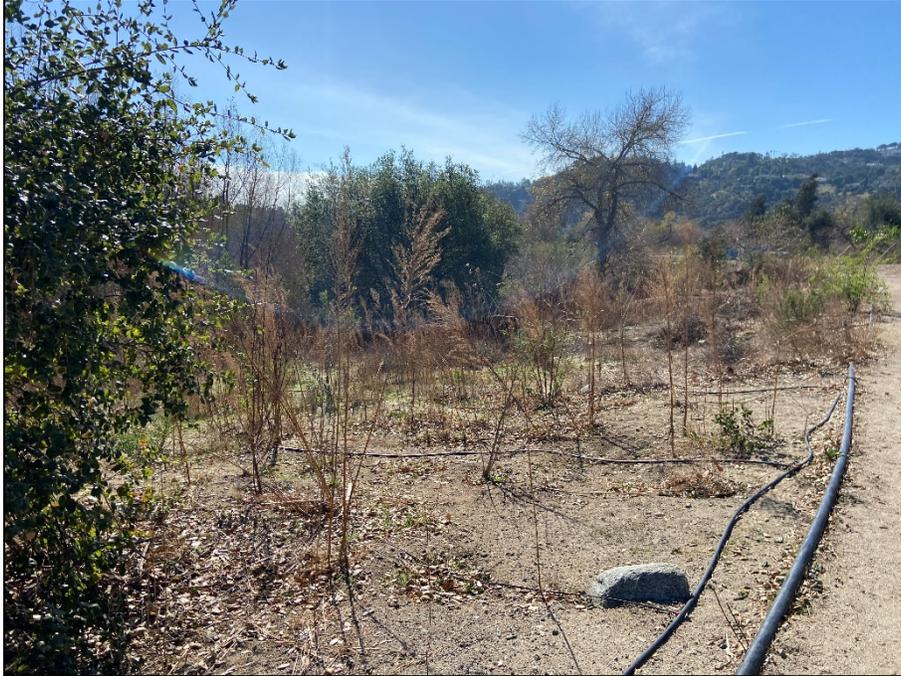
The overall health of the container plants in mitigation area DG-4C was noted as being good. Approximately 10 percent of all container plants were noted as showing varied levels of stress, which is approximately the same percentage of plants that were showing stress during the previous qualitative monitoring event. The types of stress the plants were exhibiting are the same as those described for the plants in DG-2A. A negligible number of container plants were noted as being missing or dead. Formal mortality counts were taken for DG-4C during the quantitative monitoring and will be included in the annual reporting. Similar to DG-4, the container planted willow species and Fremont's cottonwood were showing signs of seasonal dieback. Some of the planting basins were observed to have minor erosion and should be repaired. The installation of plants in the DG-4C mitigation area appears to have been completed successfully and the issues noted during the monitoring are not expected to have an impact on the continued growth of the plants. Photos 22 and 23 in Attachment B document the mitigation area during the monitoring visit.

Native plant growth was noted throughout the DG-4C mitigation area, likely both from natural recruitment and from seeding. Native plants such as mugwort, mulefat, California poppy, telegraph weed, caterpillar phacelia, and stinging nettle were observed sprouting in the DG-4C mitigation area.

Nonnative weed cover in DG-4C was estimated at approximately 10 to 15 percent, which is approximately 5 percent higher than the level of nonnative cover that was observed during the previous qualitative monitoring event. Nonnative species observed in DG-4C included wild oat (*Avena fatua*), black mustard, perennial pepperweed, and white horehound.

Photo 22: Overview Mitigation Area DG-4C

Photo 23: Overview Mitigation Area DG-4C

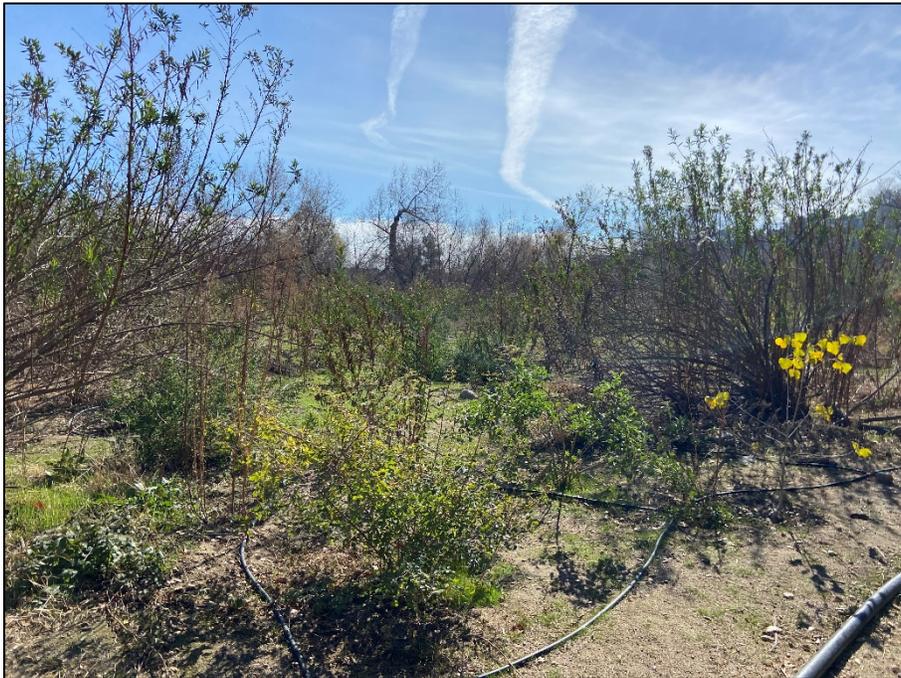
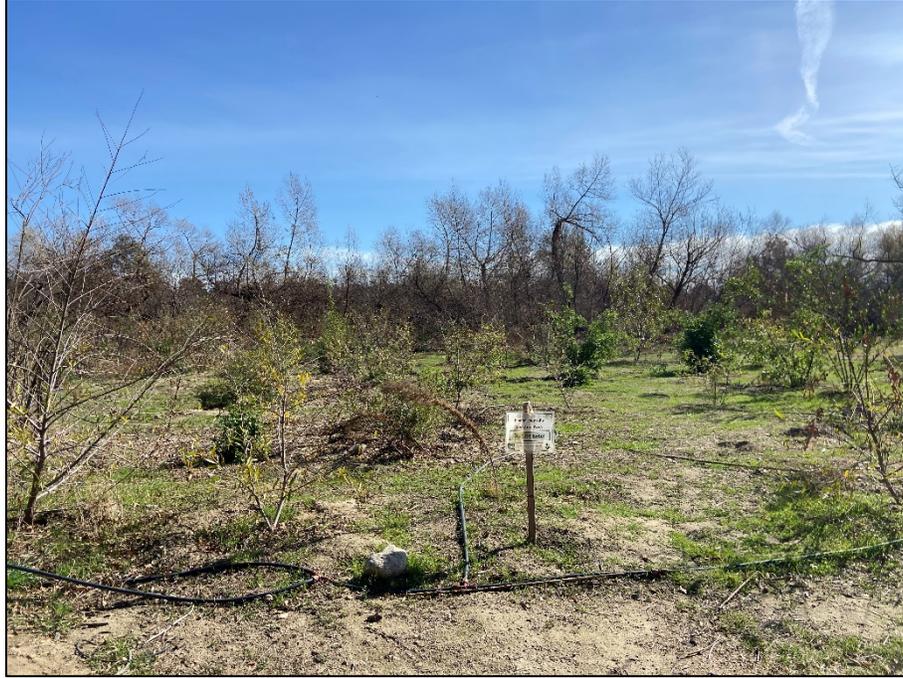
The overall health of the container plants in the DG-5 mitigation area was noted as being good. Approximately 10 percent of all container plants were noted as showing varied levels of stress, which is approximately five percent less than the percentage of plants that were showing stress during the previous qualitative monitoring event. While the 300-foot buffer around a least Bell's vireo nest that affected all of DG-5 has been removed, weed proliferation in this area prior to buffer removal likely contributed to plant stress and mortality. Gopher herbivory is also a significant problem in DG-5 and accounts for the majority of the missing container plants. In addition, gopher activity has increased the level of basin degradation and many basins need repair. Formal mortality counts were taken for DG-5 during the quantitative monitoring and will be included in the annual reporting. Similar to DG-4, the container planted willow species and Fremont's cottonwoods were showing signs of seasonal dieback. Some of the planting basins were observed to have minor erosion and should be repaired. The installation of plants in the DG-5 mitigation area appears to have been completed successfully and the issues noted during the monitoring are not expected to have a negative impact on the continued growth of the plants. Photos 24 and 25 in Attachment B document the mitigation area during the monitoring visit.

Native plant growth was noted throughout the DG-5 mitigation area, likely both from natural recruitment and from seeding. Native plants such as mugwort, mulefat, caterpillar phacelia, and stinging nettle were observed sprouting in the DG-5 mitigation area.

Nonnative weed cover in DG-5 was estimated at approximately 15 to 20 percent, which is approximately 10 percent higher than the percent of nonnative weed cover that was observed during the previous qualitative monitoring event. Nonnative species observed in DG-5 included wild oat, poison hemlock, red-stemmed filaree (*Erodium cicutarium*), common barley (*Hordeum vulgare*), perennial pepperweed, and white horehound.

Photo 24: Overview Mitigation Area DG-5

Photo 25: Overview Mitigation Area DG-5

Rabbit herbivory of container plants was observed in the Phase 1 mitigation areas. California rose, California buckwheat, and basket rush (*Juncus texilis*) appeared to be the most affected by herbivory. In addition, gopher herbivory of container plants was observed in DG-5. Minor herbivory generally will not kill the plants, but continued monitoring should be conducted during future visits to determine the level of the herbivory isn't such that plants are dying. If browsing by rabbits or other animals begins to worsen, caging around affected and/or favored container plants may be warranted. In addition, below grade gopher traps should be installed at DG-5 to remove the gophers from this area.
