July 28, 2021
2018-047.031

Re: *Devil's Gate Reservoir Restoration Project – Phase 2 Restoration Plant Establishment Period Monitoring Conducted on July 15, 2021*

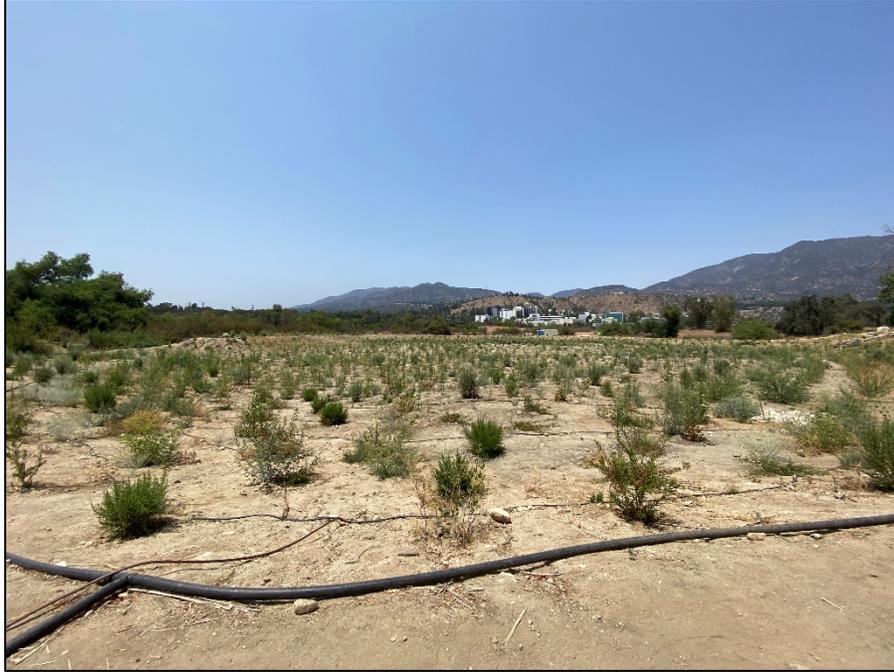
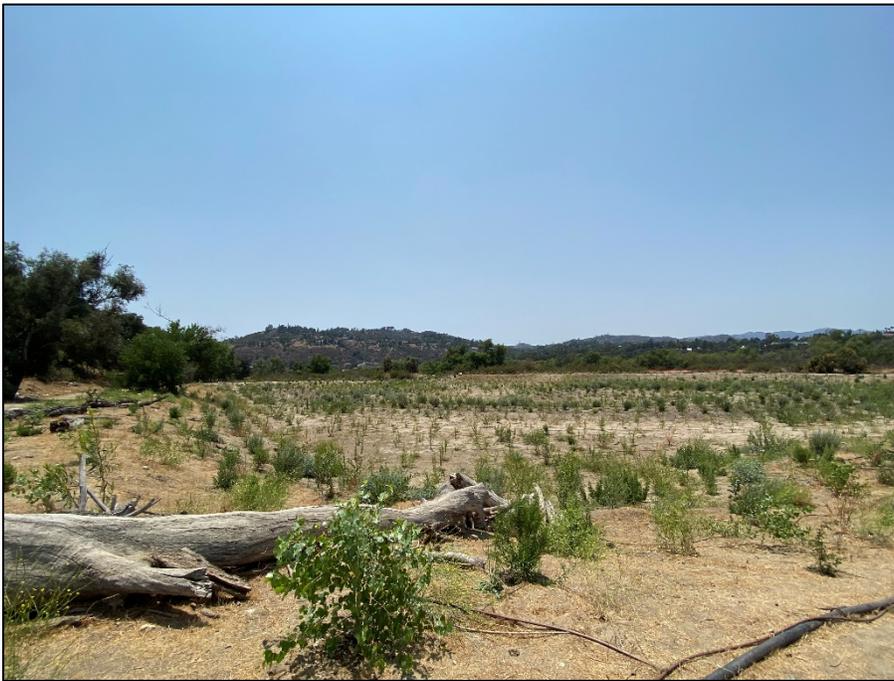
The overall health of the container plants in DG-W-1 was noted as being good. Approximately five to ten percent of the container plants in DG-W-1 were noted as showing varied levels of stress and a negligible number were noted as being dead or missing. This is the same percentage of plants that were showing stress during the last monitoring event. Stress may be occurring as a result of 1) transplant shock 2) herbivory by rabbits or other wildlife, 3) competition from nonnative and invasive weeds, 4) misplaced emitters, 5) recreational traffic through the mitigation areas, or 6) drought stress caused by recent high temperatures. Formal mortality counts were taken for DG-W-1 during the 2021 quantitative monitoring and will be included in the 2021 annual reporting. Some of the container plants were noted as lacking well defined basins and should have their basins properly constructed and/or repaired. The installation of plants in the DG-W-1 mitigation area appears to have been completed successfully. The current issues identified during the monitoring visit are not expected to have an effect on the continued growth of the plants in the mitigation area. Photos 1 through 2 in Attachment B document the mitigation area during the monitoring visit.

Photo 1: Overview Mitigation Area DG-W-1 (Johnson Field)

Photo 2: Overview Mitigation Area Overview Mitigation Area DG-W-1 (Johnson Field)

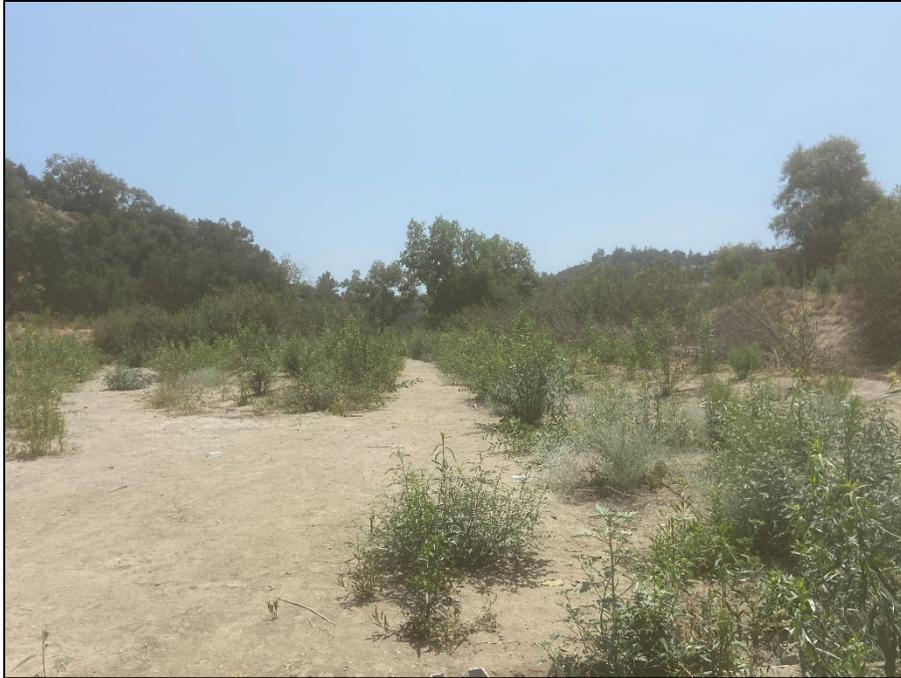
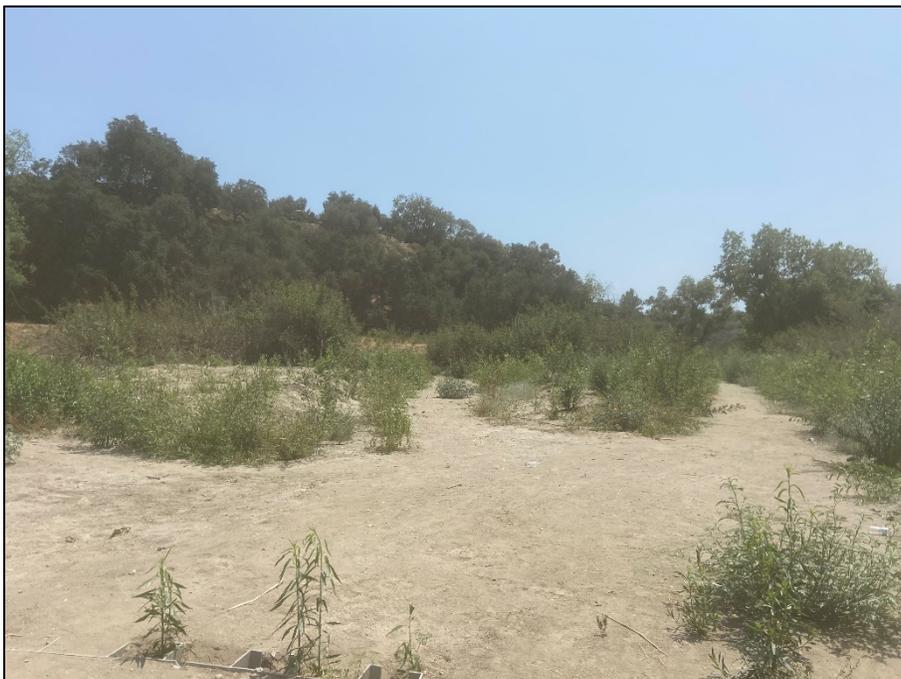
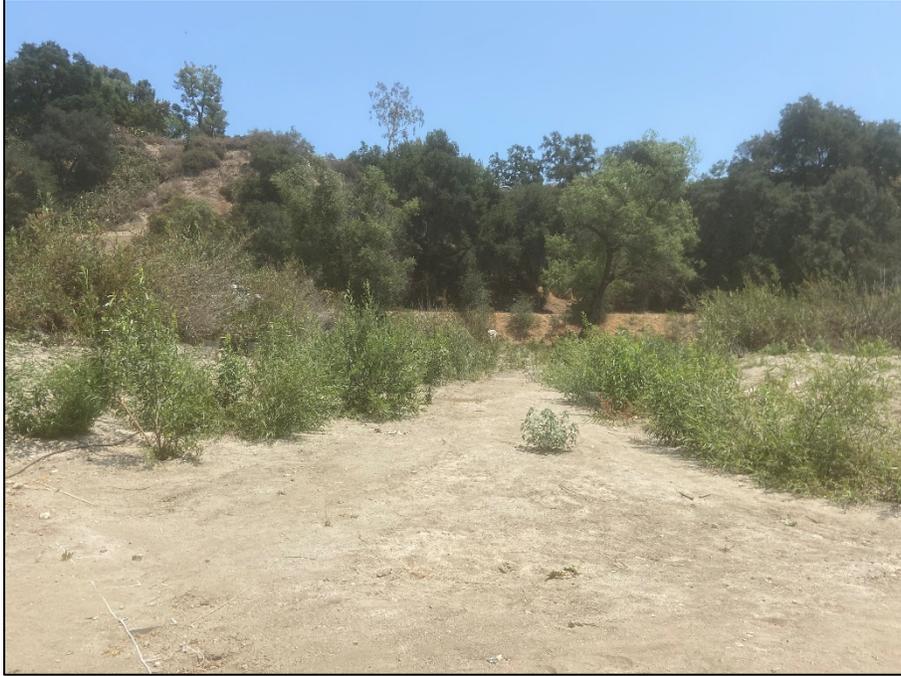
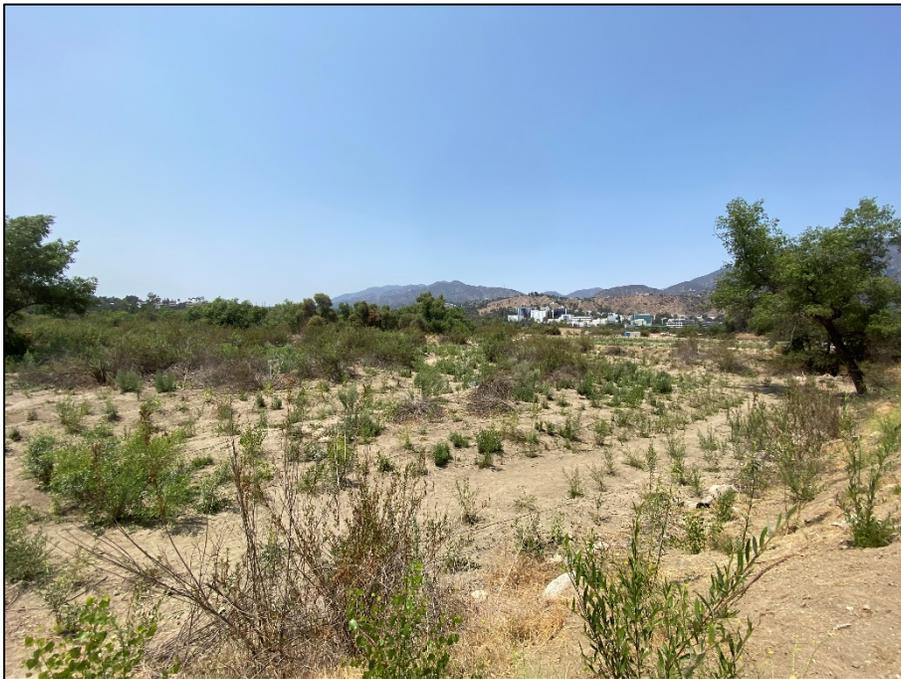
The overall health of the container plants in DG-2, DG-2 New Channels, and DG-2 WOUS was noted as being good. Approximately five to ten percent of the container plants were noted as showing varied levels of stress and a negligible number were noted as being dead or missing. This is the same percentage of plants that were showing stress during the last monitoring event. Stress may be occurring due to similar reasons described for DG-W-1. Formal mortality counts were taken for DG-2, DG-2 New Channels, and DG-2 WOUS during the 2021 quantitative monitoring and will be included in the 2021 annual reporting. Some of the container plants were noted as lacking well defined basins and should have their basins properly constructed and/or repaired. The installation of plants in the DG-2, DG-2 New Channels, and DG-2 WOUS mitigation areas appears to have been completed successfully. The current issues identified during the monitoring visit are not expected to have an effect on the continued growth of the plants in the mitigation area. Photos 3 through 6 in Attachment B document the mitigation areas during the monitoring visit.

Photo 3: Overview Mitigation Area Overview Mitigation Area DG-2 & DG-2 New Channels

Photo 4: Overview Mitigation Area DG-2 & DG-2 New Channels

Photo 5: Overview Mitigation Area DG-2 & DG-2 WOUS

Photo 6: Overview Mitigation Area DG-2, DG-2 New Channels, DG-2 WOUS

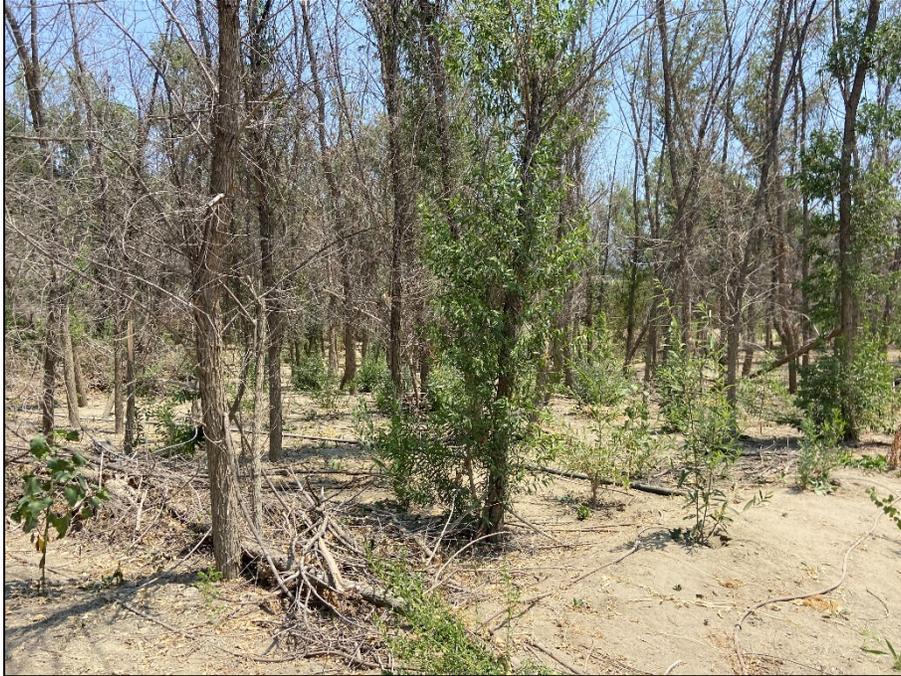
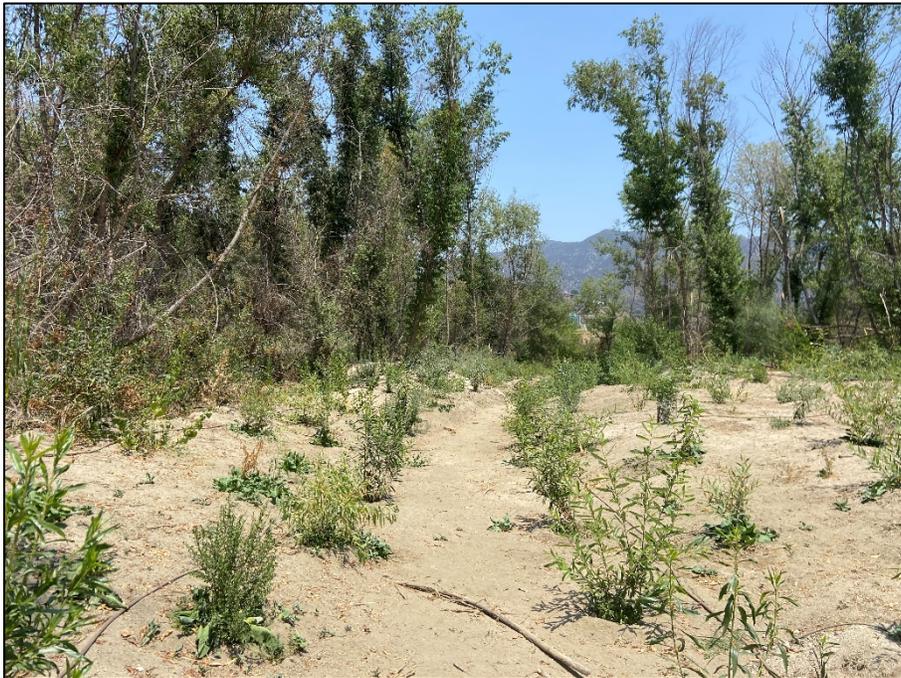
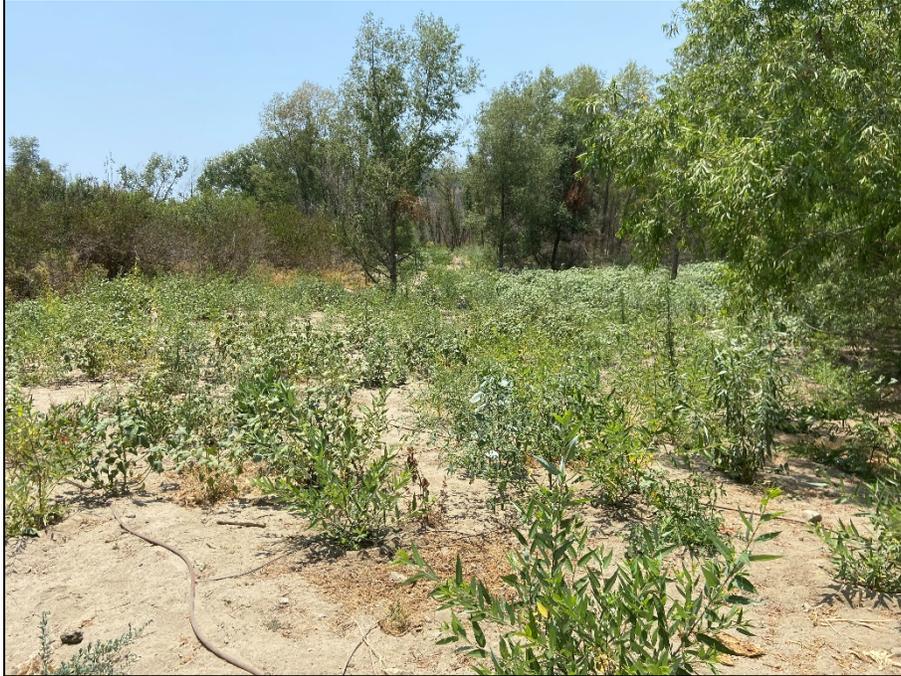
The overall health of the container plants in mitigation area DG-W-2 was noted as being good. Approximately 15 to 20 percent of container plants were showing varied levels of stress which is approximately five percent more than the level of stress observed during the last monitoring event. Stress may be occurring due to similar reasons described for DG-W-1; however, recent high temperatures appear to be contributing to a higher level of drought stress in this mitigation area. Formal mortality counts were taken for DG-W-2 during the 2021 quantitative monitoring and will be included in the 2021 annual reporting. Some of the container plants were noted as lacking well defined basins and should have their basins properly constructed and/or repaired. In addition, minor herbivory of young plants was observed within the DG-W-2 mitigation area and should continue to be monitored. The installation of

plants in the DG-W-2 mitigation area appears to have been completed successfully and the issues noted during the monitoring are not expected to have an impact on the continued growth of the plants. Photos 7 through 9 in Attachment B document the mitigation area during the monitoring visit.

Photo 7: Overview Mitigation Area DG-W-2 (Mining Pit)

Photo 8: Overview Mitigation Area DG-W-2 (Mining Pit)

Photo 9: Overview Mitigation Area DG-W-2 (Mining Pit)

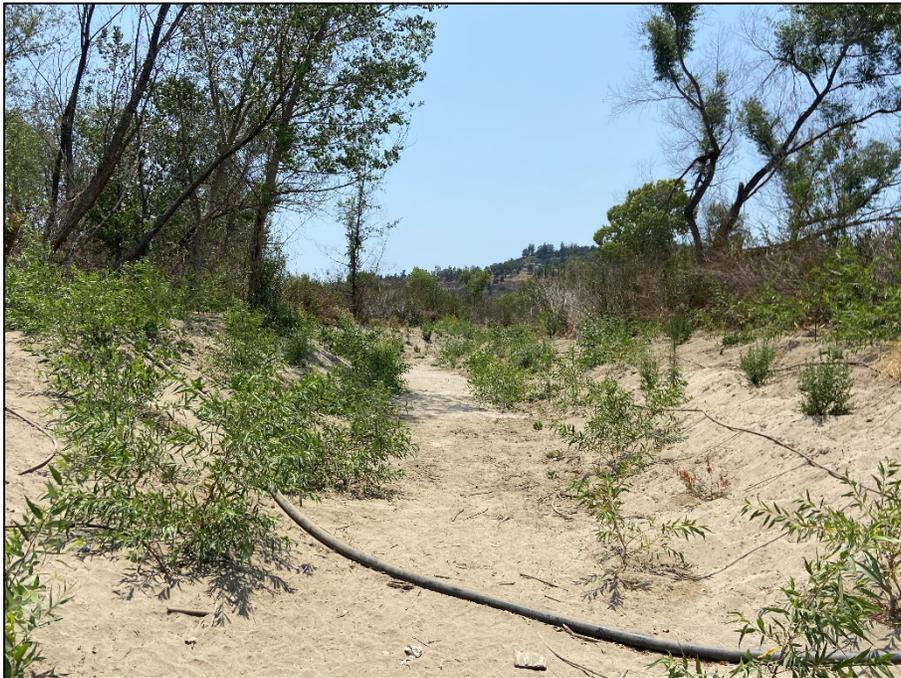
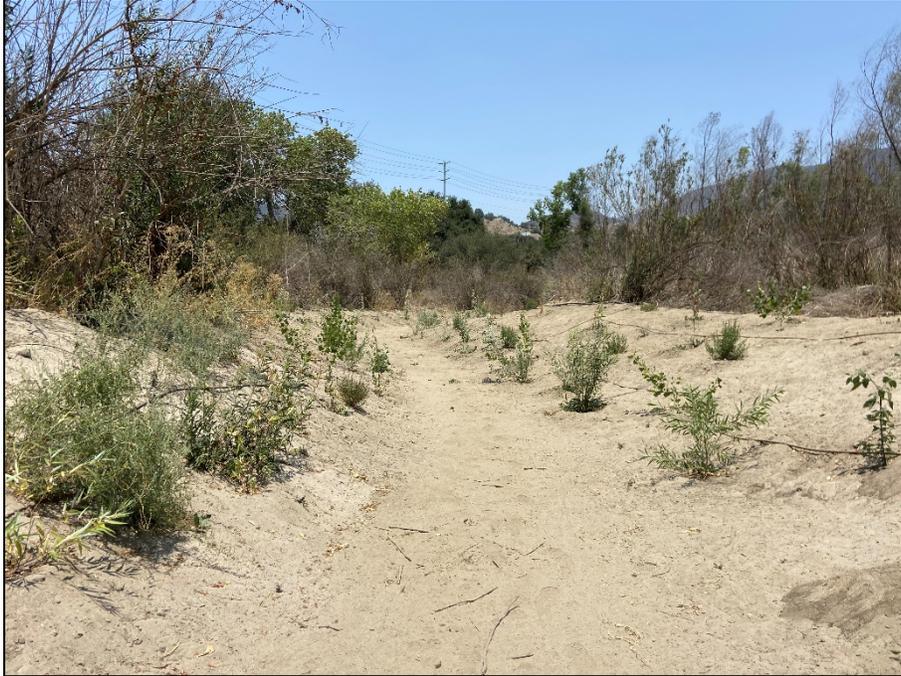
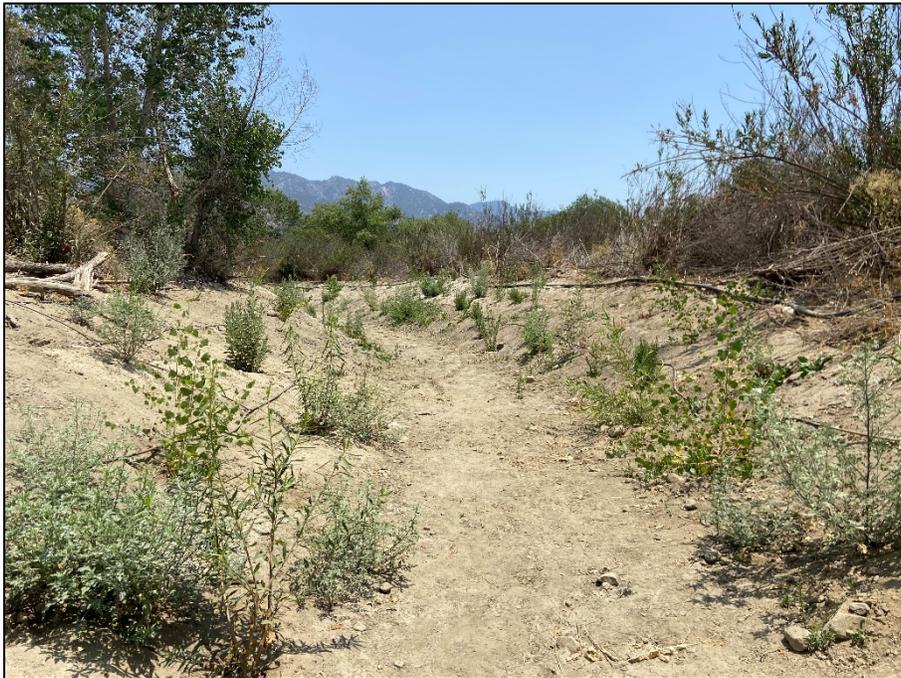
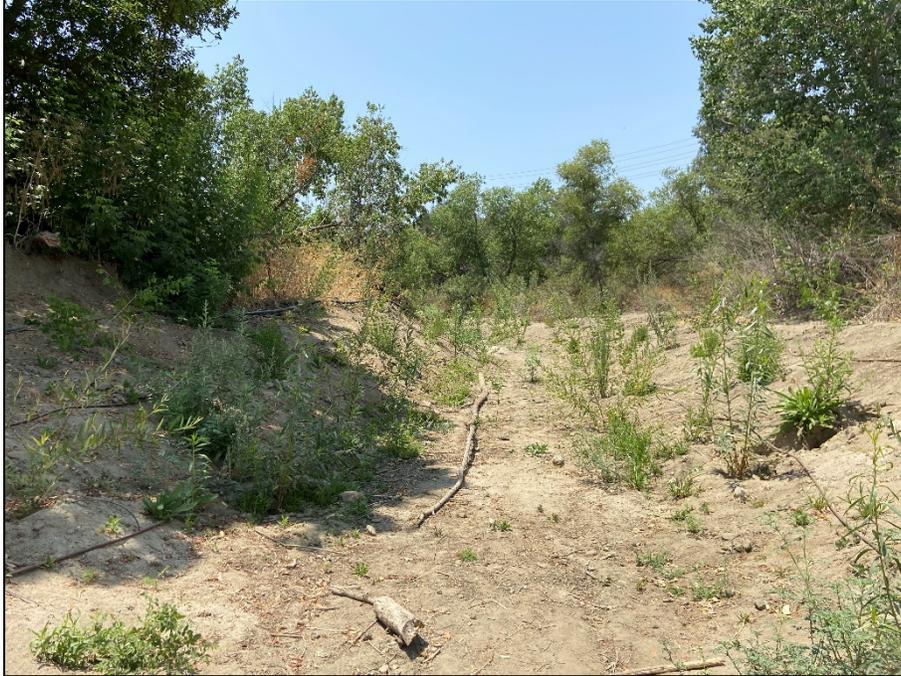
The overall health of the container plants in mitigation area DG-W-2 Outlet was noted as being good. Approximately 10 to 15 percent of the container plants were noted as showing varied levels of stress and a negligible number were noted as being dead or missing. Stress may be occurring due to similar reasons described for DG-W-1; however, recent high temperatures appear to be contributing to a higher level of drought stress in this mitigation area. Formal mortality counts were taken for DG-W-2 Outlet during the 2021 quantitative monitoring and will be included in the 2021 annual reporting. Some of the container plants were noted as lacking well defined basins and should have their basins properly constructed and/or repaired. In addition, minor herbivory of young plants was observed within the DG-W-2 Outlet mitigation area and should continue to be monitored. The installation of plants in the DG-W-2 Outlet mitigation area appears to have been completed successfully and the issues noted during the monitoring are not expected to have an impact on the continued growth of the plants. Photos 10 through 13 in Attachment B document the mitigation area during the monitoring visit.

Photo 10: Overview Mitigation Area DG-W-2 (Mining Pit Outlet)

Photo 11: Overview Mitigation Area DG-W-2 (Mining Pit Outlet)

Photo 12: Overview Mitigation Area DG-W-2 (Mining Pit Outlet)

Photo 13: Overview Mitigation Area DG-W-2 (Mining Pit Outlet)

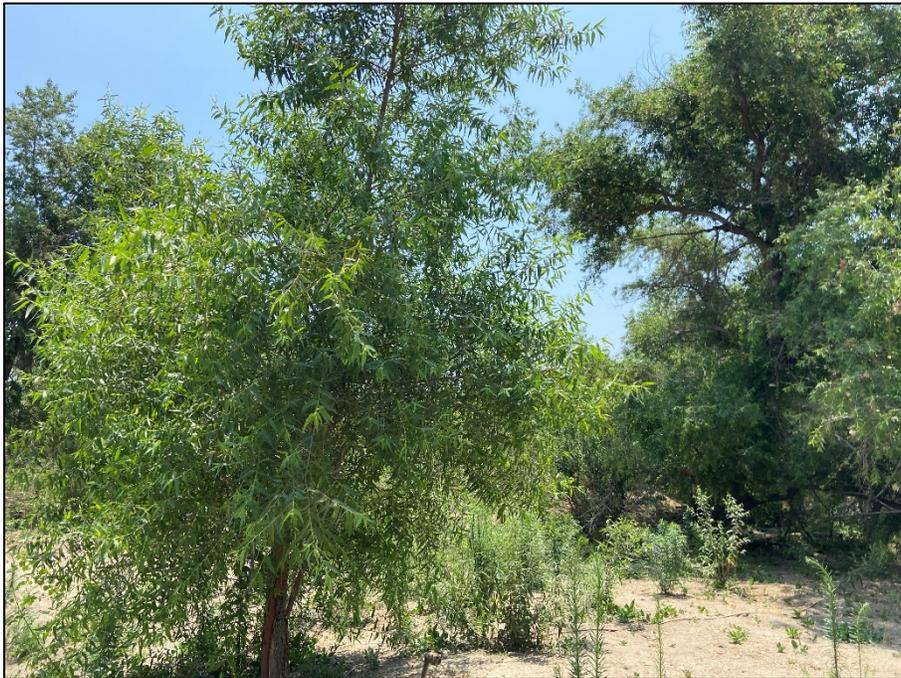
The overall health of the container plants in mitigation areas DG-4 Sheet Flow (northern) and DG-SF-1 was noted as being good. Approximately five to ten percent of container plants were showing varied levels of stress which is approximately five percent less than the percentage of container plants that were showing stress during the previous monitoring event. Stress may be occurring due to similar reasons described for DG-W-1; however, recent high temperatures appear to be contributing to a higher level of drought stress in this mitigation area. Formal mortality counts were taken during the 2021 quantitative monitoring and will be included in the 2021 annual reporting. Some of the container plants were noted as lacking well defined basins and should have their basins properly constructed and/or repaired. In addition, minor herbivory of young plants was observed within the DG-4 Sheet Flow and DG-SF-1 areas and should continue to be monitored. The installation of plants in the DG-4 Sheet Flow and DG-SF-1 mitigation areas appears to have been completed successfully and the issues noted during the monitoring are not expected to have an impact on the continued growth of the plants. Photo 14 in Attachment B documents the mitigation area during the monitoring visit.

Photo 14: Overview Mitigation Area DG-4 Sheet Flow/DG-SF-1
