November 17, 2021
2018-047.031

**Re: Devil's Gate Reservoir Restoration Project – Phase 2 Restoration Qualitative Monitoring
Conducted on October 20, 2021**

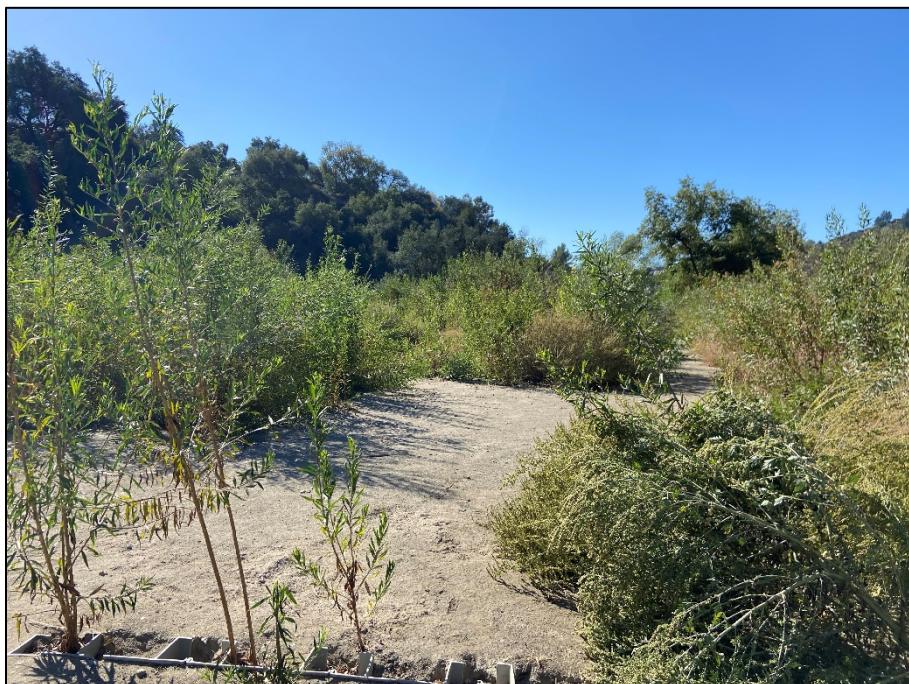
Photo 4: Overview Mitigation Area DG-2 & DG-2 New Channels

The overall health of the container plants in DG-2, DG-2 New Channels, and DG-2 WOUS was noted as being good. Approximately 10 to 15 percent of the container plants were noted as showing varied levels of stress and a negligible number were noted as being dead or missing. This is approximately 5 to 10 percent more than the percentage of plants that were showing stress during the last monitoring event. Stress may be occurring due to similar reasons described for DG-W-1. Formal mortality counts were taken for DG-2, DG-2 New Channels, and DG-2 WOUS during the 2021 quantitative monitoring and will be included in the 2021 annual reporting. Some of the container plants were noted as lacking well defined basins and should have their basins properly constructed and/or repaired. The installation of plants in the DG-2, DG-2 New Channels, and DG-2 WOUS mitigation areas appears to have been completed successfully. The current issues identified during the monitoring visit are not expected to have an effect on the continued growth of the plants in the mitigation area. Photos 4 through 11 in Attachment B document the mitigation areas during the monitoring visit.

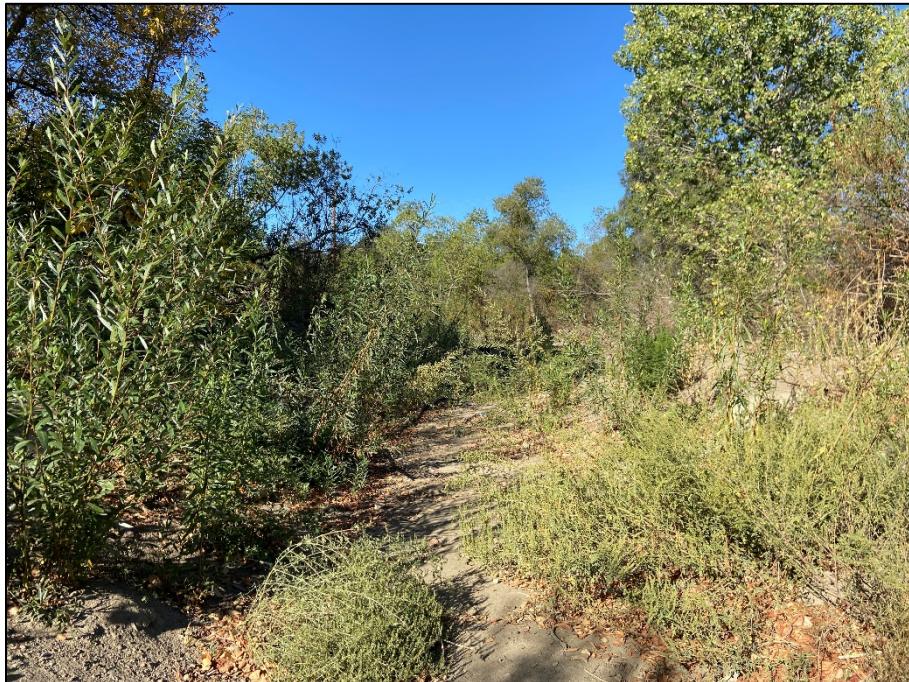
Photo 12: Overview Mitigation Area DG-W-2 (Mining Pit Outlet)

an impact on the continued growth of the plants. Photos 12 through 13 in Attachment B document the mitigation area during the monitoring visit.
