CONDITION ASSESSMENT PROGRAM FISCAL YEAR 2005-06 PROJECT Y0TV0506A

The Sewer Condition Assessment Program utilizes the Pipeline Assessment and Certification Program (PACP). The enclosed report outlines the structural and maintenance ratings of your system based on PACP's rating methodology. Included in the report are the following:

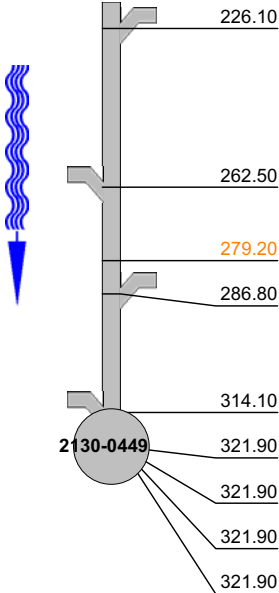
Date: 11/22/2005	P.O.#: Y0TV0506A	Weather: 1 Dry	Surveyed By: J.ALEJOS	section number: 634	PSR: 114082
Total Pipe Length:	Survey Customer: 26-007.00	System Owner: LAM	Clean Date:	Pre-Cleaned: J Jetting	Map Grid #: 2130

1:528	position	code	observation	MPEG	photo	grade
	226.10	TFA	Tap Factory Made Active, at 10 o'clock, 6", within 8 inch: NO	00:14:08	262a	
	262.50	TFA	Tap Factory Made Active, at 02 o'clock, 6", within 8 inch: NO, Remark: ROOTS	00:14:57	263a	
	279.20	CM	Crack Multiple, from 11 to 04 o'clock, within 8 inch: YES	00:15:42	264a	S 3
	286.80	TFA	Tap Factory Made Active, at 10 o'clock, 6", within 8 inch: NO	00:16:08	265a	
	314.10	TFA	Tap Factory Made Active, at 02 o'clock, 6", within 8 inch: NO	00:16:49	266a	
	321.90		SLIGHT CIRCULAR CRACKS THROUGHOUT 15% OF REACH	00:17:42		
	321.90		SLIGHT LONGITUDE CRACKS THROUGHOUT 10% OF REACH	00:18:13		
	321.90		END OF SEGMENT	00:18:26		
	321.90		MATERIALS FOUND-VCP	00:18:43
